## **DOVER HARBOUR BOARD**

### **HERITAGE RECORDING FOR THE PROMENADE**

### **TO THE DOVER WESTERN DOCKS, DOVER, KENT**

#### **Desktop Study**

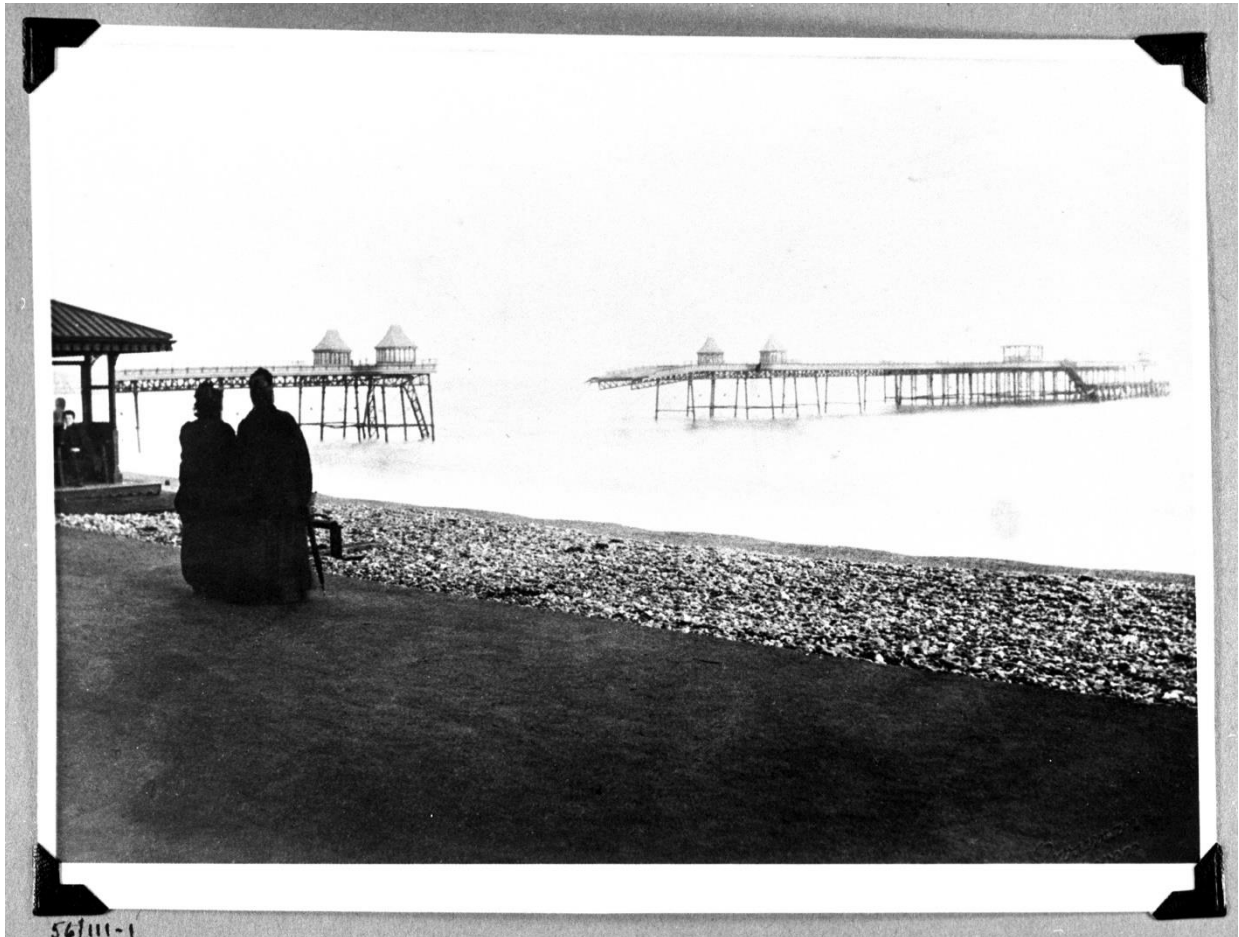
The 'Christine', collided with the pier in November in 1893, with a further 100ft being damaged by a storm in 1894, **Plates 1-5** show the damage to the pier. Maintenance and repairs took place and the pier was reopened on 4<sup>th</sup> August 1895 as seen in **Plate 3** ([Piers.org.uk](http://Piers.org.uk), 2016).

**Plate 1:** *The Pleasure Pier after it had suffered damage by a storm, c.1894, looking north-east, DHB.*

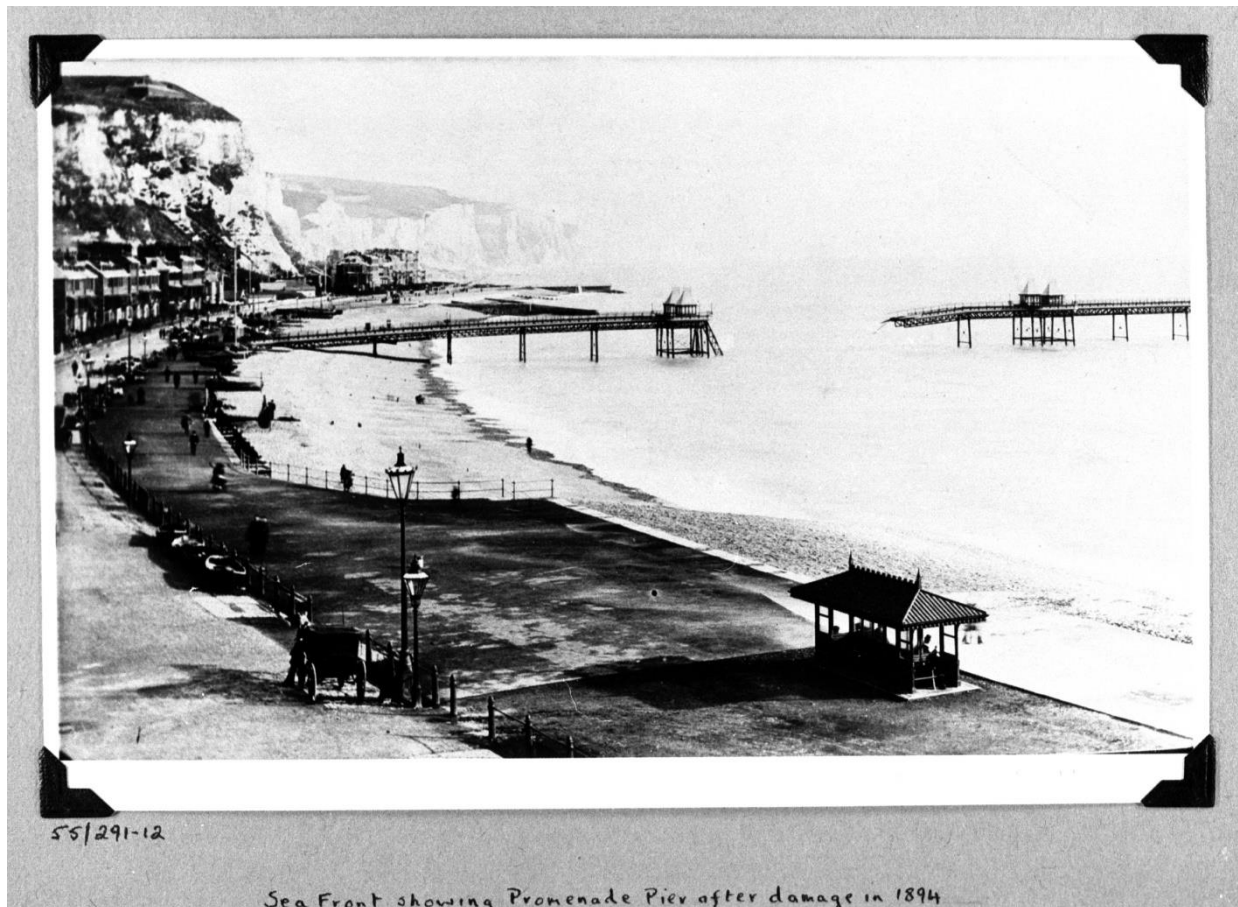
**Plate 2:** *The Pleasure Pier after it had suffered damage by storm, c.1894, looking North, Dover Museum d22111.*

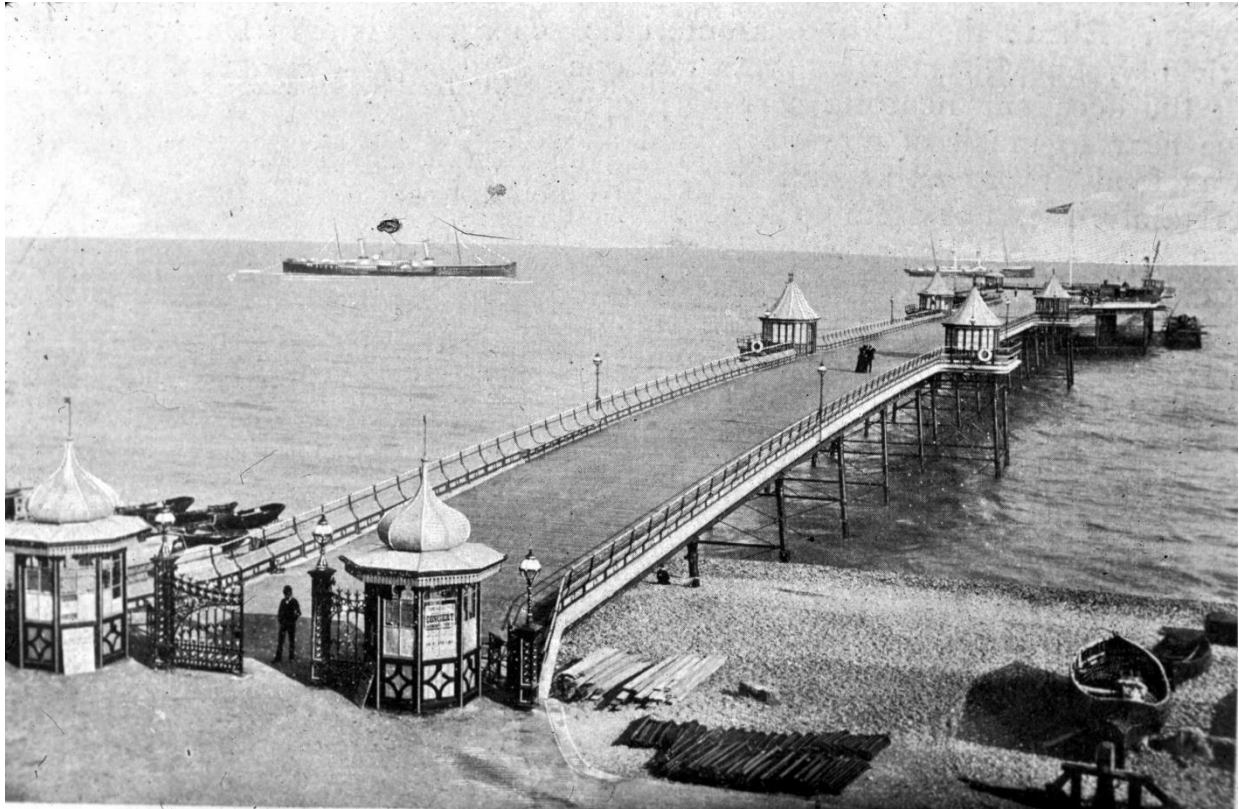
**Plate 3:** *The Pleasure Pier after its restoration, c.1895-1900, looking North, Dover Museum d25956.*

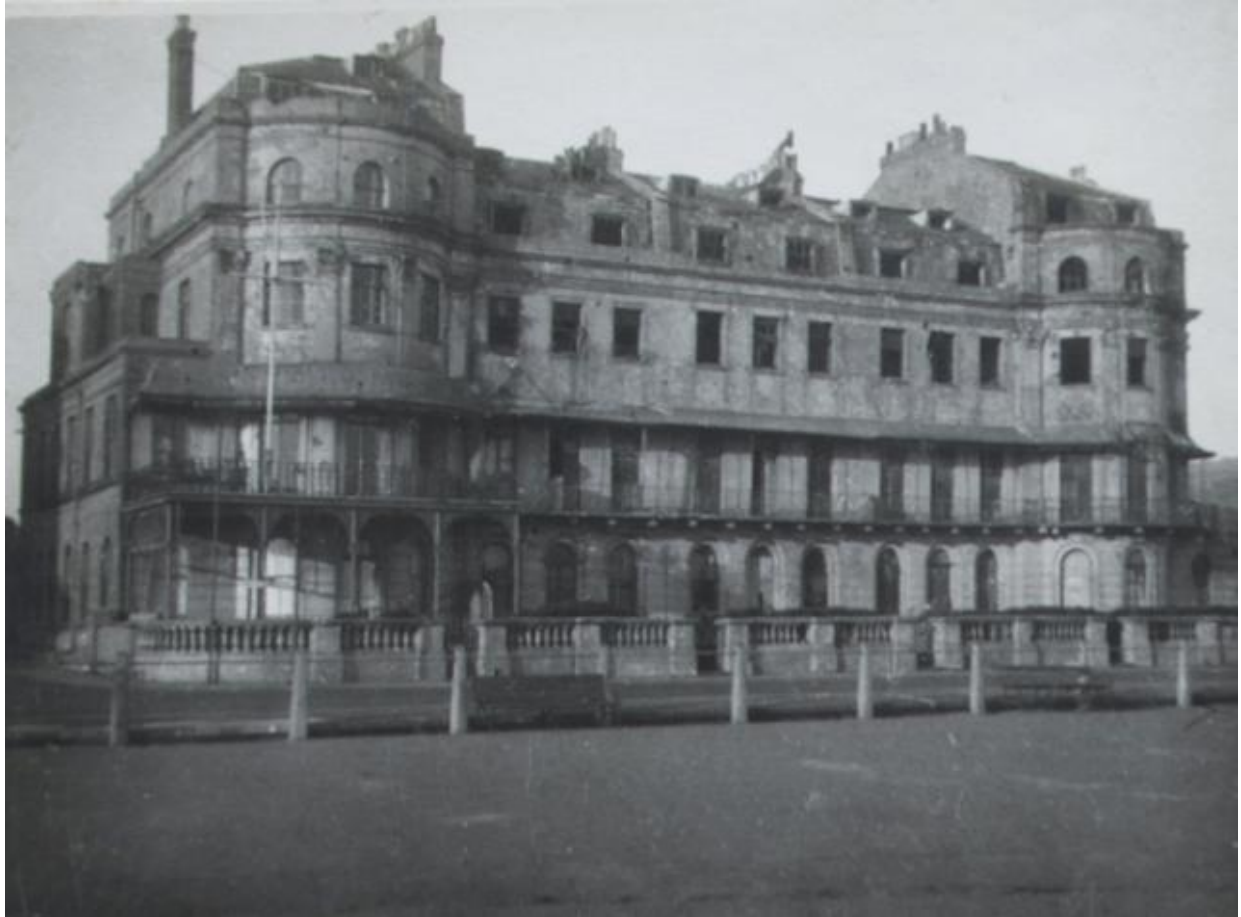
**Plate 20:** 3 Waterloo Crescent showing damages and dilapidation after WWII, c.1950, looking north-west, DHB.

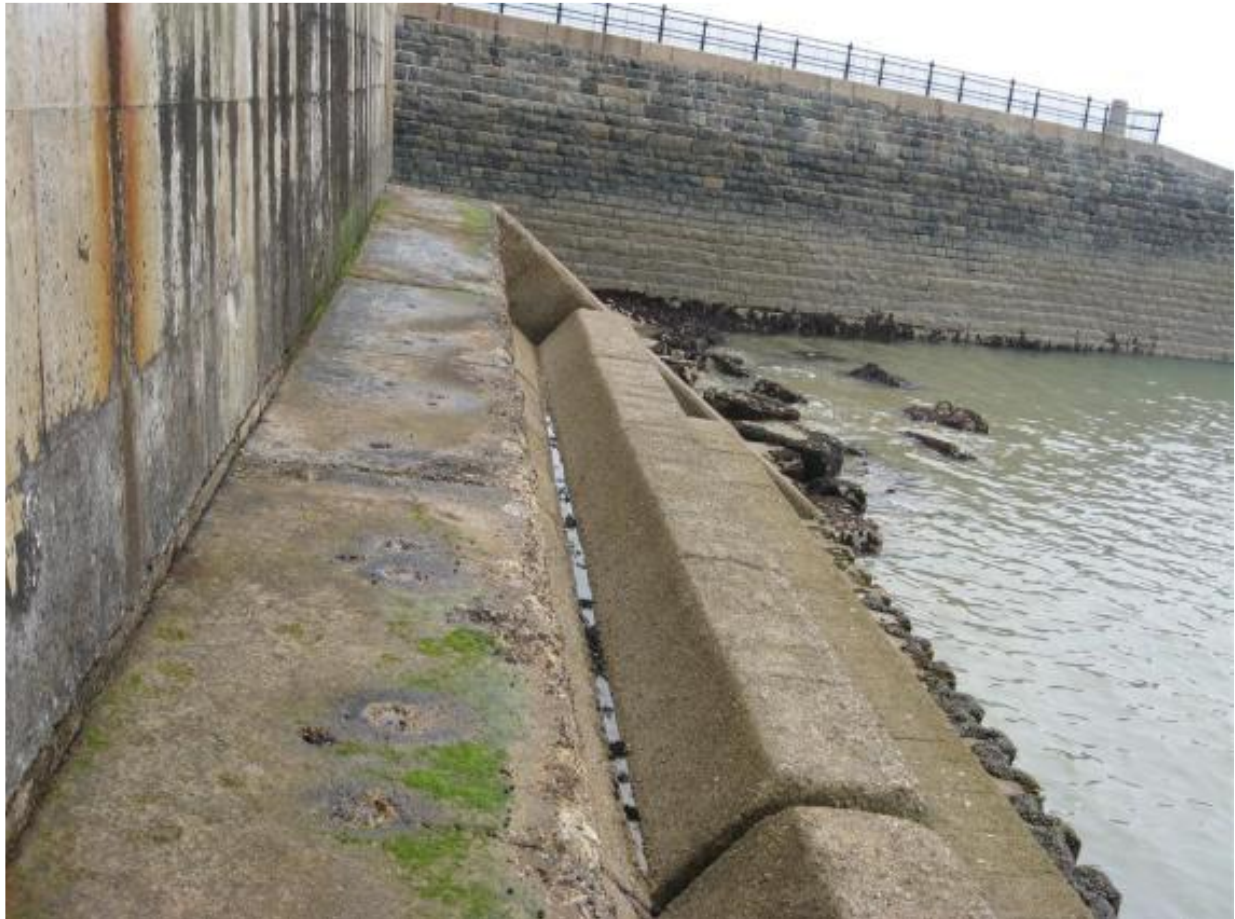
**Plate 53:** *Concrete spalling with a masonry base, could have been installed as a tank or sea defence, 2013, looking North, Atkins 2014, 16.*

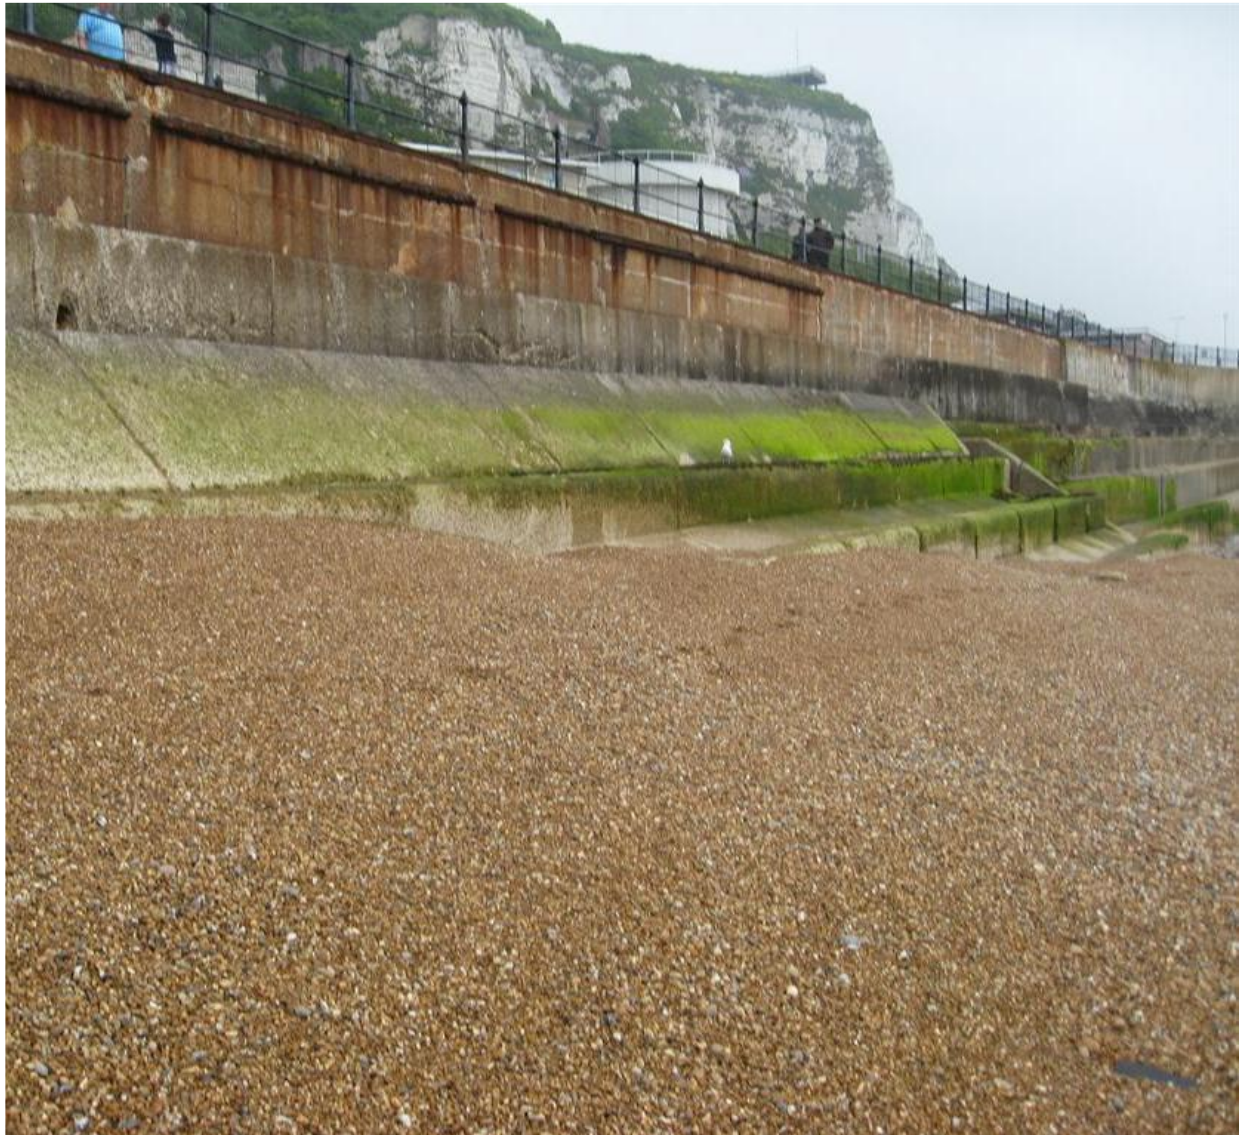
**Plate 54:** *Marine Growth along the concrete additions to the sea wall, 2013, looking North, Atkins 2014, 19.*

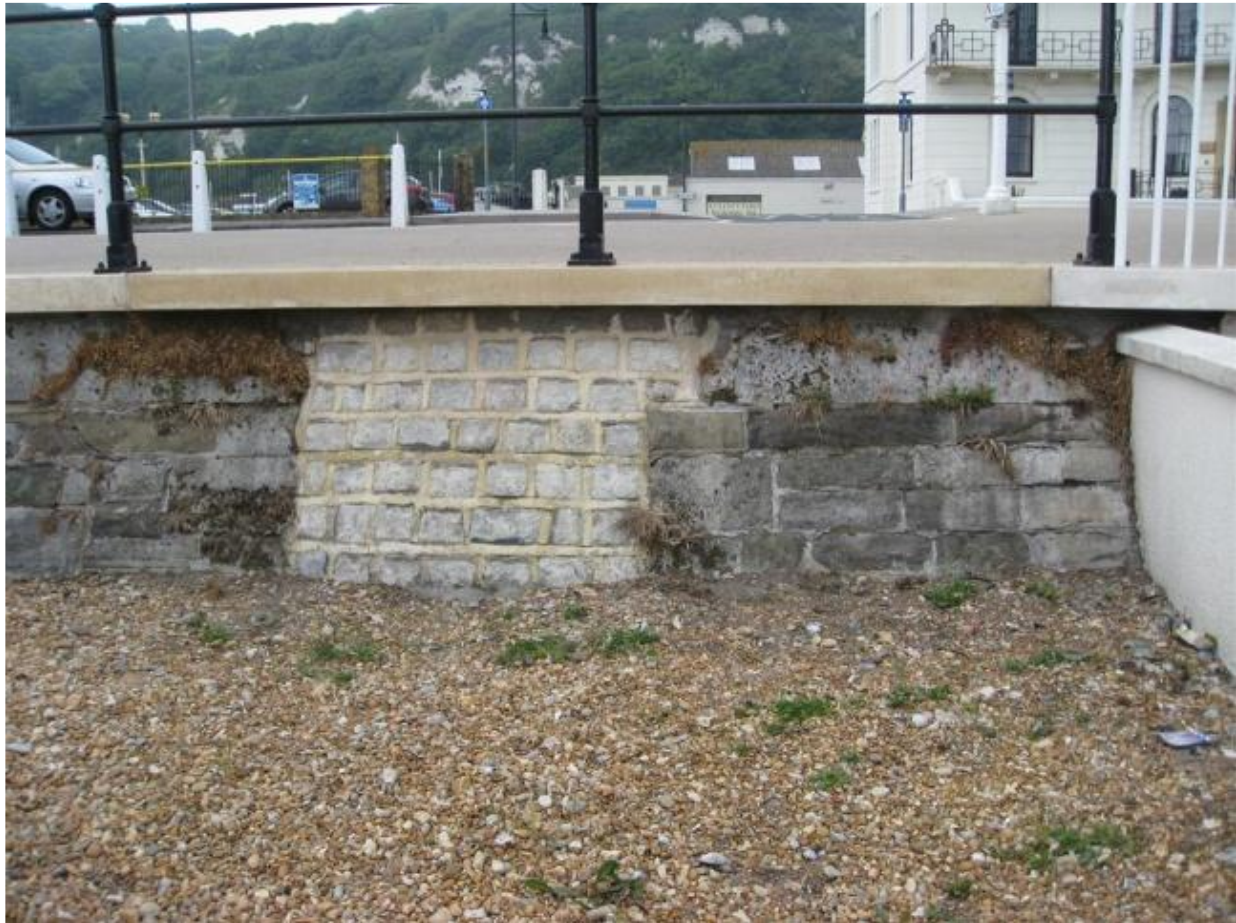
**Plate 64:** *A section of patched sea wall showing a clear change in material, outside of Harbour House, 2013, Atkins 2014, 31.*
