## **DOVER HARBOUR BOARD**

### **HERITAGE RECORDING PRINCE OF WALES PIER**

### **TO THE DOVER WESTERN DOCKS, DOVER, KENT**

### **Desktop Study**

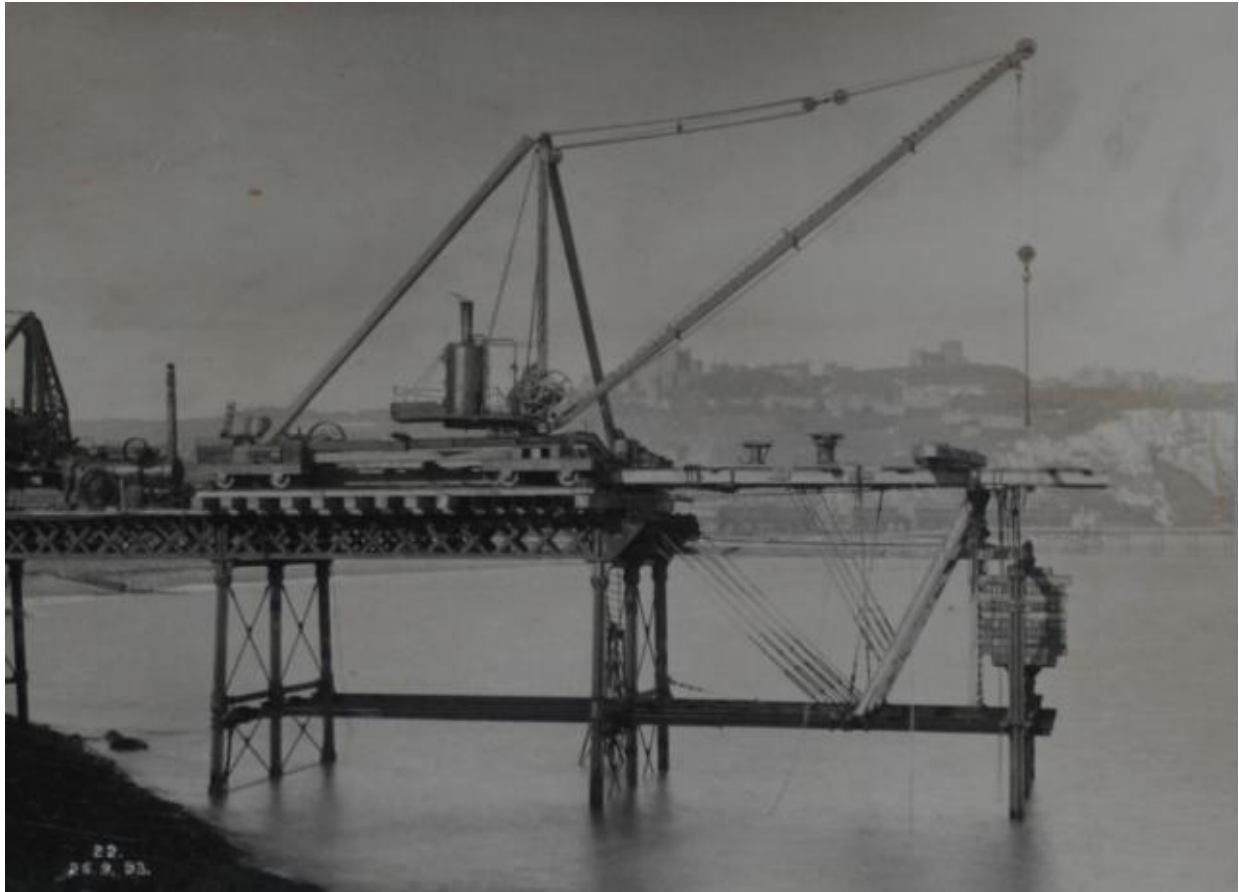
**Plate 5-** *An old steam crane working on the foundations of the Prince of Wales Pier, 1893, looking north, DHB.*

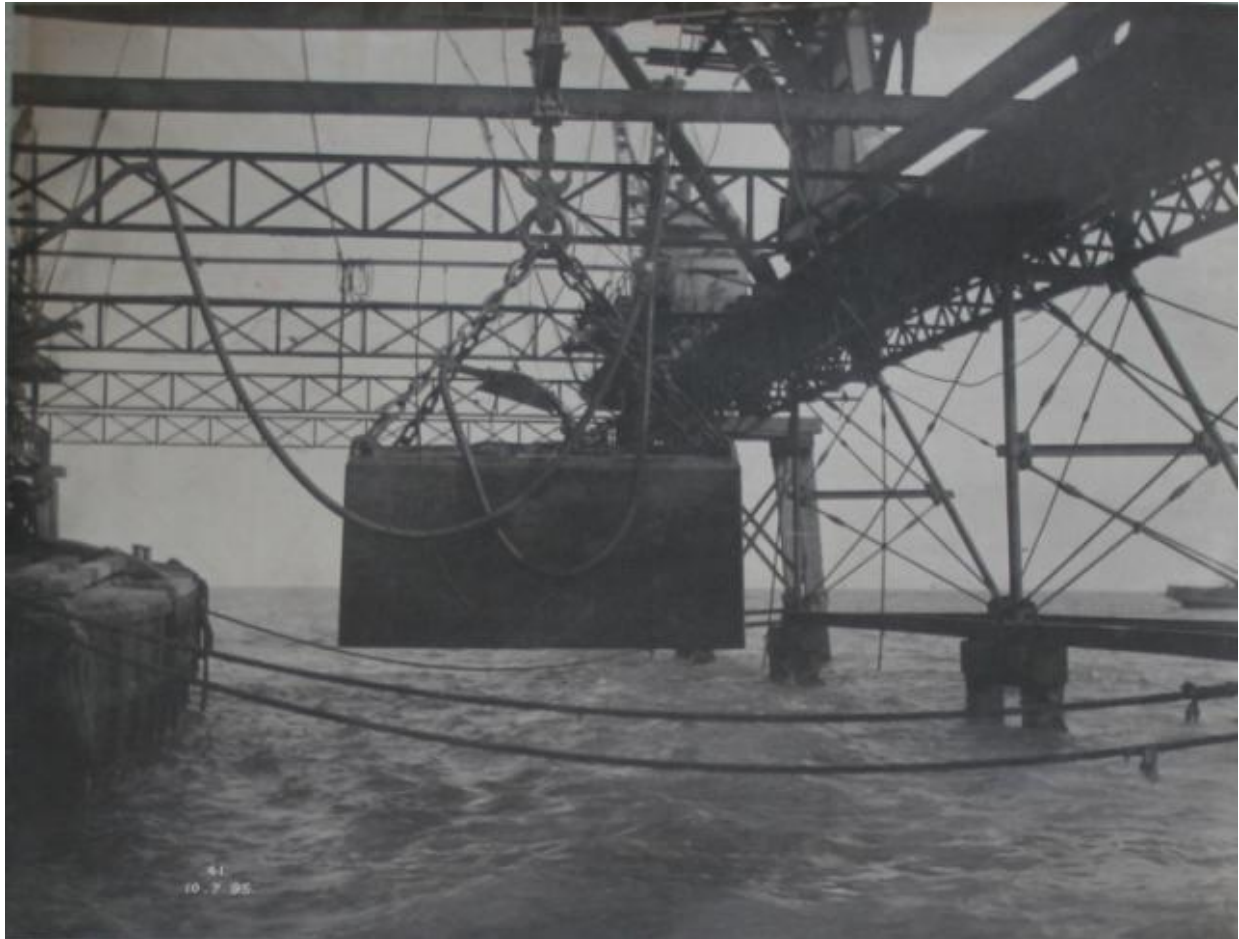
**Plate 10-** *Thought to be a diving bell to allow men to work on the sea bed c.1895, DHB.*

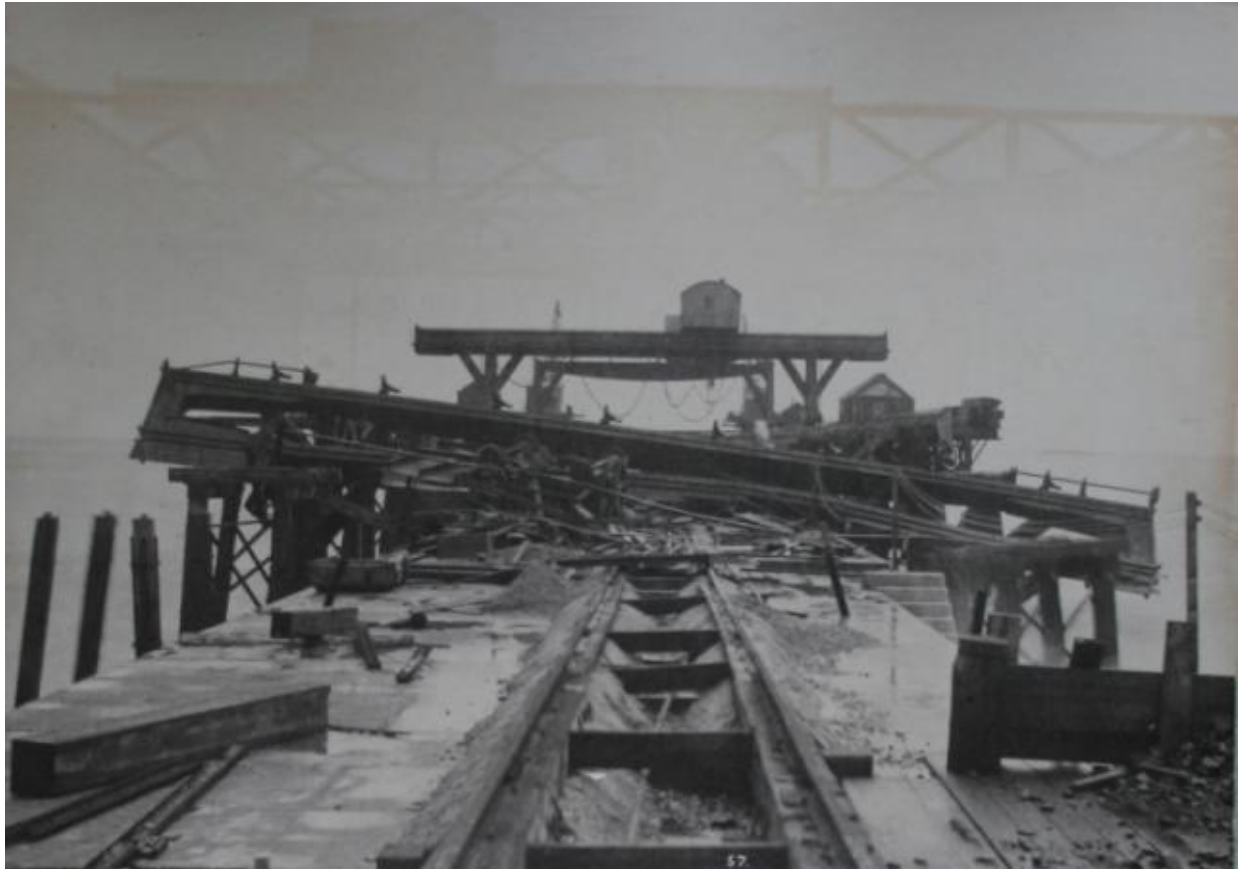
**Plate 13-** *Some of the lifting equipment has collapsed, c.1895, Looking south-east, DHB.*

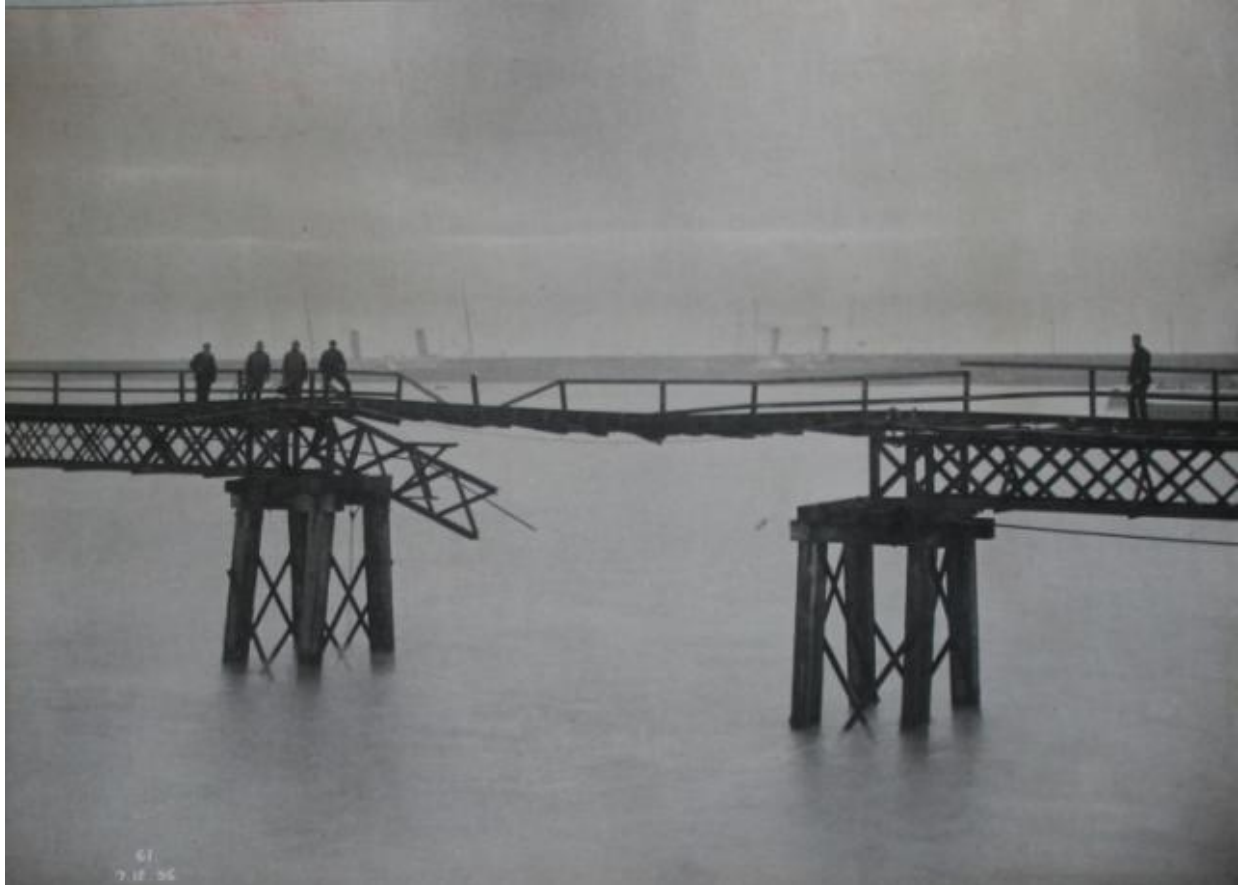
**Plate 14-** *A partially collapsed gangway c.1895, Looking north-east, DHB.*

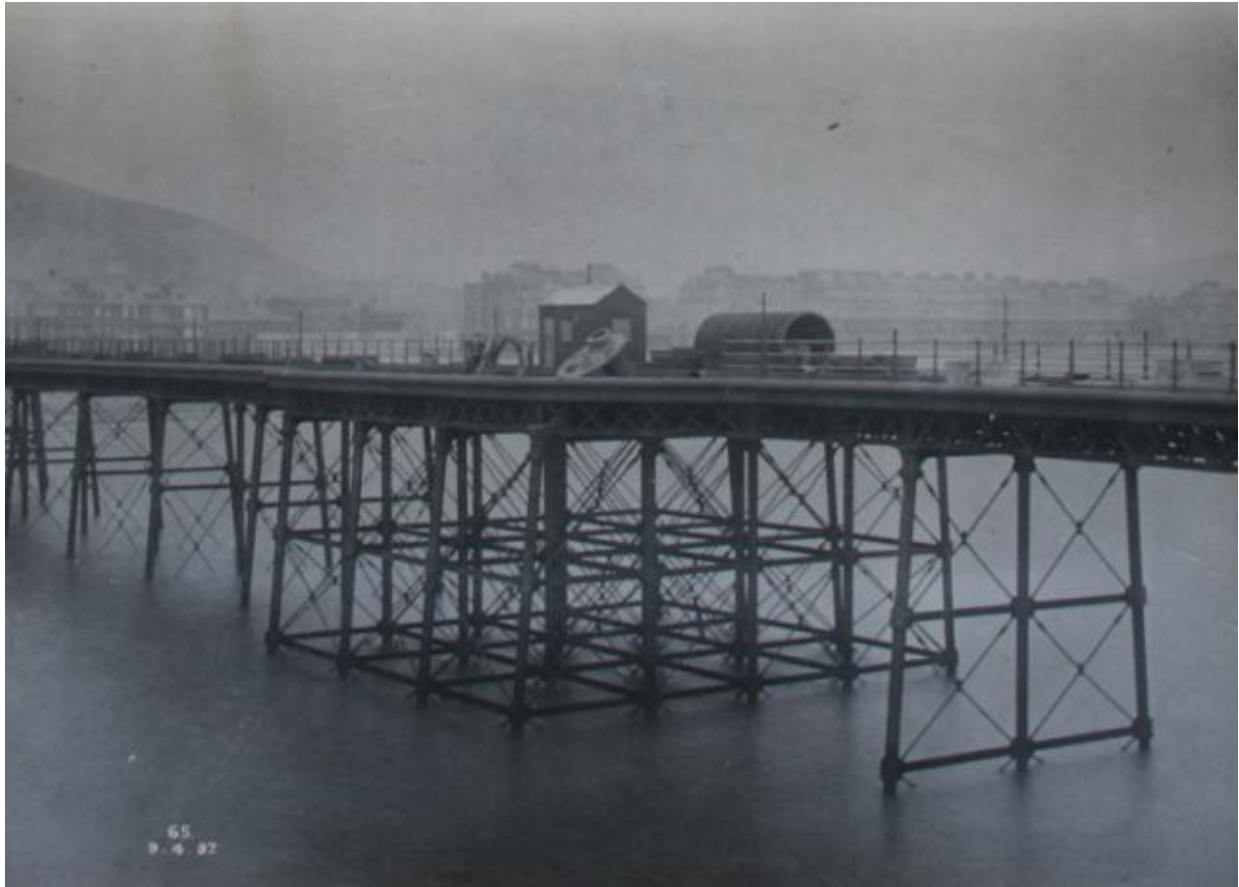
**Plate 15-** *The finished iron structure can be seen here with some works still taking place on the pier 9/04/1897, Looking north-west, DHB.*

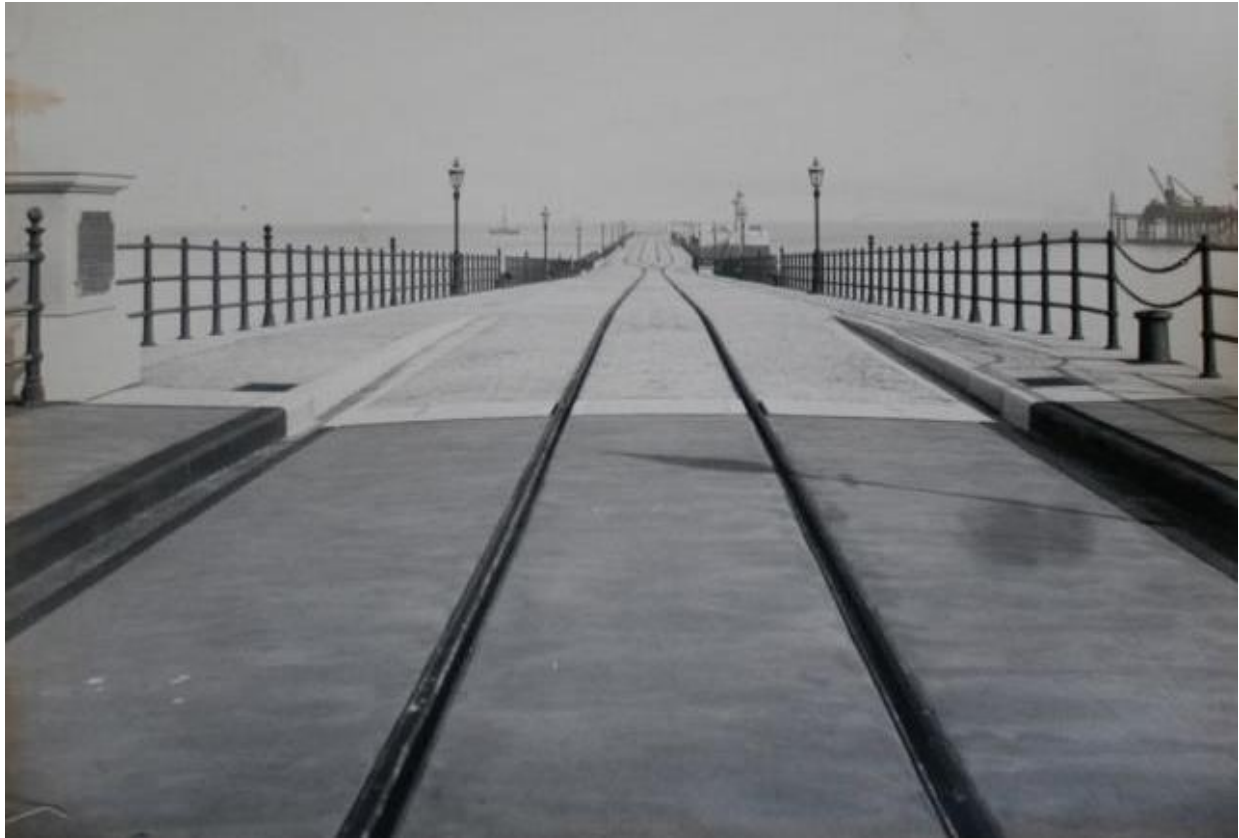
**Plate 22-** *The train lines running centrally down the pier allowed passengers to directly get on or off liners when travelling c.1903, Looking south-east, DHB.*

In 1905 a railway track was installed along the pier allowing an easier connection with the shipping berths; this track ran the length of the seafront and also ran across Union Street, finishing at Marine Station, now Cruise Terminal One. Images of this track can be seen in **Plates 21-23**. When the Admiralty Pier extension was completed in 1909 the Prince of Wales Pier became the inner Pier to the harbour (Hasenson, 1980).

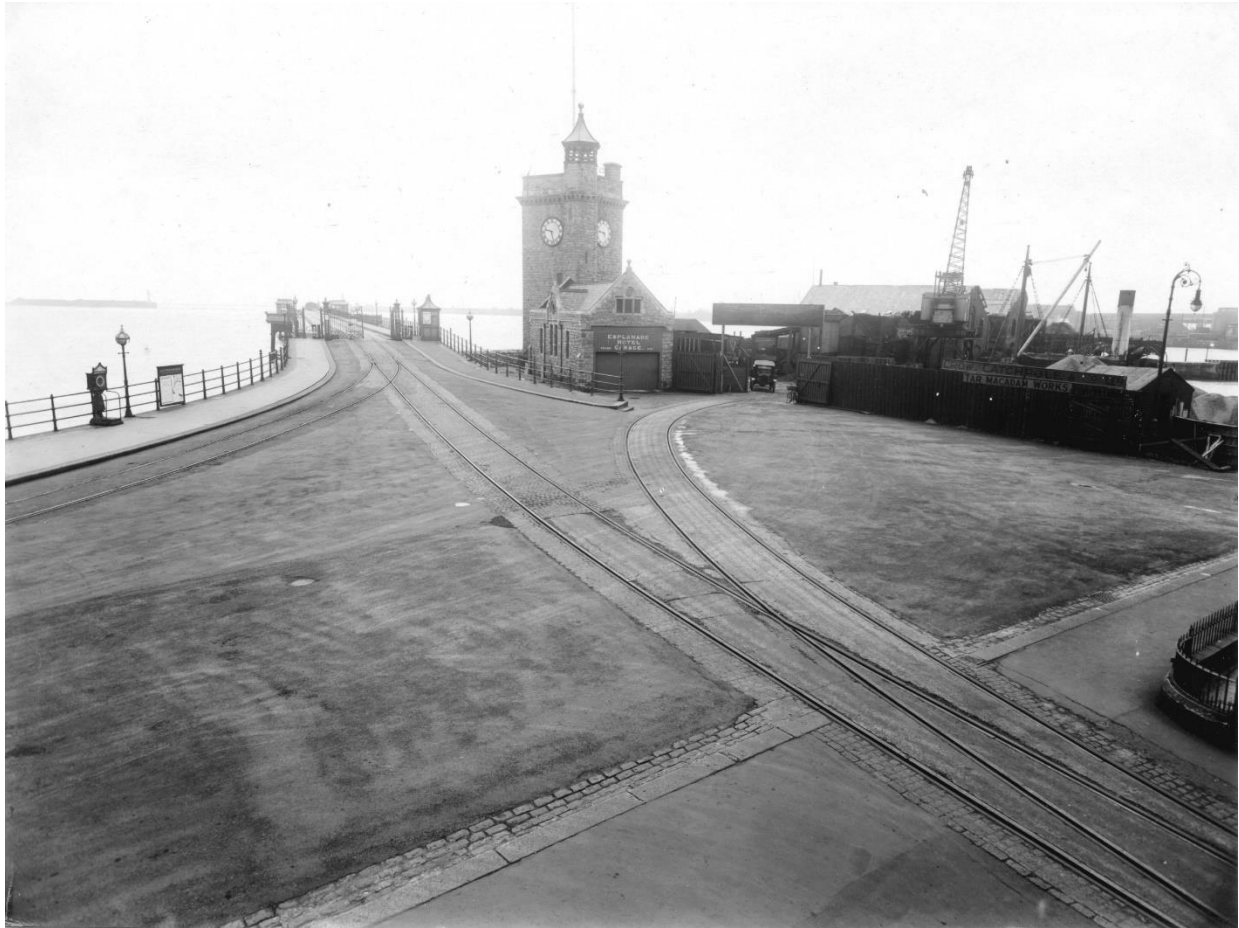
**Plate 23-** *The arrangement of the train lines which connected the pier with other local stations, c.1903, Looking south-east, Dover Museum Collection d05808.*

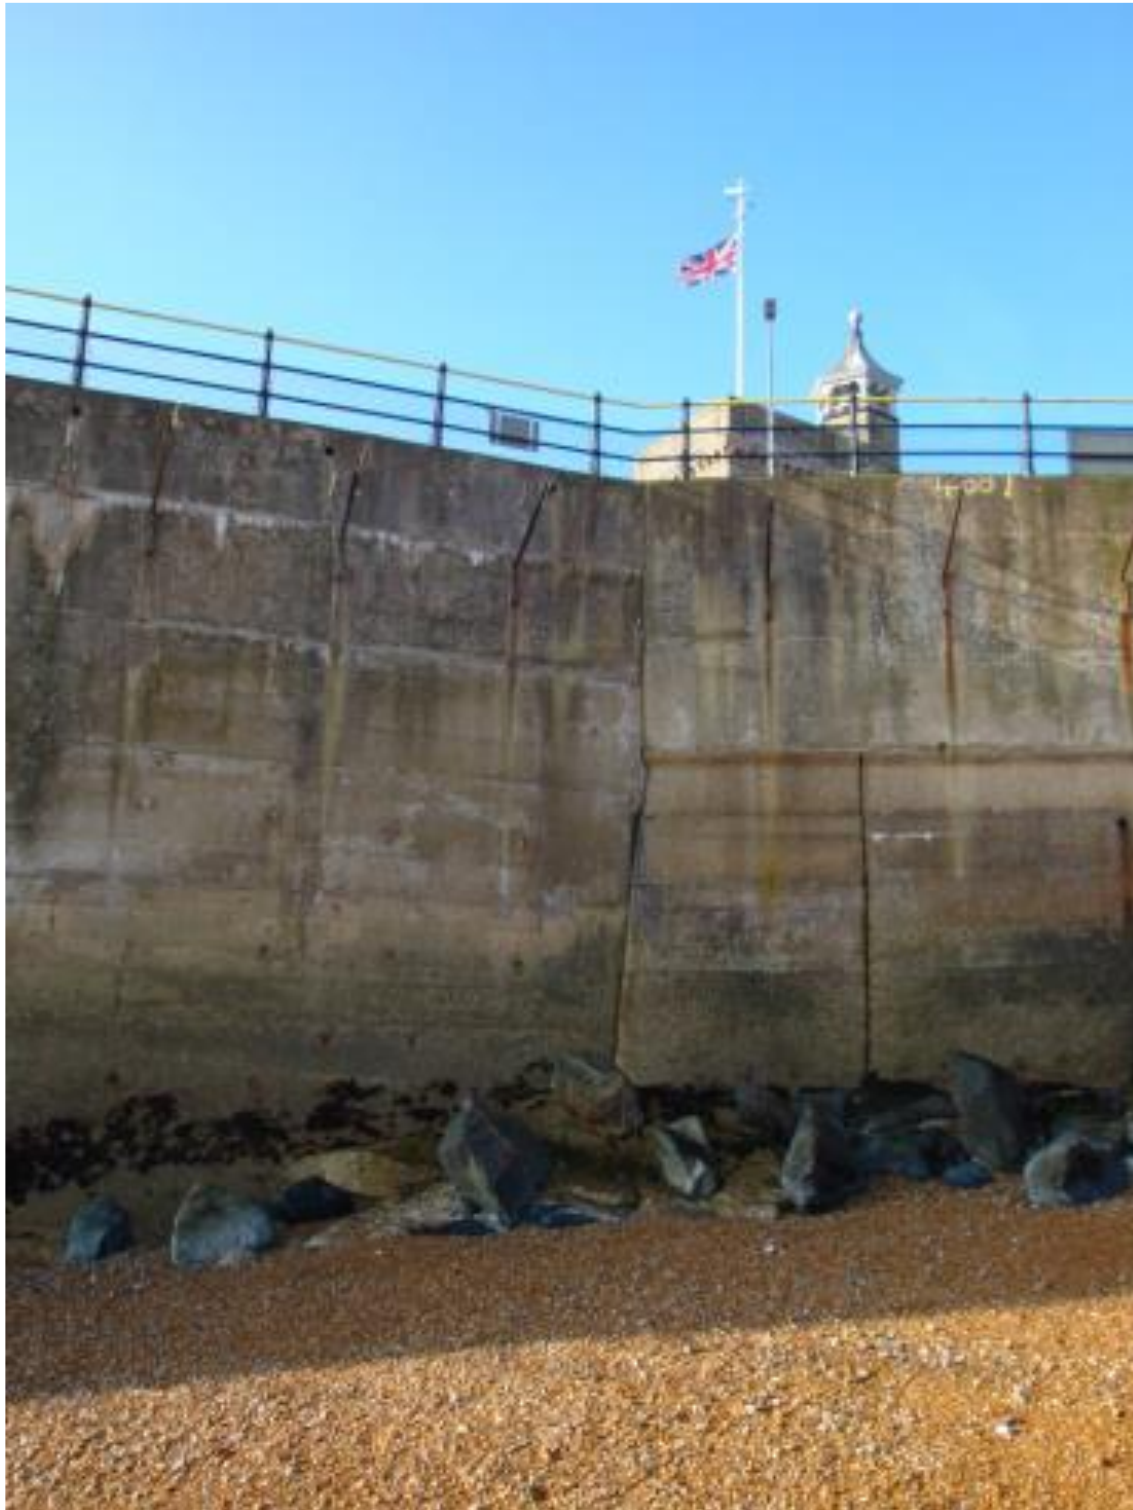
**Plate 26:** Sea wall and entrance ramp to the Prince of Wales Pier, looking West. Atkins 2014A: 100.

The construction of the quay wall is shown in **Plate 26**, comprising of a mass concrete wall with mass concrete fill and embedded rock armour protecting the wall at bed level.

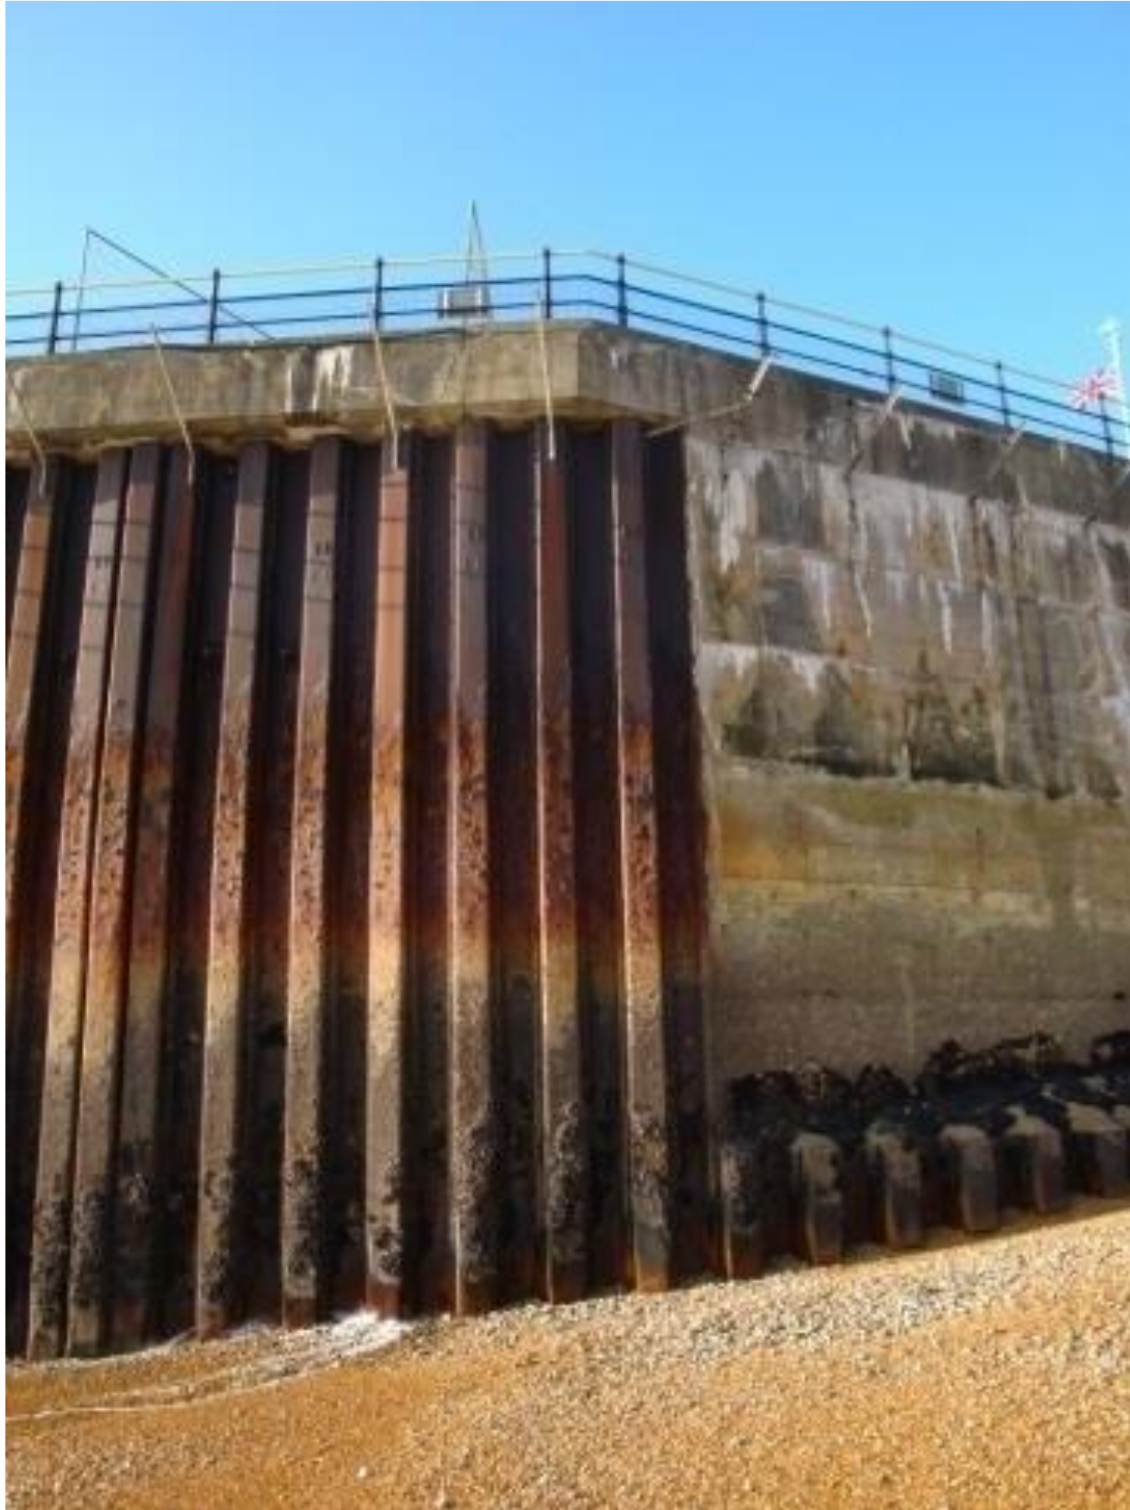
**Plate 27:** *The point where the masonry work ends and the iron sheet piling begins on the East side of the pier, some sheet piling can also be seen at beach level, looking south-west, Atkins 2014A: 98.*

*[At the start of the survey] the steel sheet piled wall arrangement abuts the existing mass gravity wall structure. Drawing records show that the steel sheet pile line continues through the existing pier structure, however this appears to not be the As-Built condition.... The pile line appears to have been cut to suit the shape of the existing wall with mass concrete fill in behind.... The pile line changes direction here and tie rods located at every third inpan on the top and bottom line connect towards the Western pile line. Additional tie rods are also located on every fourth inpan on the top and bottom. These tie rods appear to span in a North to South direction which would indicate that they may connect to a dead man anchor wall behind the pile line. Bolts for waling's are located at this section of the pile line. It was recorded that 3No. Predrilled holes were located on the top tie rod line which has been left open, there is also no sign of backfill material behind the pile line.*

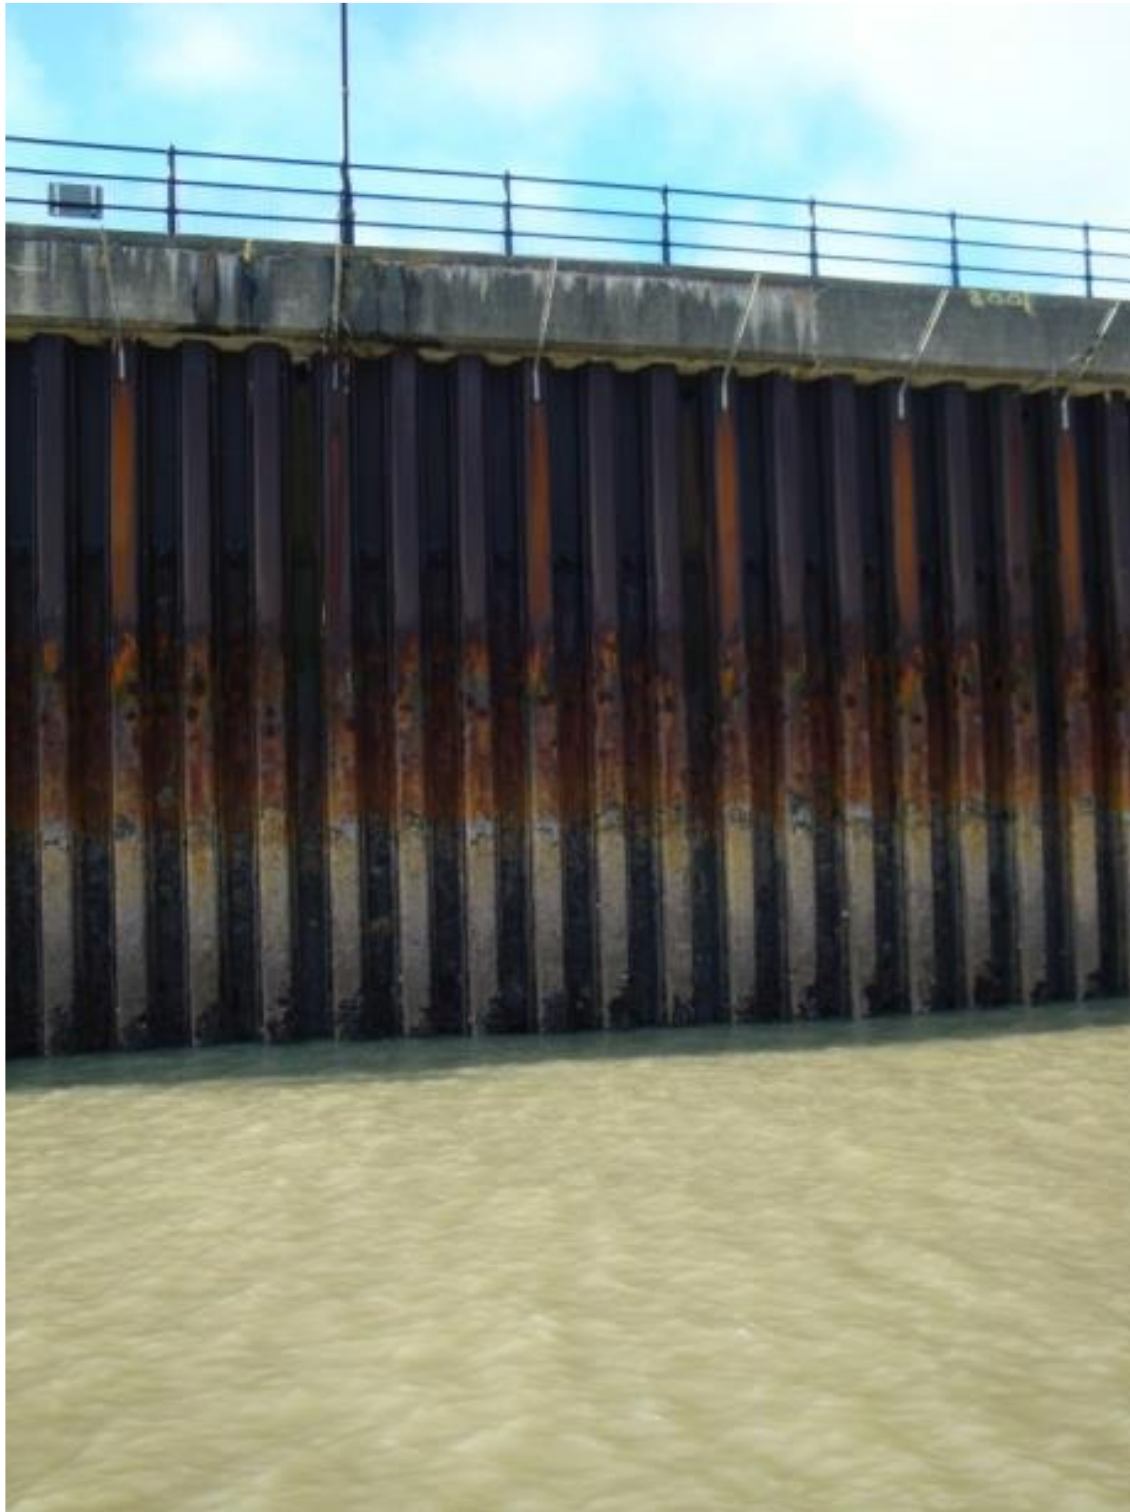
**Plate 28:** *Sheet piling on the Eastern side of the Prince of Wales Pier, looking south Atkins 2014A: 91.*

*From drawing records obtained from DHB, the construction of asset P07-WA16 consists of Larssen 4A's and 5's steel sheet piles on the East and Western side of the pier which is tied near to the top and bottom of the structure. Ballast fill was placed behind the steel piled walls with two tiers of tie rods connecting the Eastern and Western pile lines. On the top tier tie rods are located every 6<sup>th</sup> inpan, and tie rods located on the bottom tier are present every 2<sup>nd</sup> inpan. Every other inpan has a bolted connection to a waling located behind the pile line which stiffens the pile line. The top waling, bolts and row of tie rods are shown at a level of 8.61mCD, and the bottom waling, bolts and row of tie rods are shown at a level of 2.820mCD. Approx.1m thick reinforced concrete transverse beams span between the Eastern and Western piles at 5m centres which forms part of the deck. The deck itself is constructed using reinforced concrete and is only 0.5 thick.*

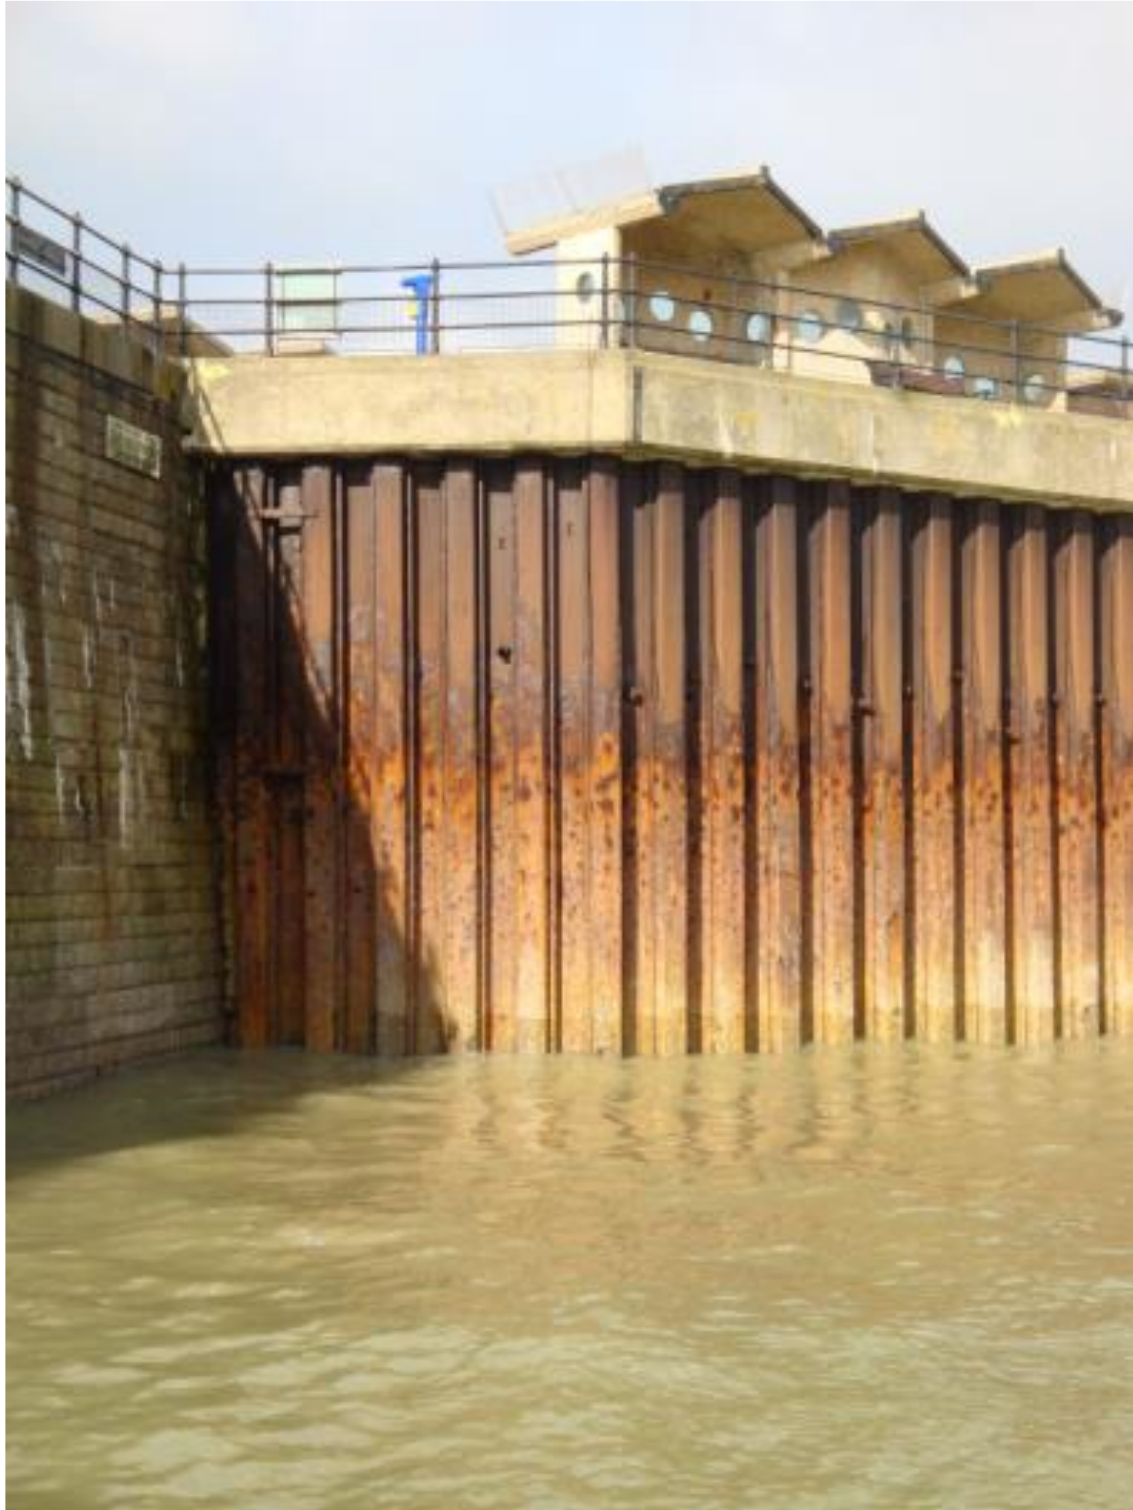
**Plate 29:** *The connecting junction between the sheet piling and the masonry section of the pier, the piles change direction here, looking West, Atkins 2014A: 61.*

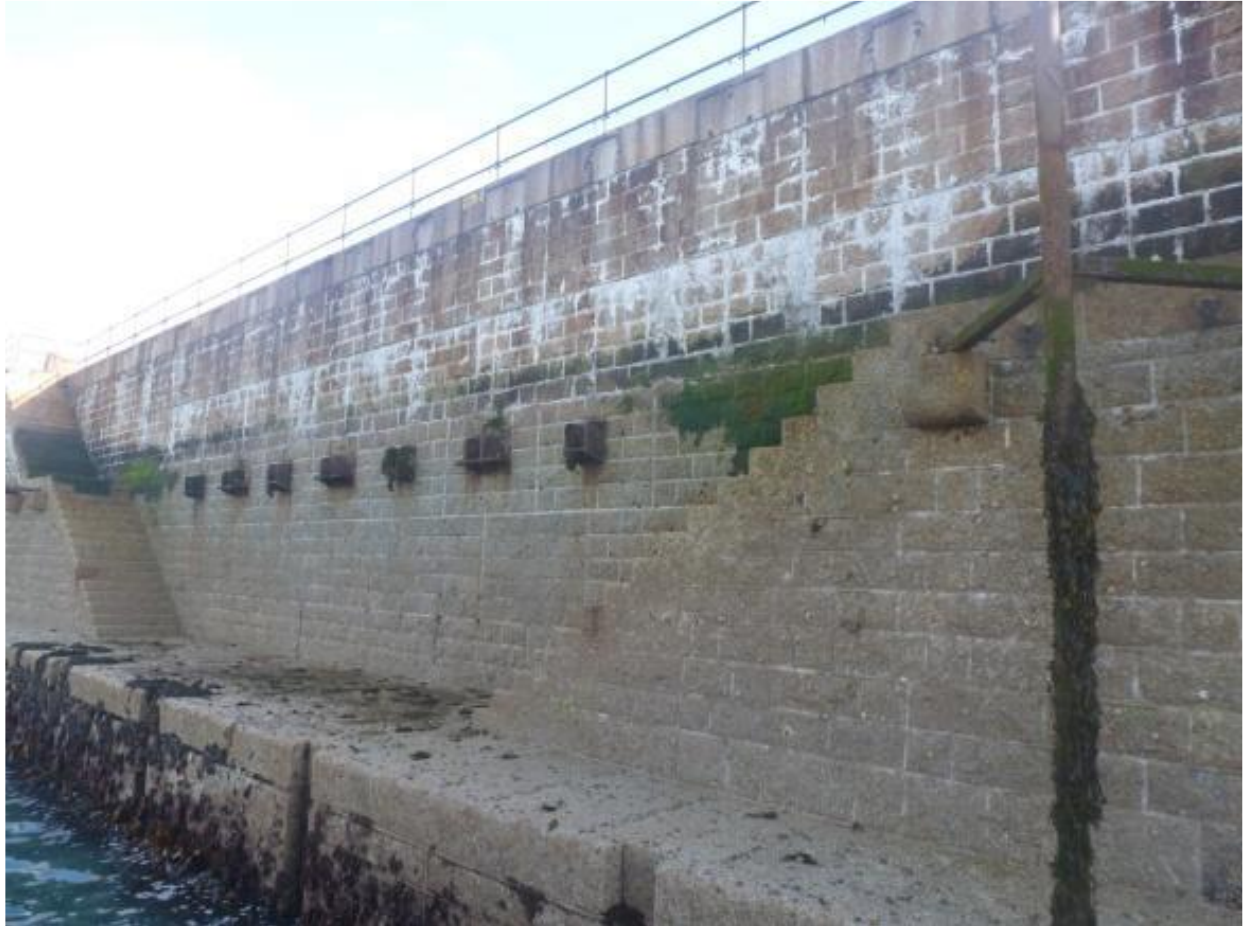
**Plate 31:** *Two stairways which have been chained off leading down to a no longer used stage landing, Atkins 2014B: 30.*

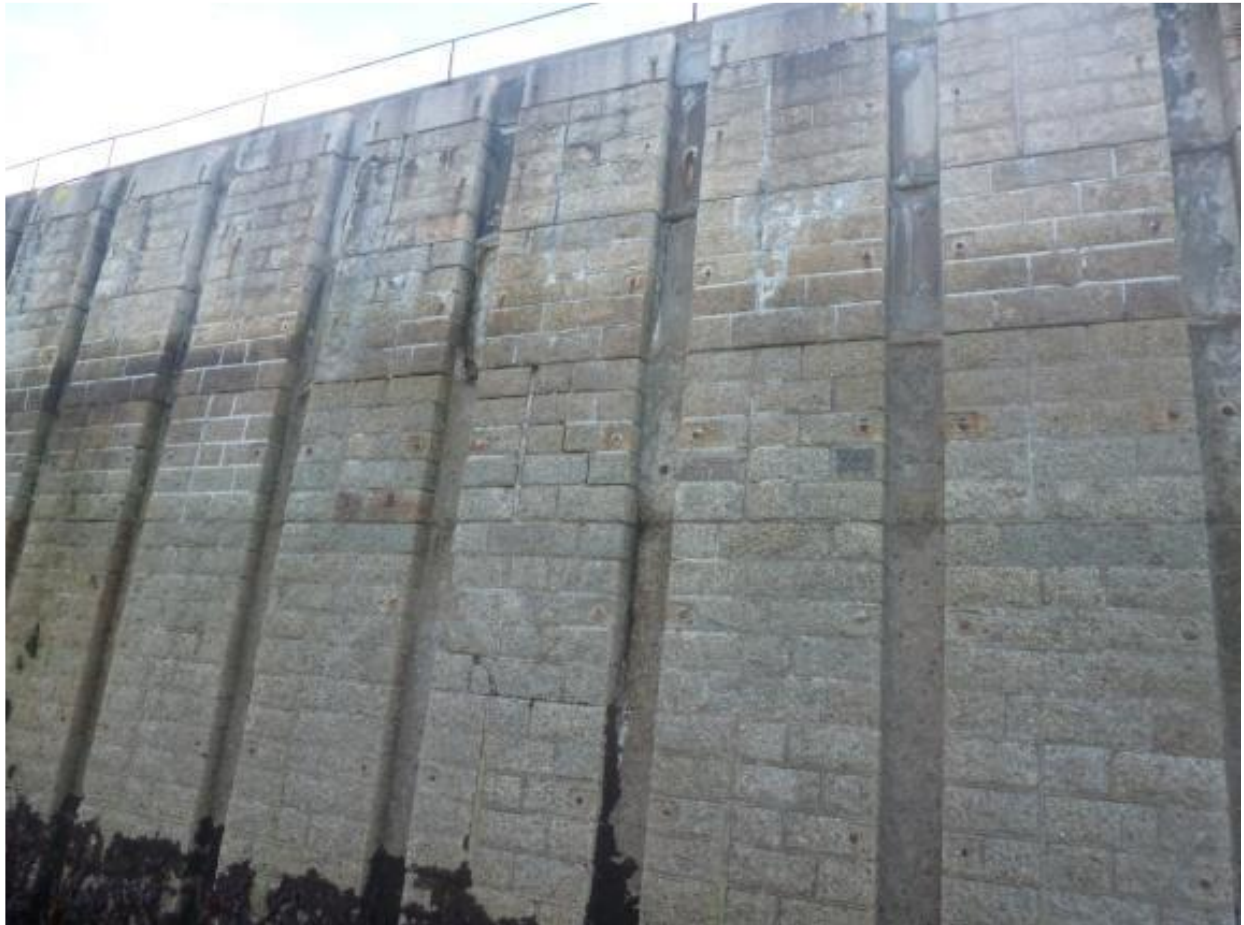
**Plate 32:** *Recesses of previous timber fenders, no longer in use, Atkins 2014B: 32.*

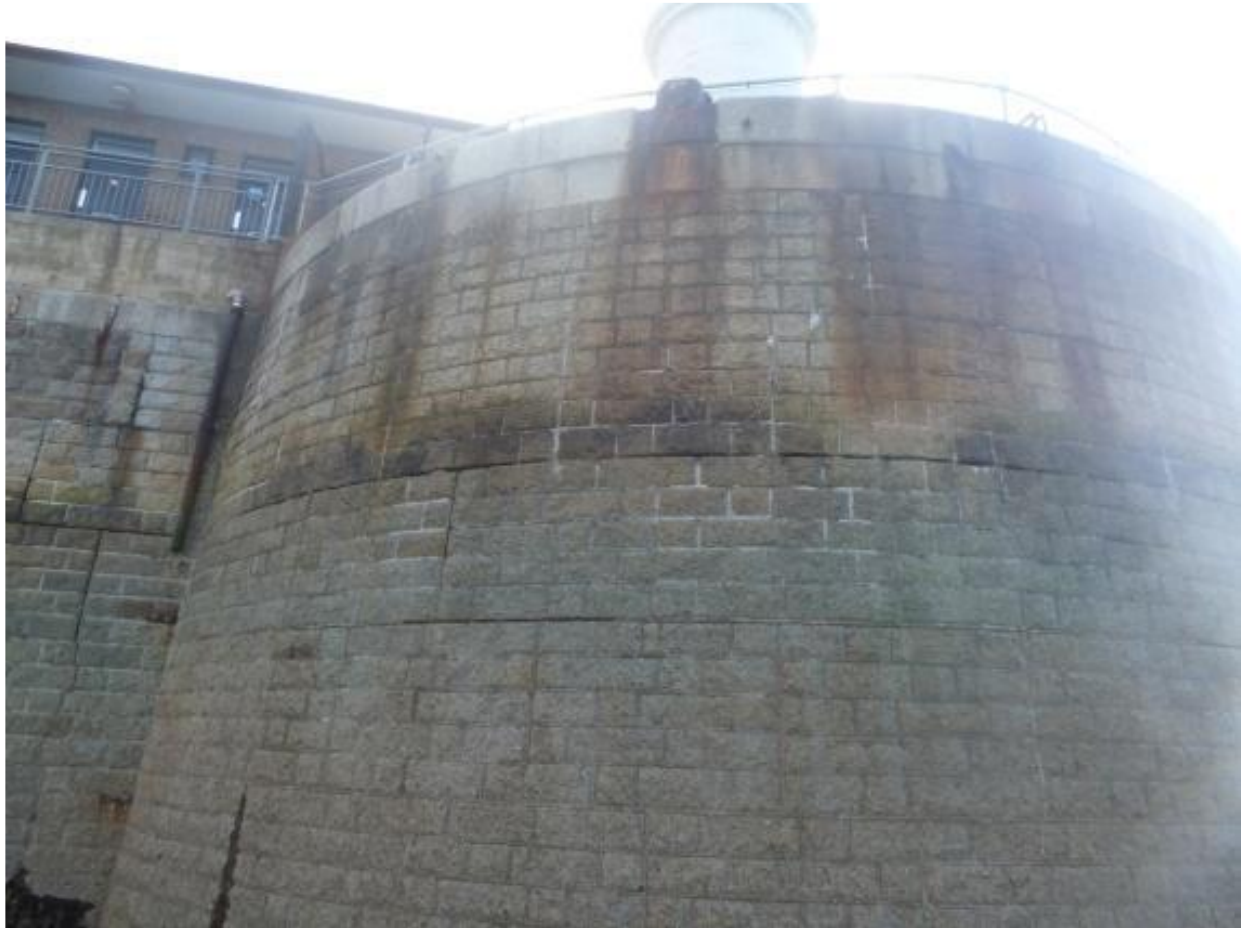
**Plate 33:** *The side view of the roundhead seaward ending of the pier, with a galvanised steel hand rail, looking North, Atkins 2014B: 34.*

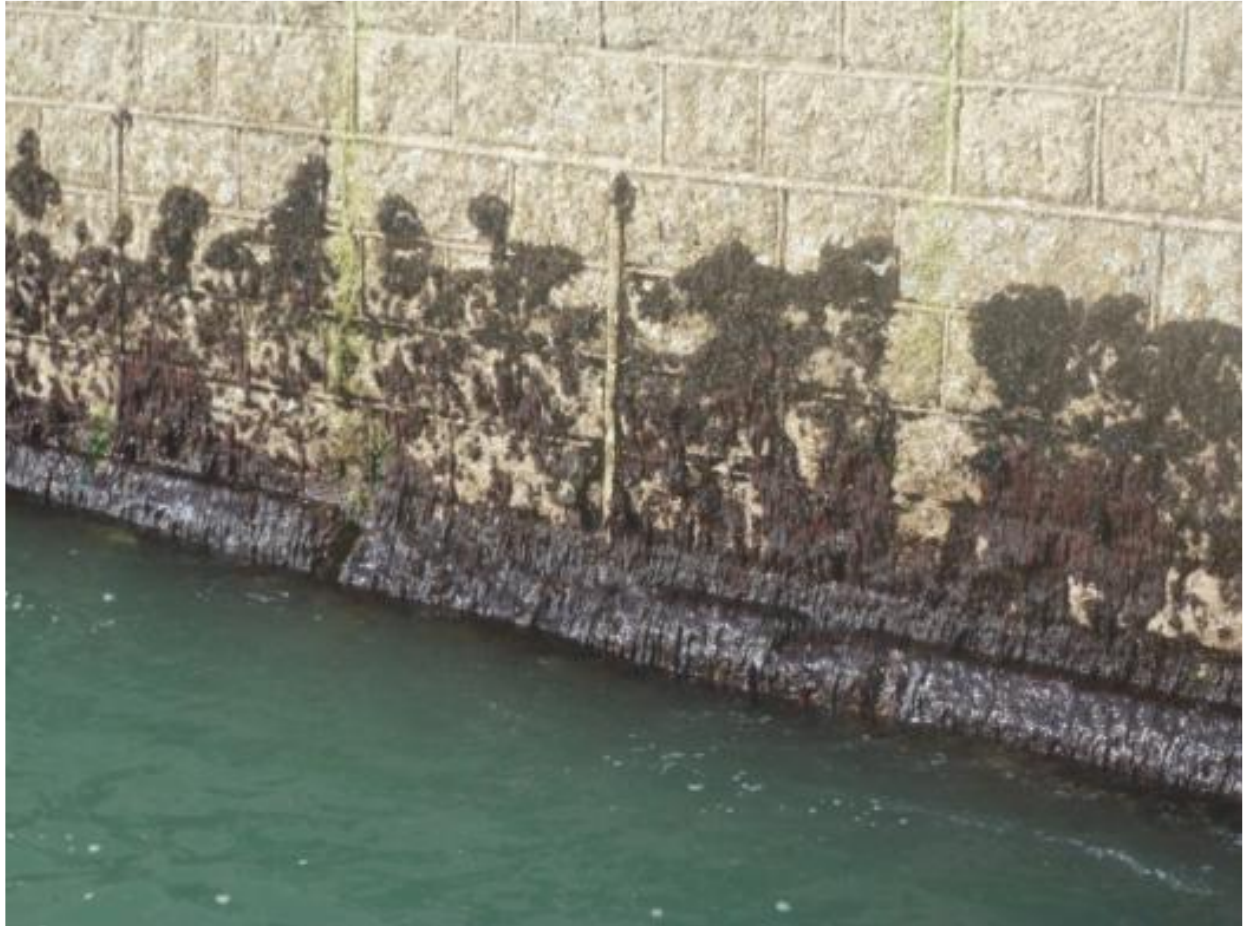
**Plate 34:** *Low water at time of recording shows a step at the base of the pier, plans show that this form is present throughout the masonry section of the entire pier, Atkins 2014B: 35.*

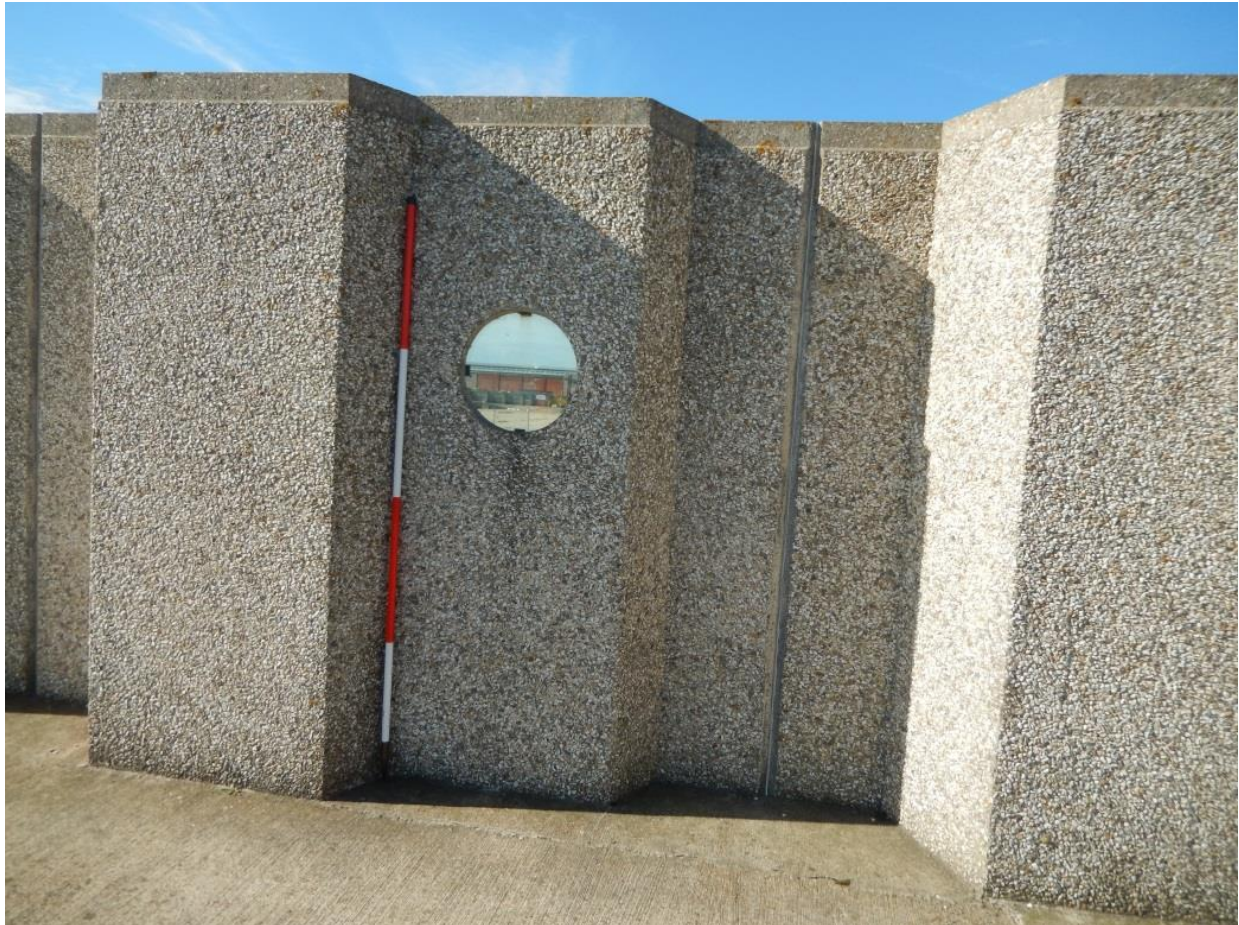
**Plate 39:** *The windbreaker wall with added windows, this shows views of the Hoverport Apron, 03/09/15, looking South, DHB.*

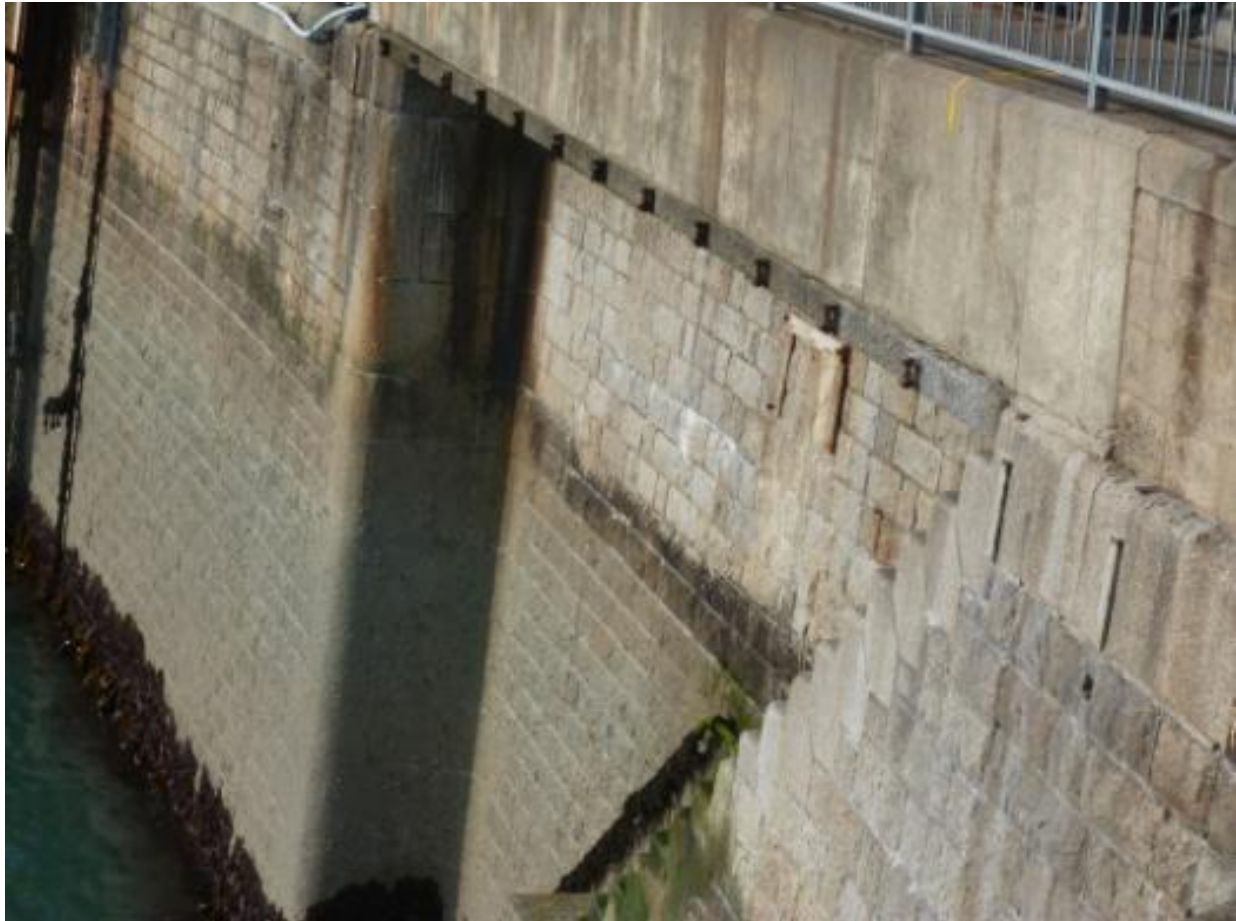
**Plate 48:** *A stepped recess which is no longer in use as a suspended masonry deck has been added over the top of it, looking North back at the side of the pier, Atkins 2014B: 21.*
