## **DOVER HARBOUR BOARD**

### **HERITAGE RECORDING PRINCE OF WALES PIER**

### **TO THE DOVER WESTERN DOCKS, DOVER, KENT**

### **Desktop Study**

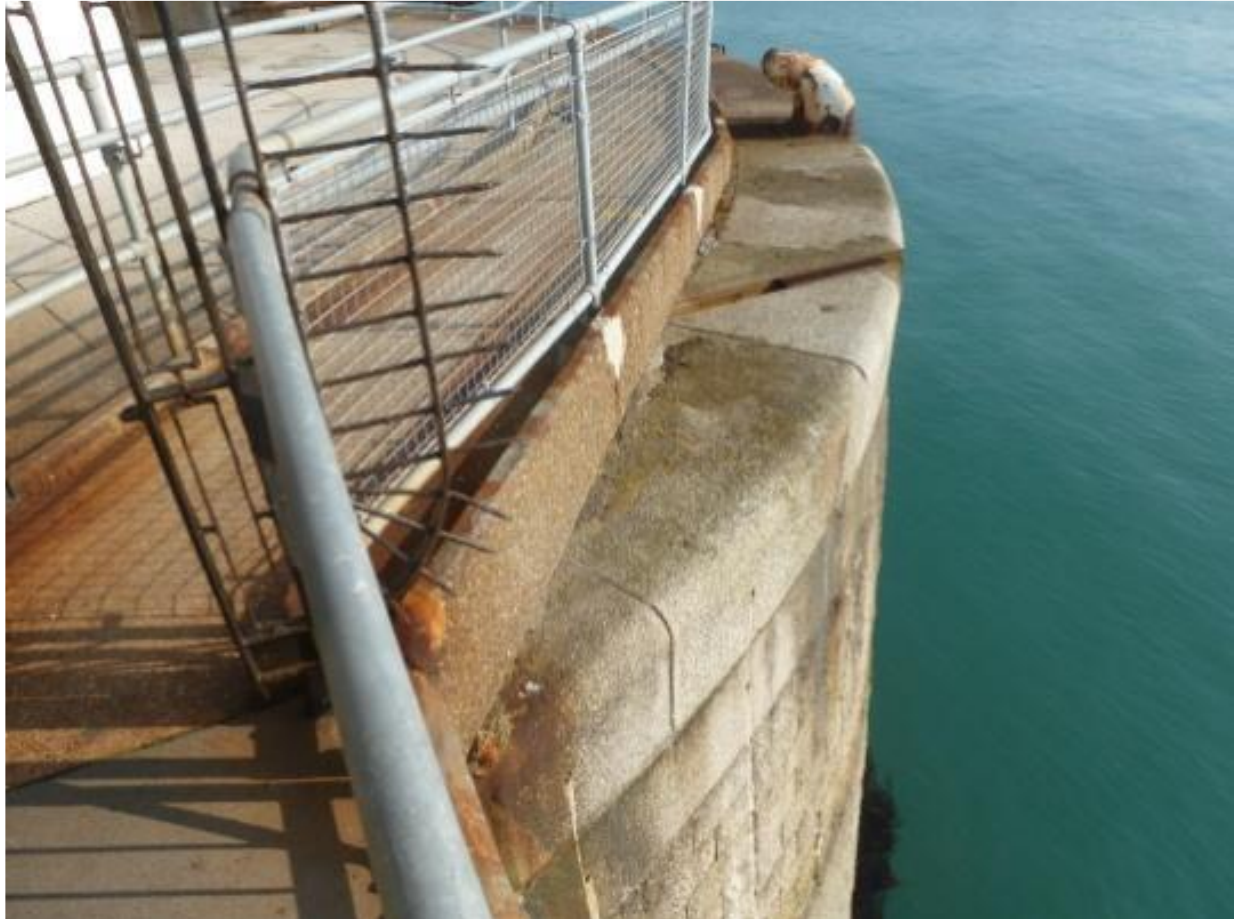
**Plate 49:** Roundhead stone at the end of the pier, also the supporting foundations for the lighthouse formed of granite blocks, Atkins 2014B: 21.

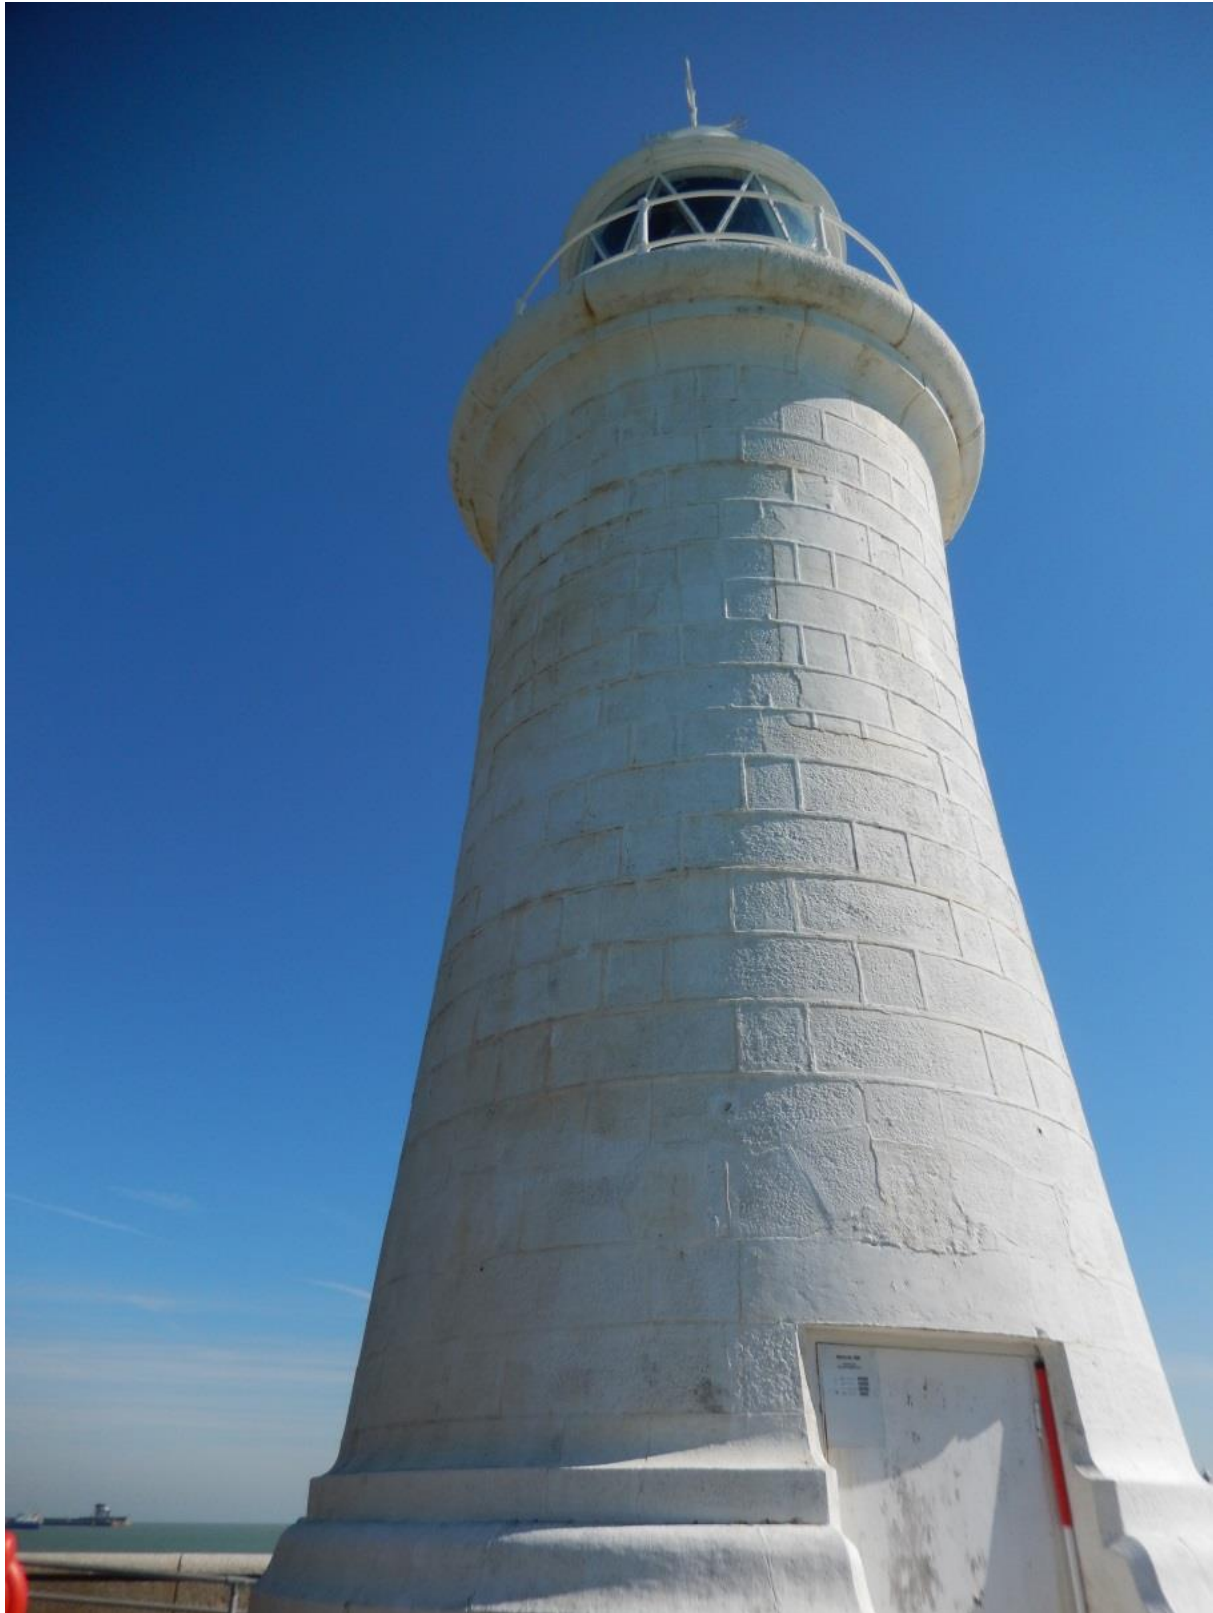
**Plate 51:** *Detail of The lighthouse no the end of the Prince of Wales Pier, 10/09/2015, DHB.*

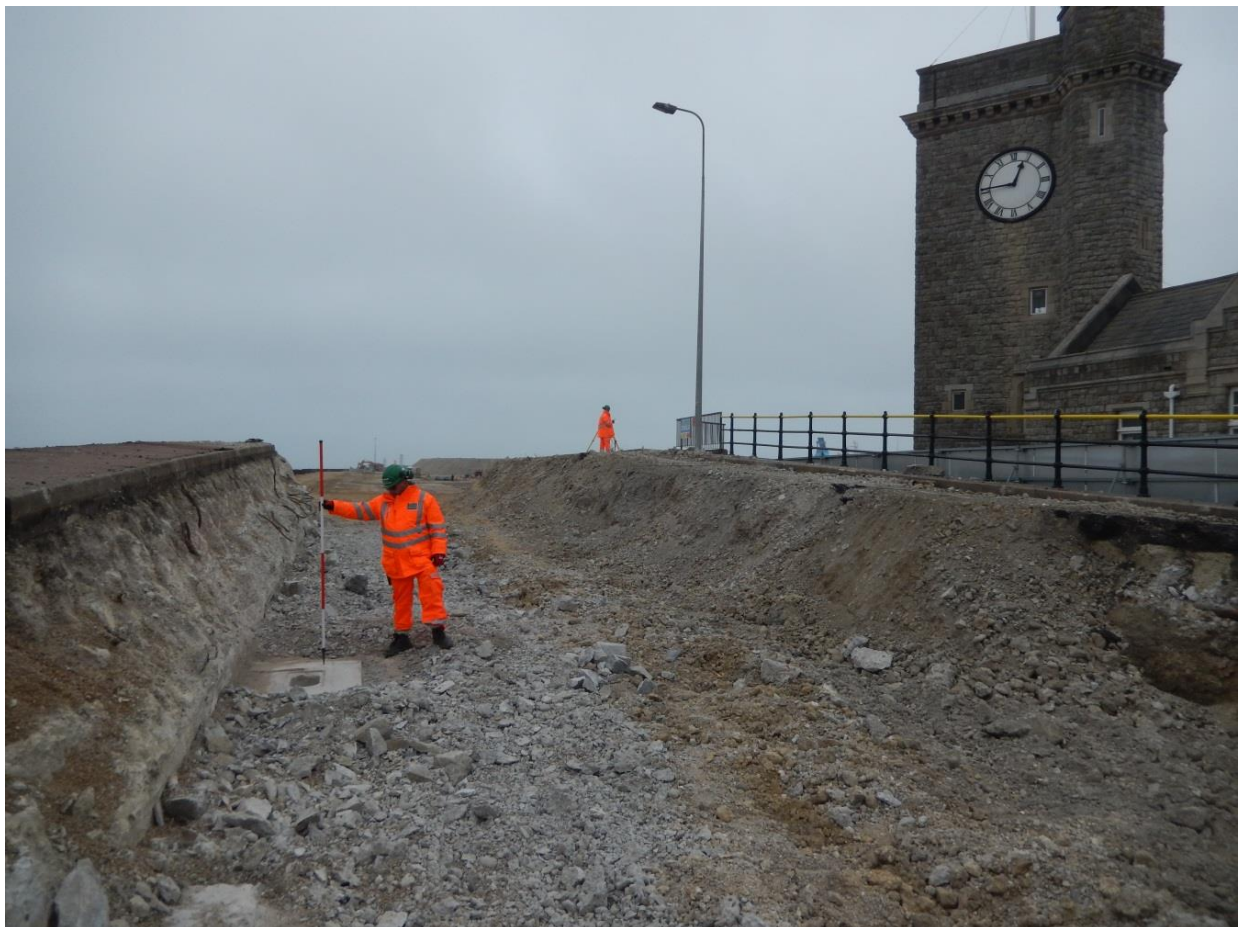
**Plate 52:** Image showing the context of where the time capsule was found, 2m Scale, looking south-east, 27/07/2016, DHB.

During the height reduction works elements of the historic structure have been revealed. These are described below. The buried time capsule in the foundation stone, laid by the Prince of Wales in 1893 (**Plate 4**) was uncovered during the height reduction works on the 25<sup>th</sup> of July 2016. Unfortunately all that remained of the buried items were the glass jars that they were encased in, with the coins and newspaper clippings gone. The plaque that once covered the capsule was also discovered. Due to the nature of the disturbance, it is concluded that this damage occurred during the construction of the hoverport.

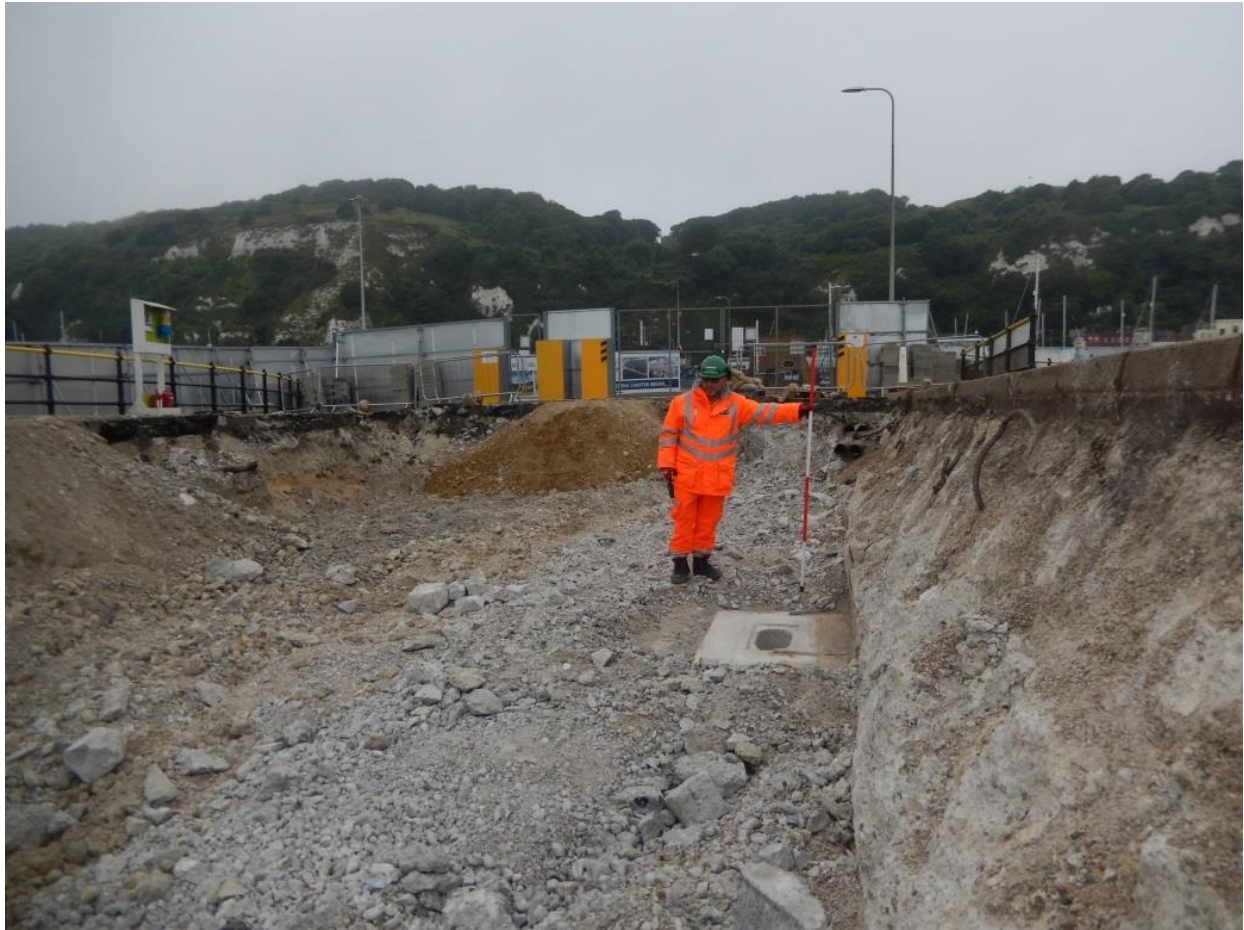
**Plate 53:** Image showing the context of where the time capsule was found, 2m Scale, looking south-east, 27/7/2016, DHB.

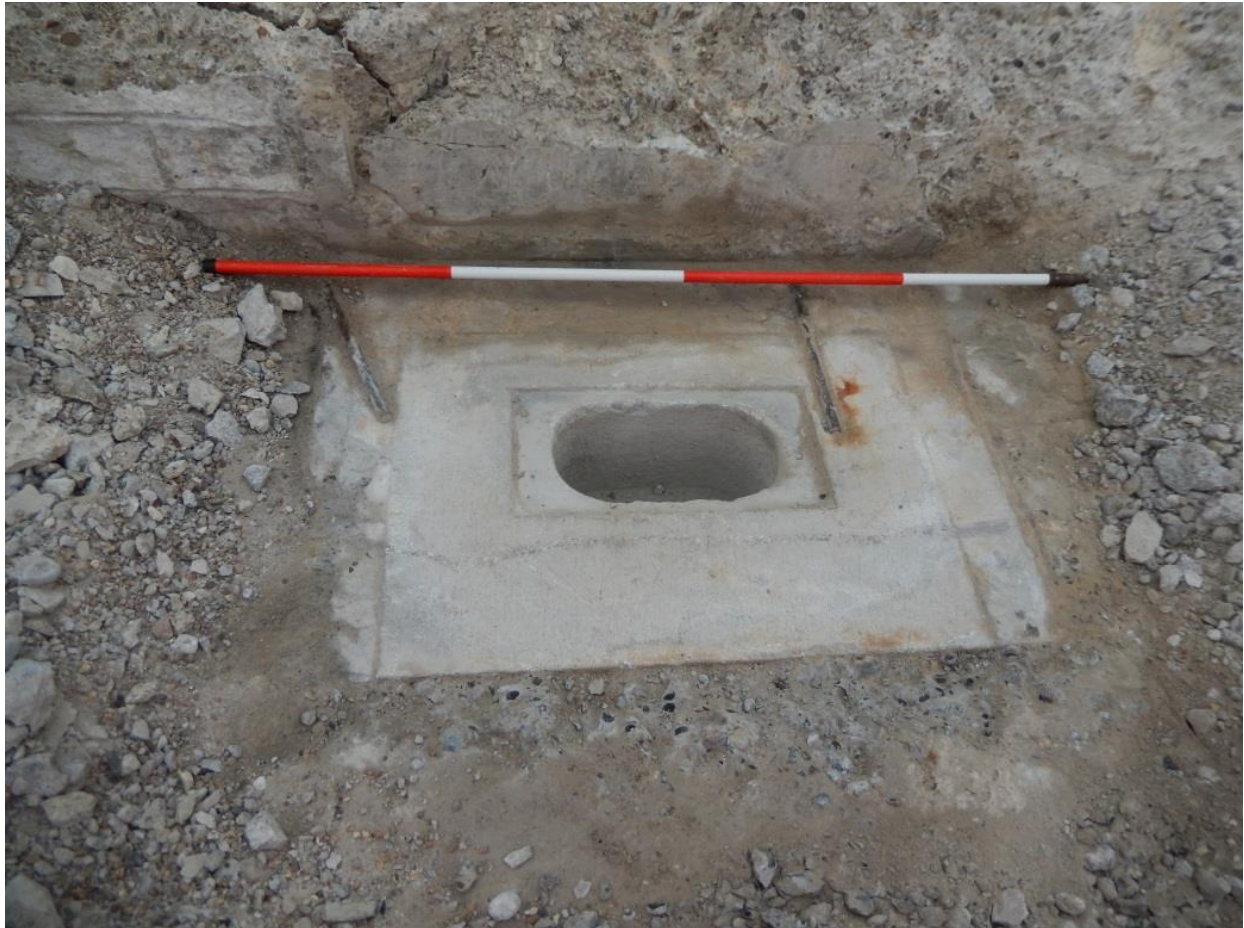
**Plate 54:** Granite block that would have held the time capsule, the commemorative plate would have fit into the rectangular slot on top,, 2m Scale, 27/7/2016, DHB.

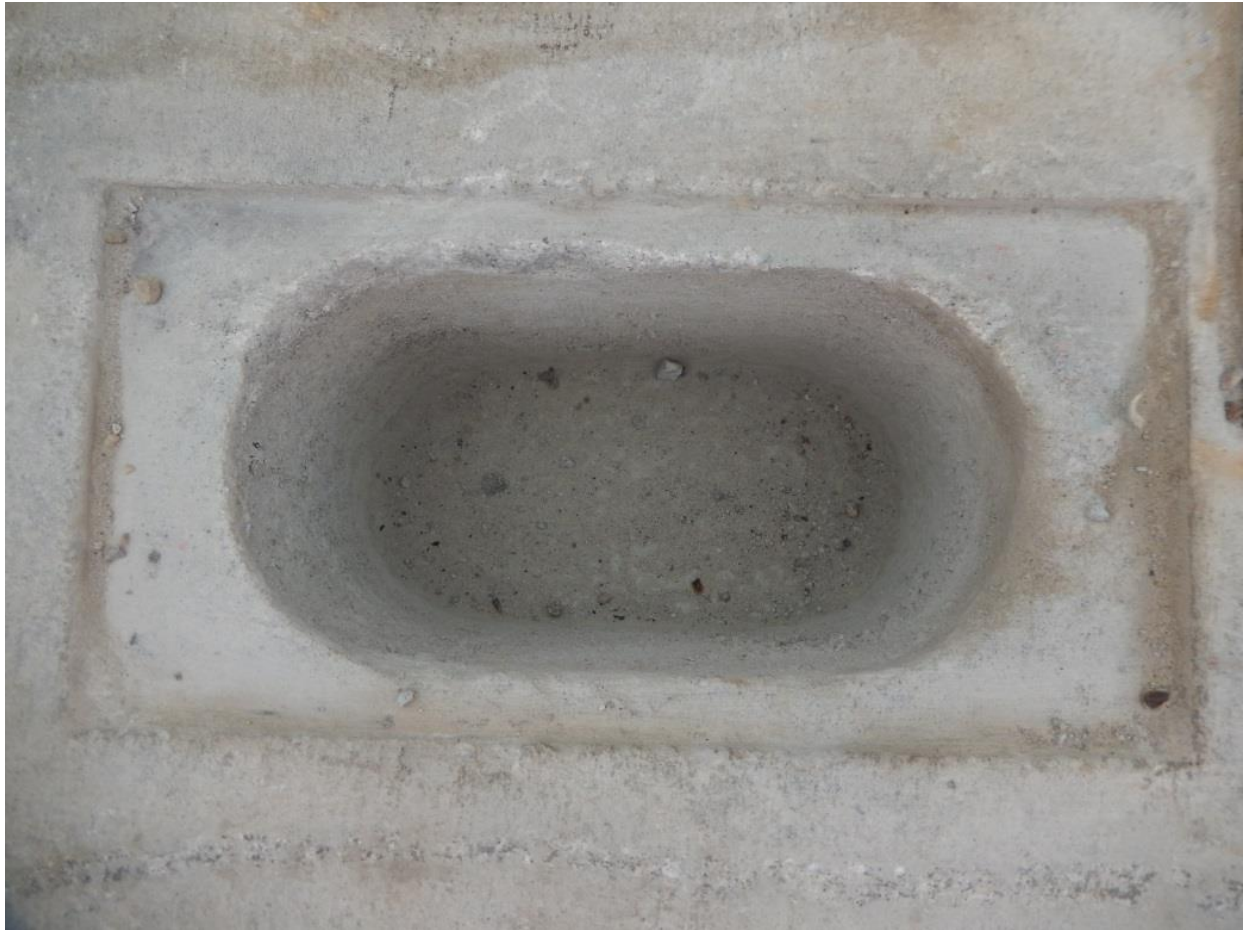
**Plate 55:** *Detail of the granite housing that held the time capsule, 27/7/2016, DHB.*

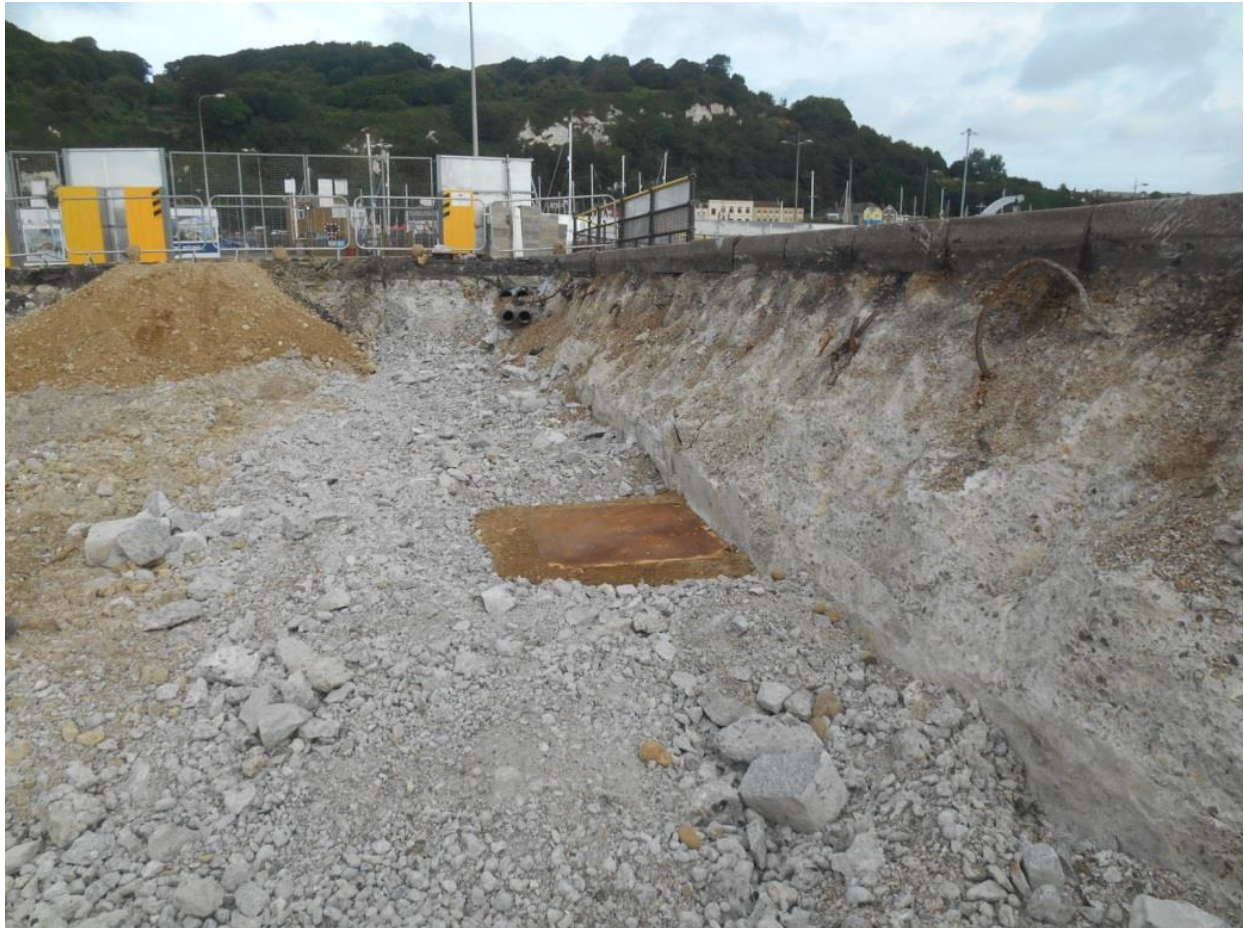
**Plate 56:** *The position of the infilled granite time capsule, looking West, 29/7/2016, DHB.*

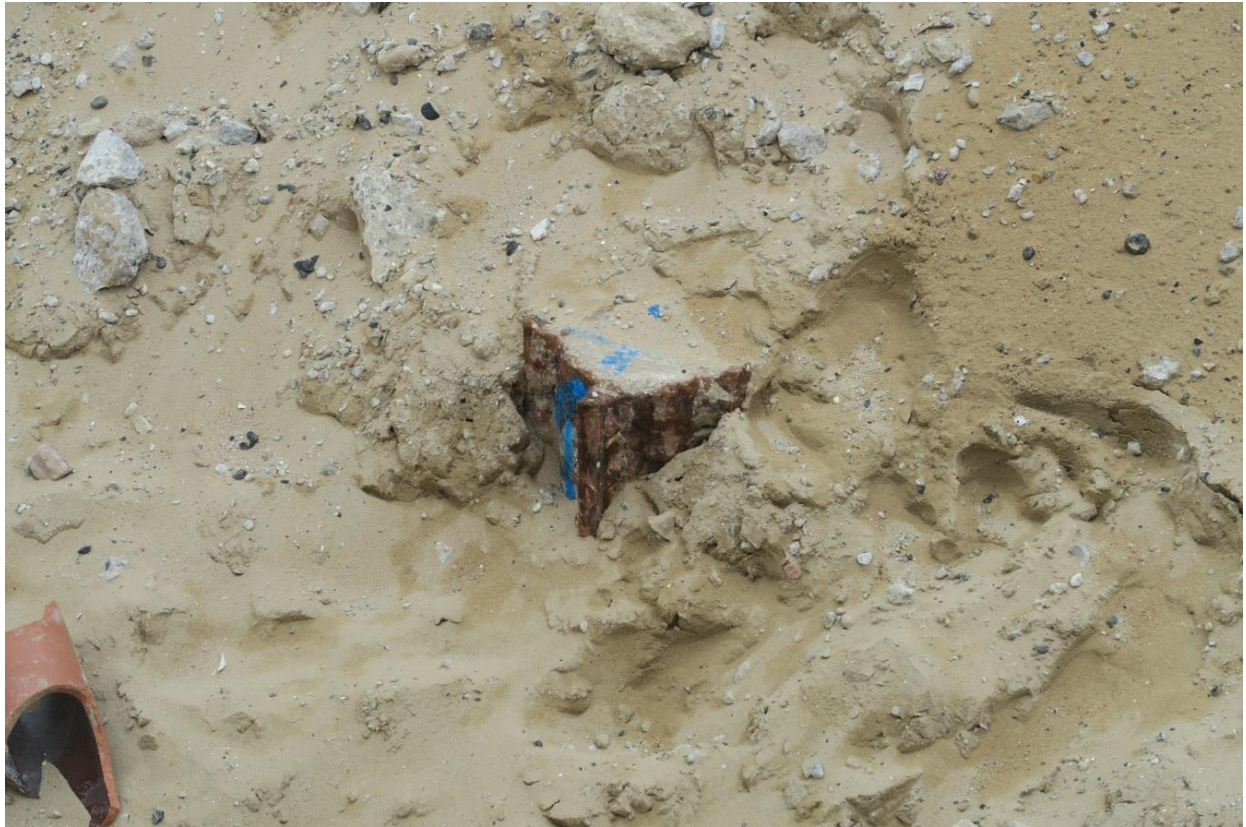
**Plate 60:** *One of the original pile foundations for the Prince of Wales Pier, 14/10/16, DHB.*

The following images show both the iron pile elements as well as the bracing joist.

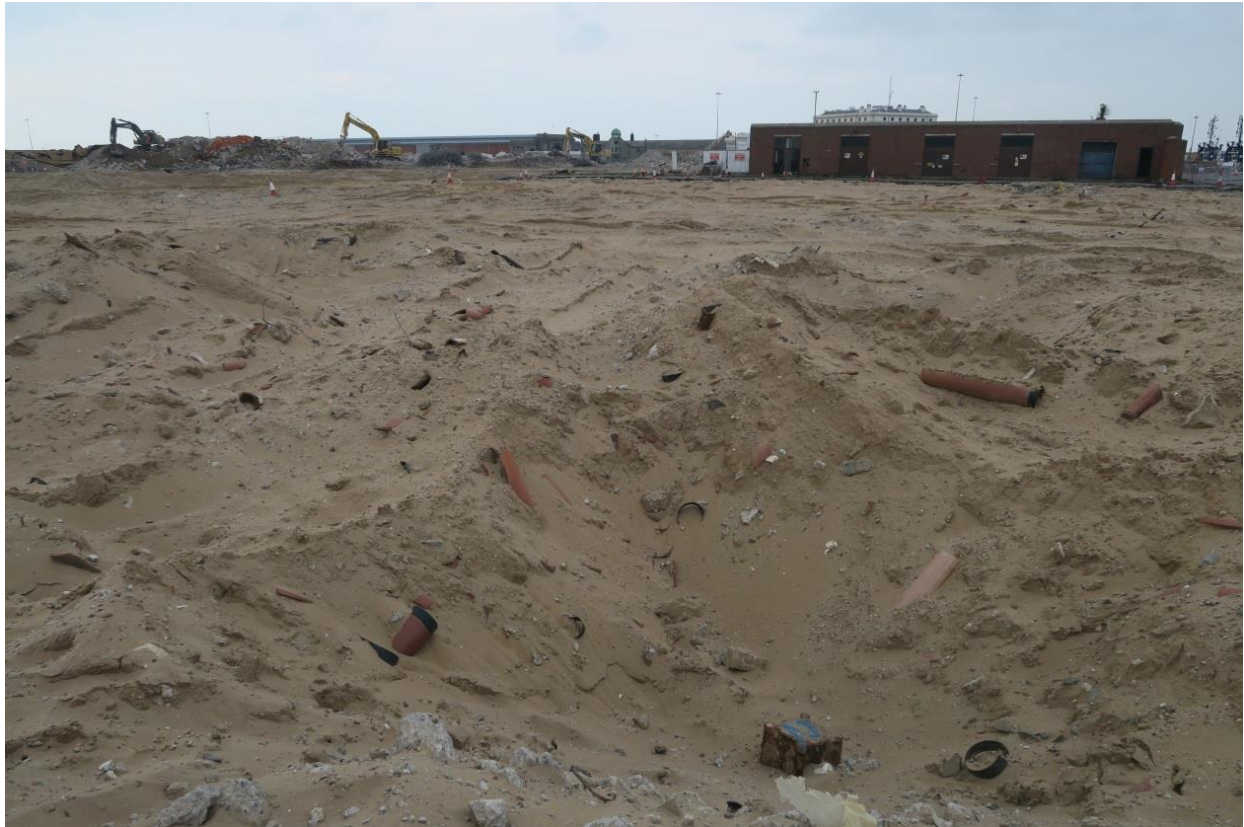
**Plate 61:** *One of the original pile foundations for the Prince of Wales Pier can be seen in the foreground, with the context of the Lord Warden House, looking South, 26/10/16, DHB.*

Also found during the height reduction works were the remains of some of the original iron pier structure, built between 1893 and 1902. They appear to be what is left of the pile foundations with the top of them being rediscovered, 11 have been found. As well as this there was a the connecting joist found, that would have connected the land as an extra brace to the newly built iron structure. This join would have a given the materials used to build the pier a slightly reduce rigidity allowing it to move slightly and then settle in a position.

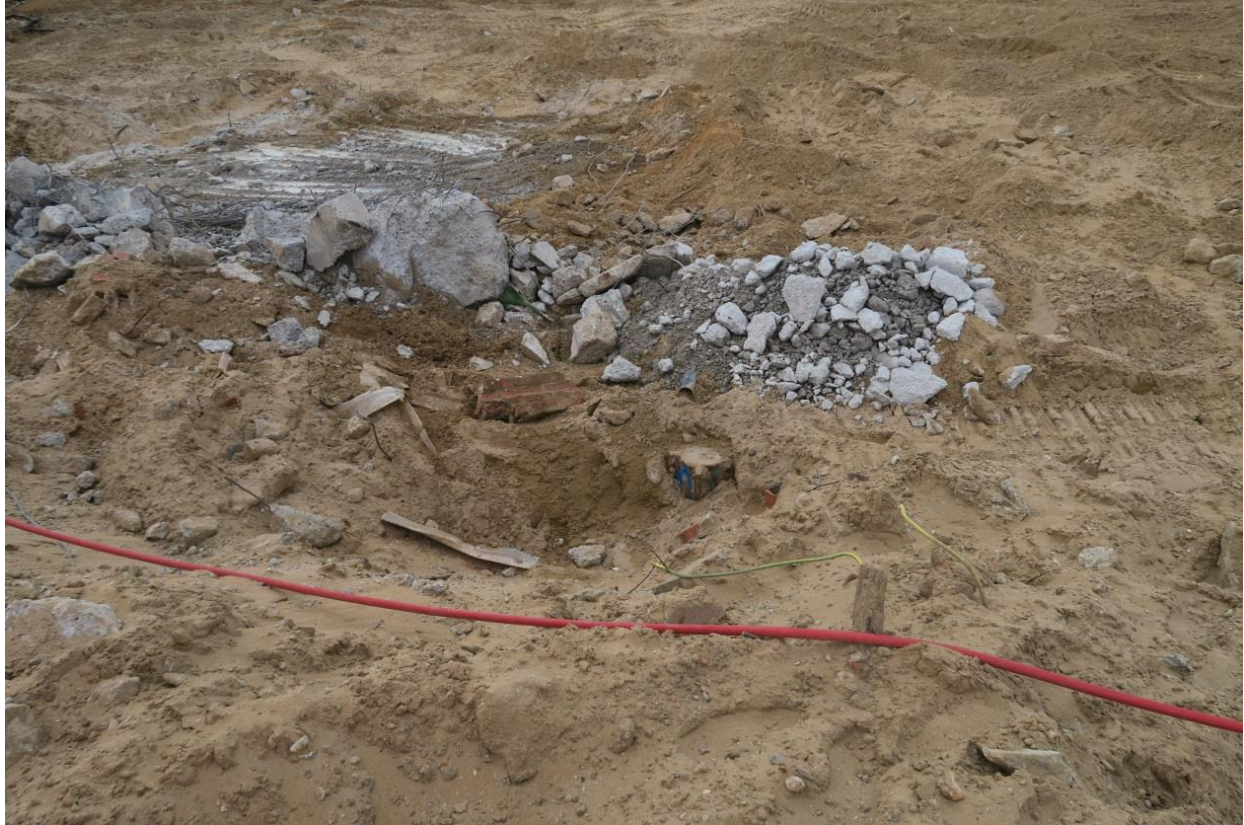
**Plate 62:** *One of the original pile foundations for the Prince of Wales Pier, 26/10/16, DHB.*

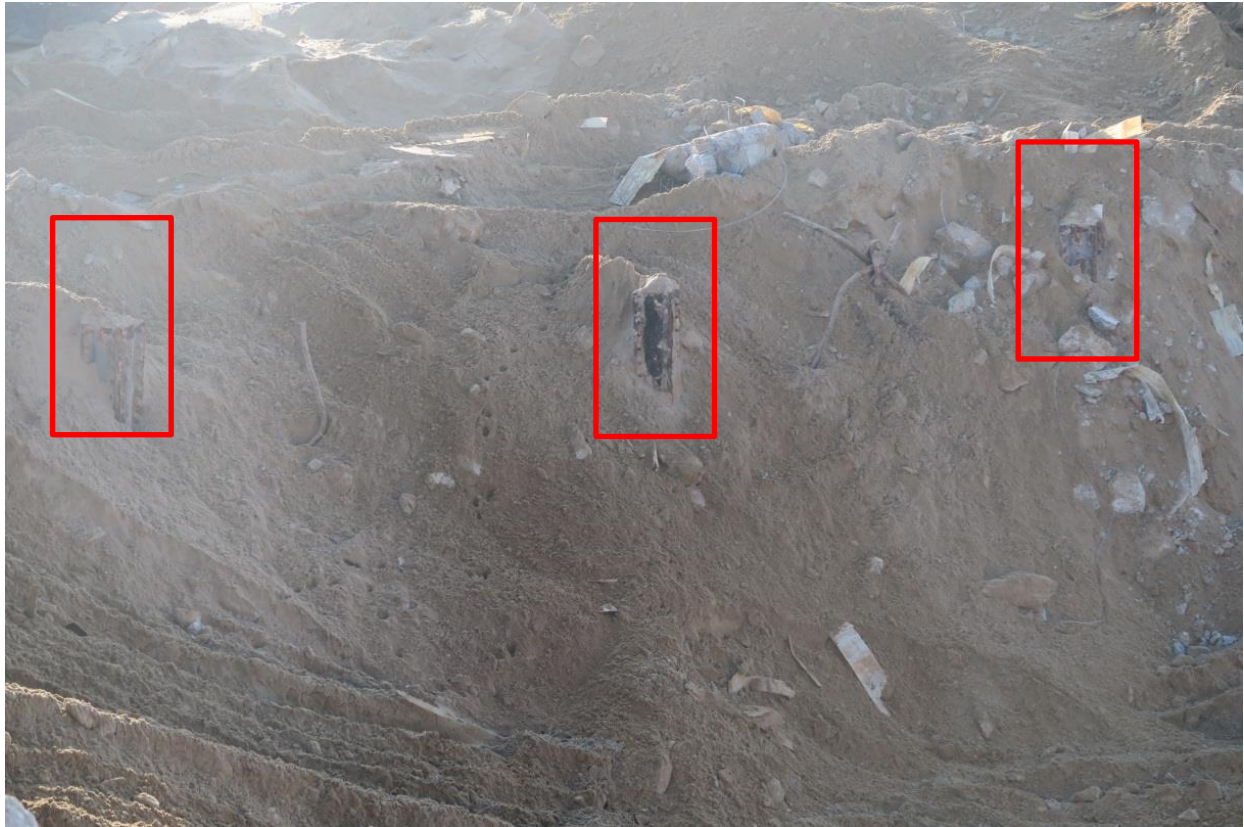
**Plate 63:** Three of original pile foundations for the Prince of Wales Pier in context with one another, highlighted in red, 26/10/16, DHB.

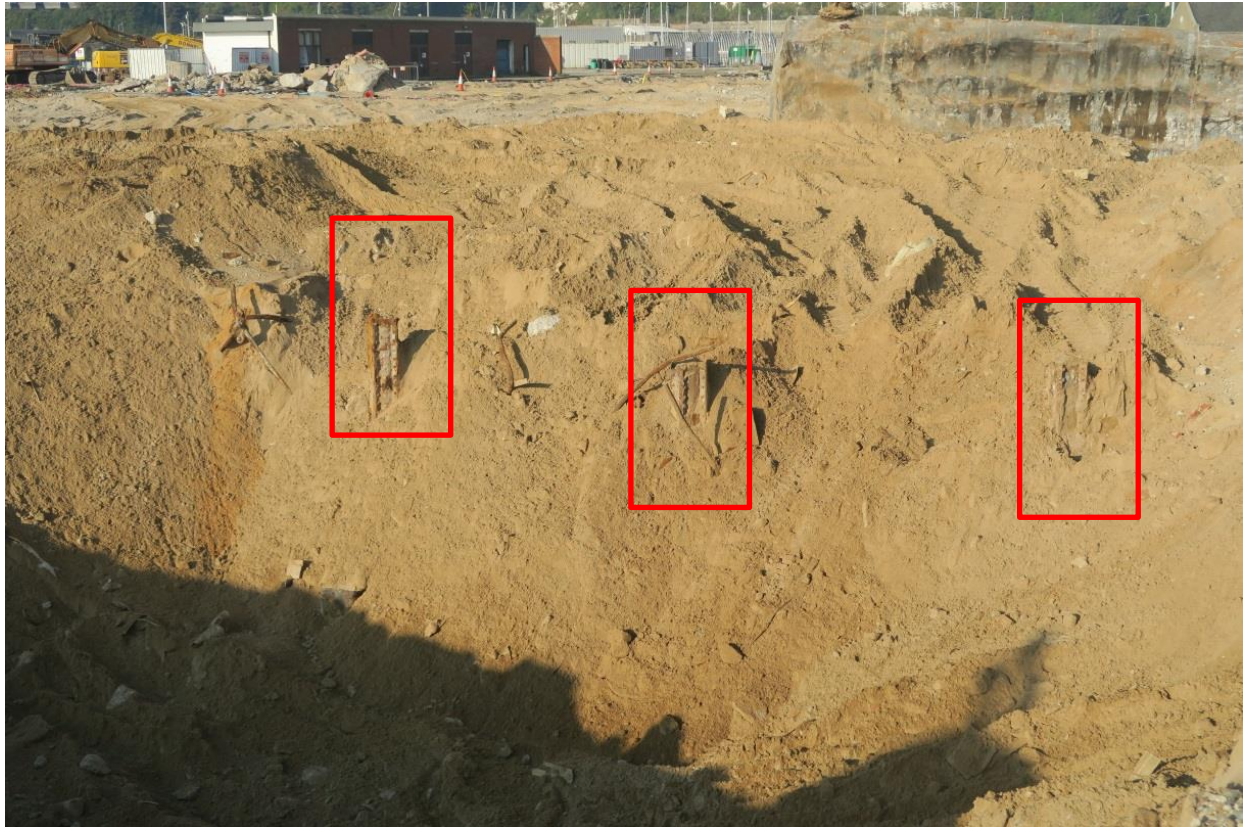
**Plate 64:** Three of original pile foundations for the Prince of Wales Pier, highlighted in red, 26/10/16, DHB.

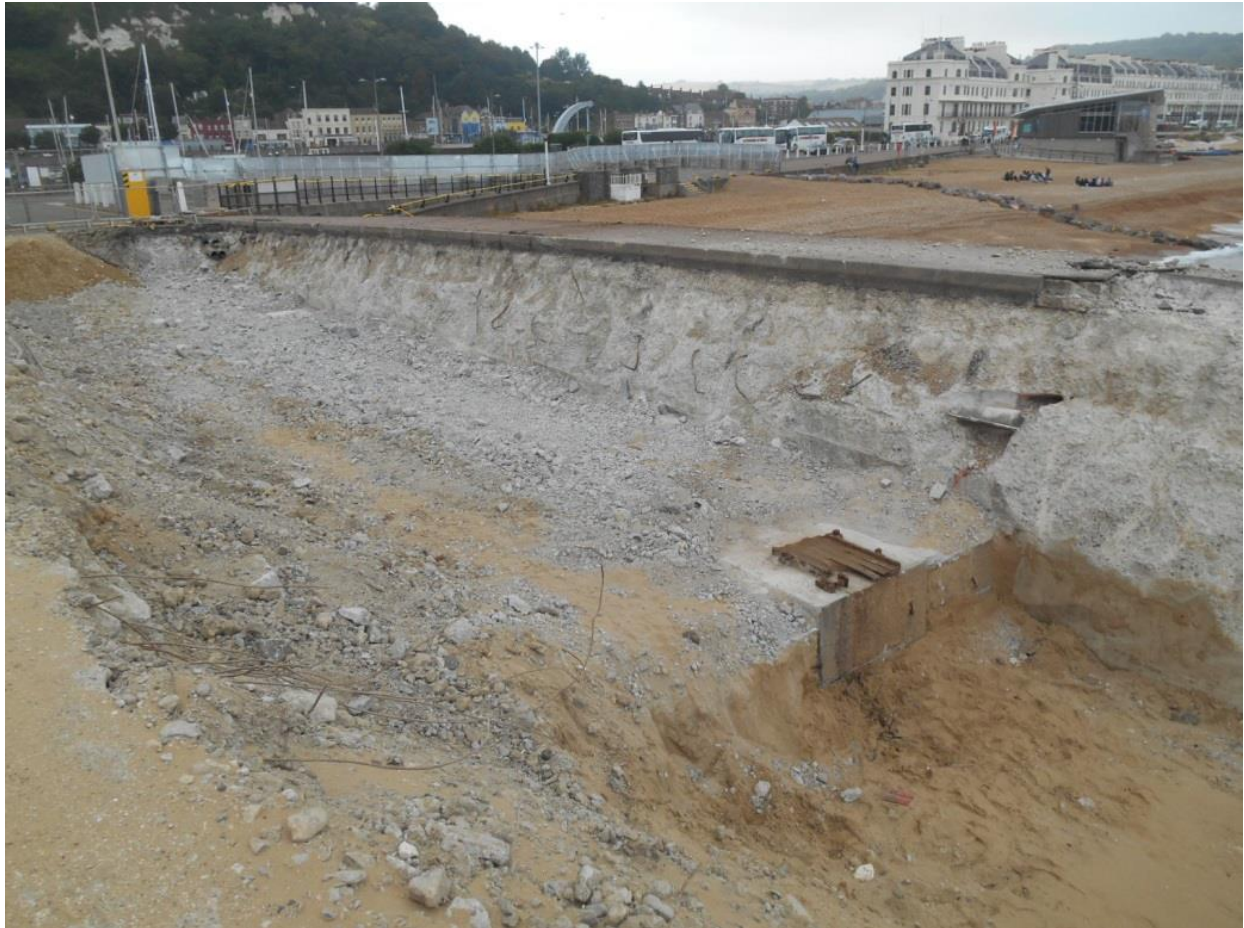
**Plate 65:** *The position of the remaining connecting joist, looking North, 28/7/2016, DHB.*

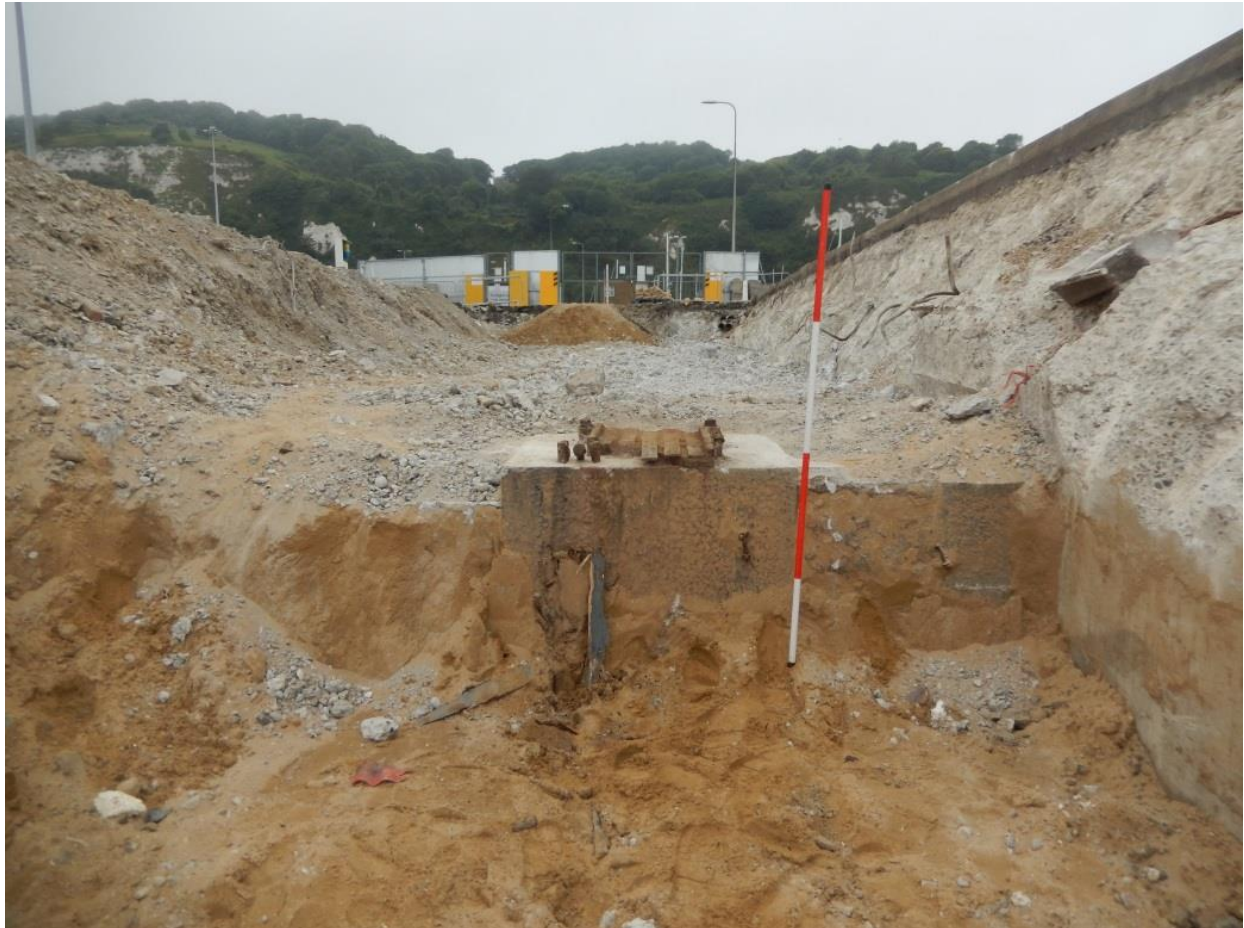
**Plate 66:** *The position of the remaining connecting joist, looking West, 2m Scale, 28/7/2016, DHB.*

Due to this item not being listed it was decided it was left in situ but recorded by photographic evidence. The joint was covered in plastic sheeting and buried in sand like the rest of its surrounding area. It will be uncovered again in a later stage of the works with the possibility of removing it then following further consultation with the HSG.

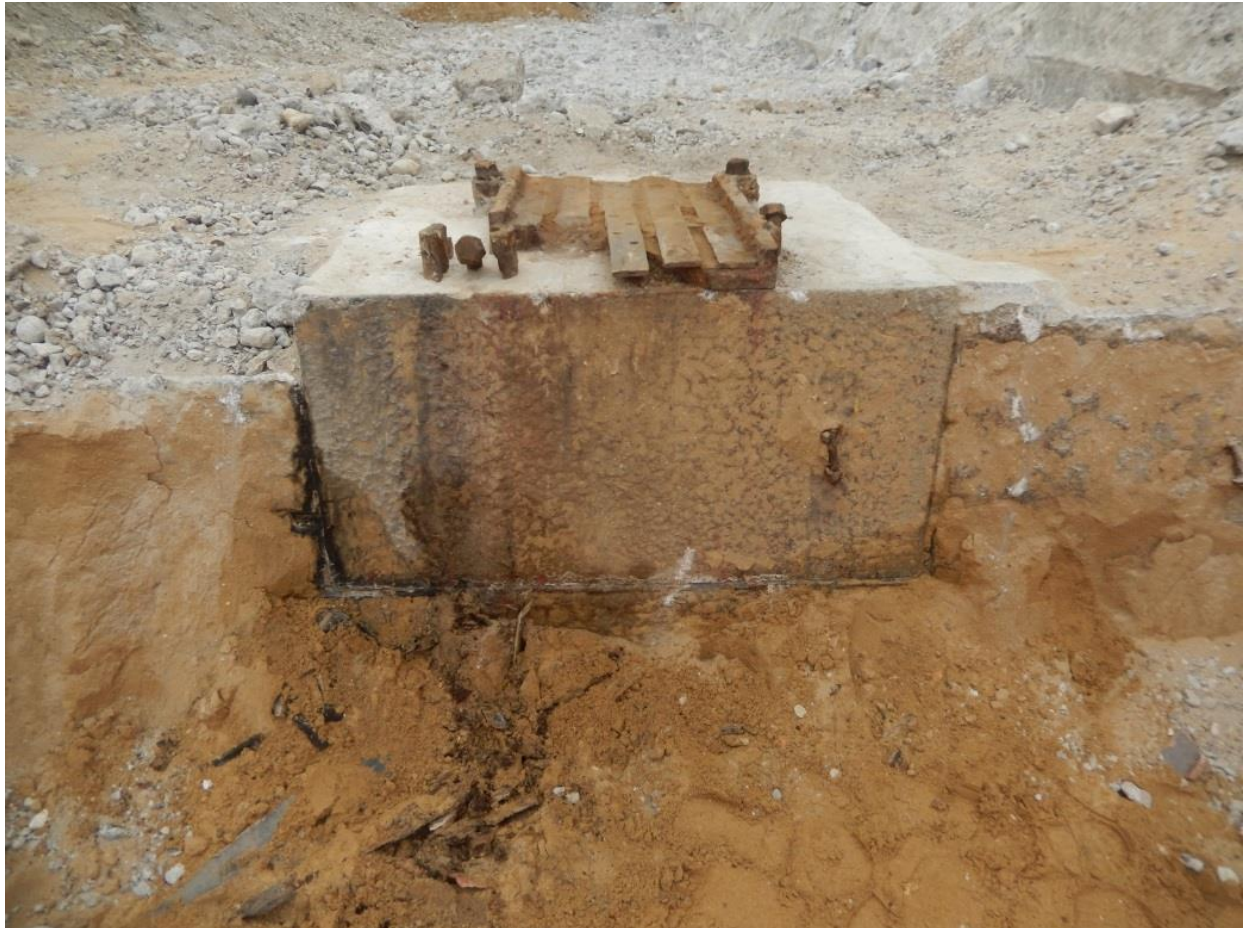
**Plate 67:** *The remaining connecting joist, looking West, 28/7/2016, DHB.*

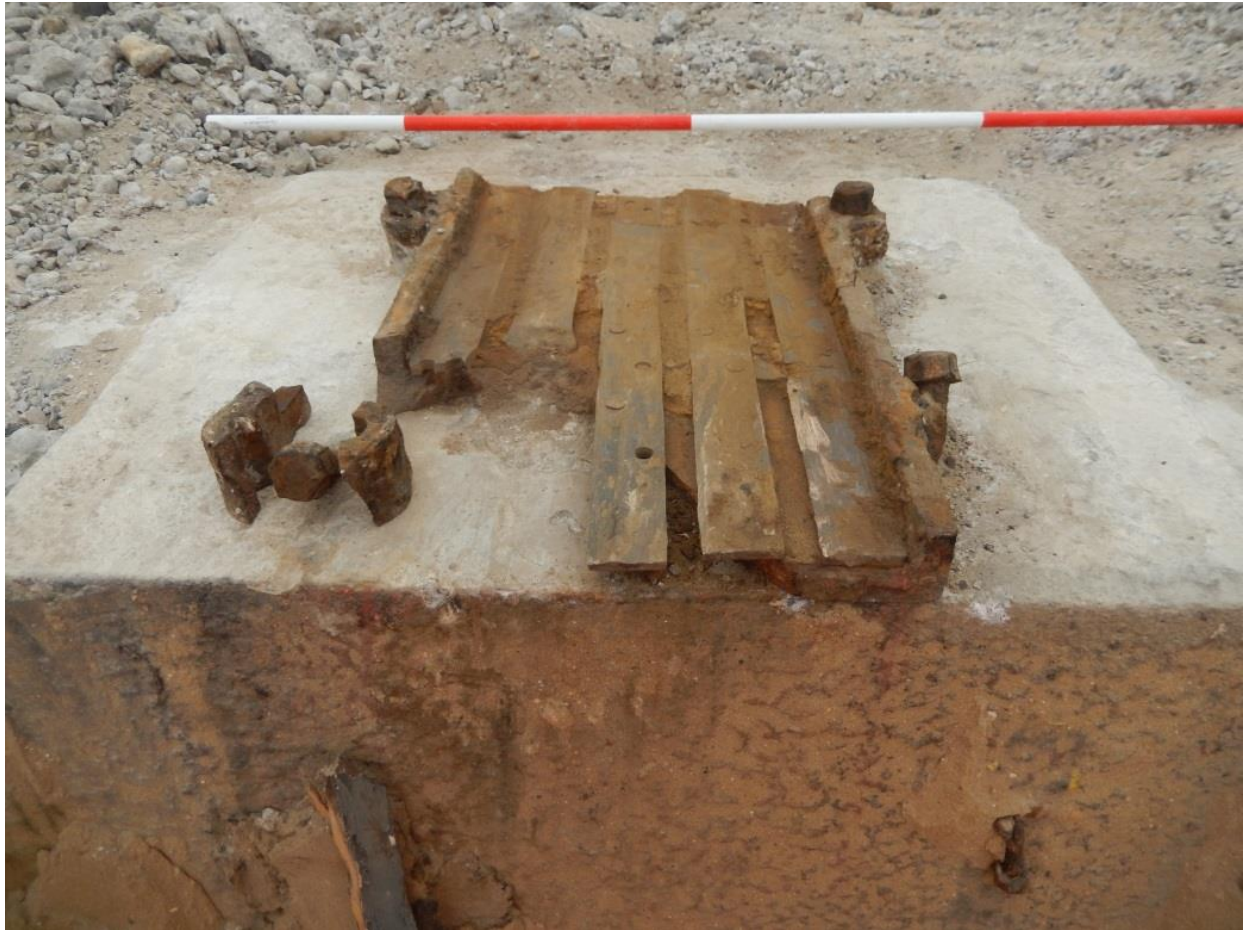
**Plate 68:** *The remaining connecting joist, looking West, 2m Scale, 28/7/2016, DHB.*

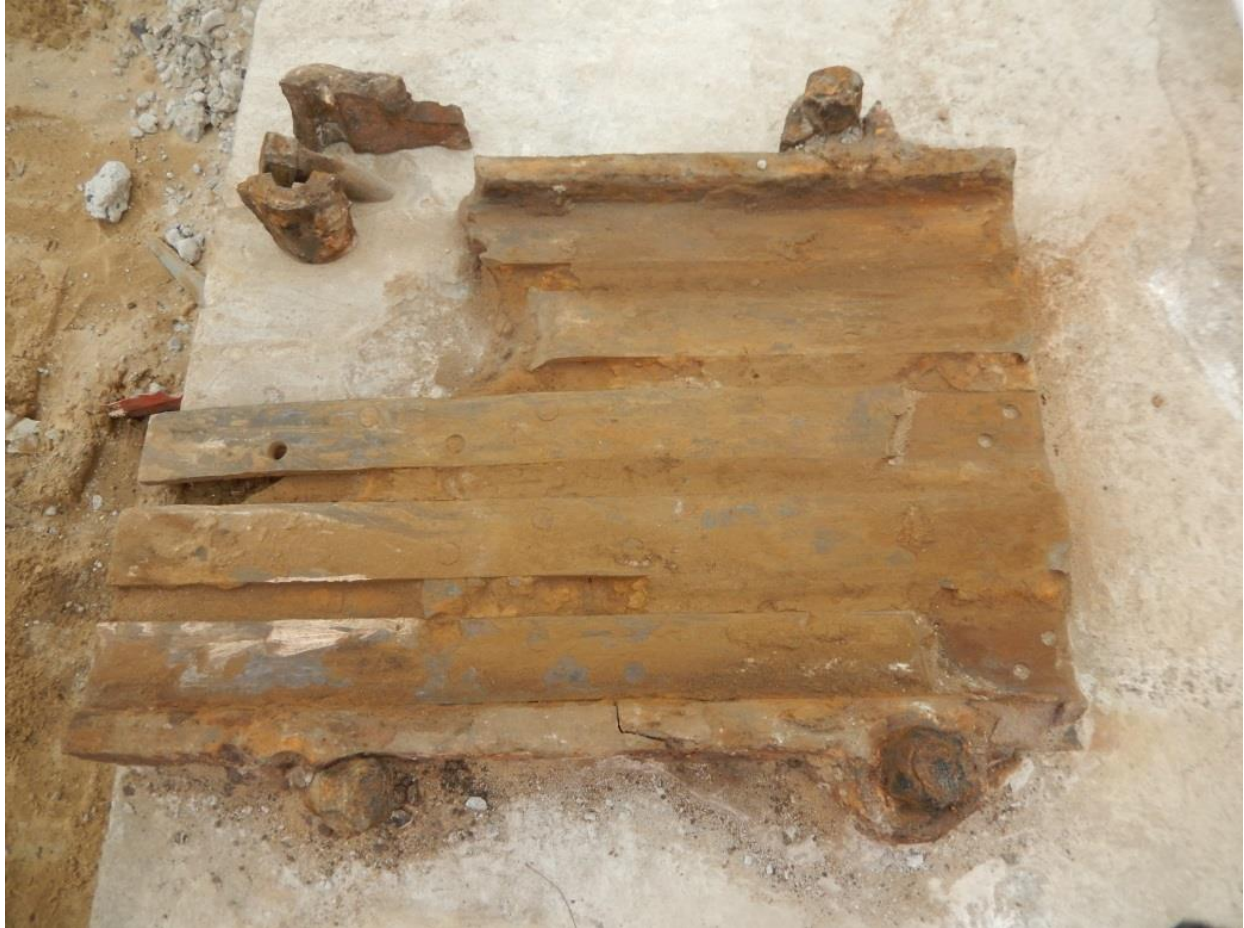
**Plate 69:** A detail of the remaining connecting joist, 28/7/2016, DHB.

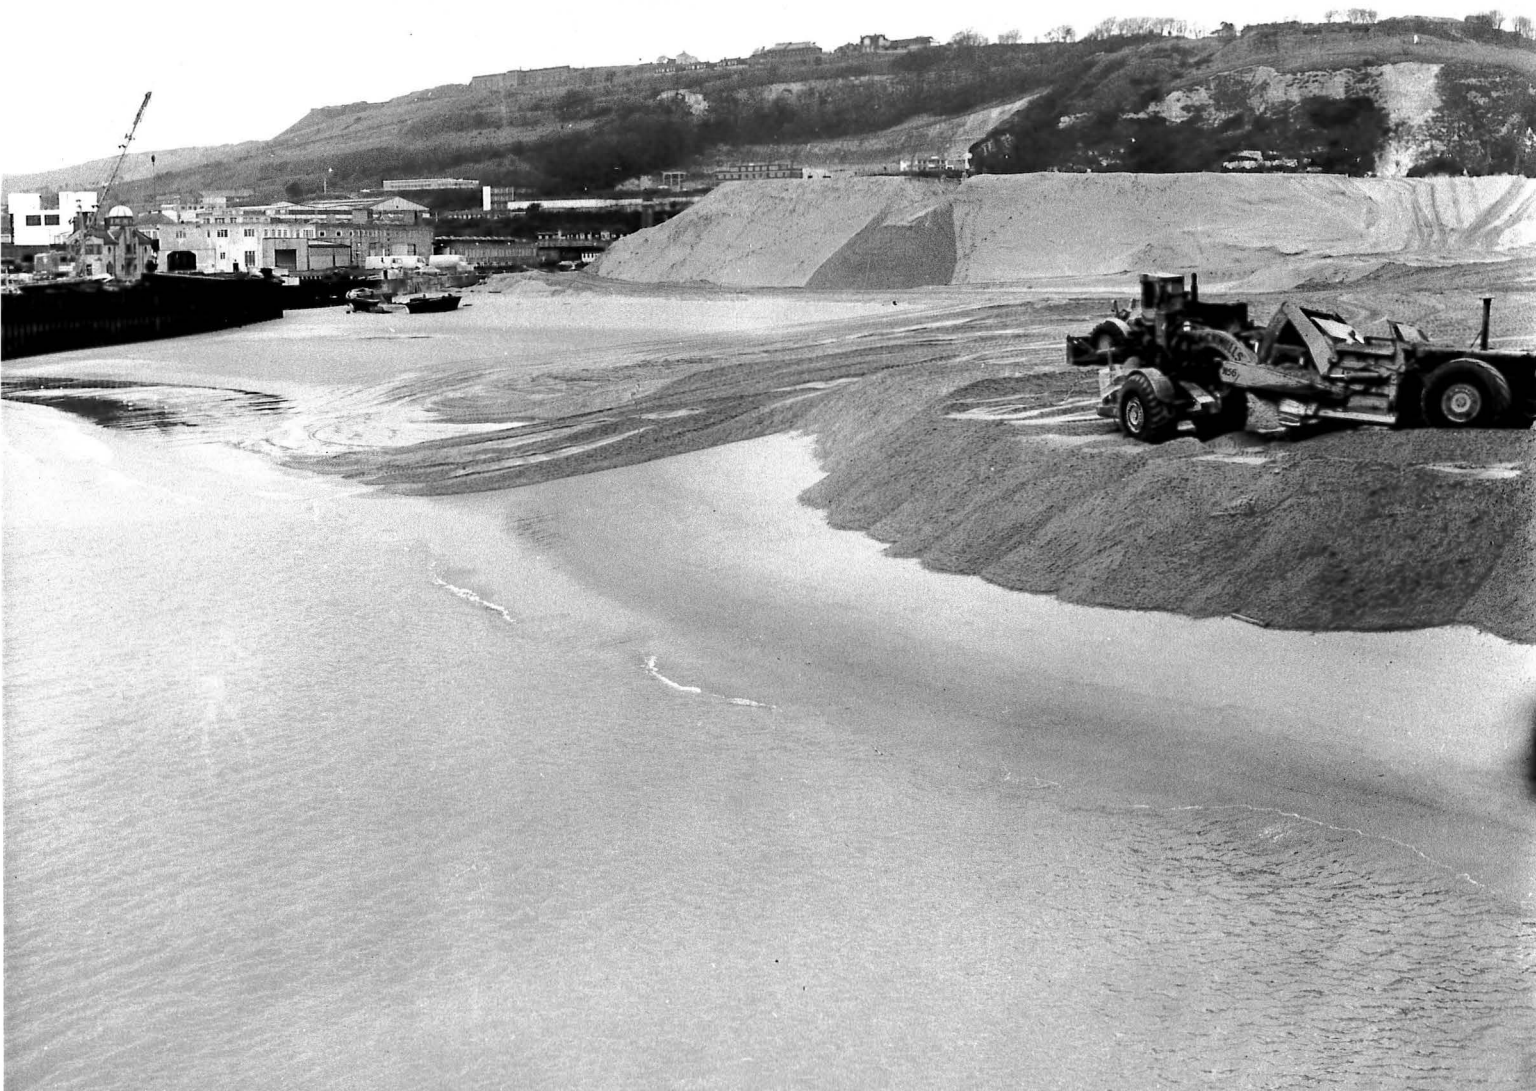
**Figure 1:** The reclamation of land with the use of sand before the main construction of the hoverport apron could start, looking north-west, 13/01/1976, DHB.
