## **DOVER HARBOUR BOARD**

### **HERITAGE RECORDING PRINCE OF WALES PIER**

### **TO THE DOVER WESTERN DOCKS, DOVER, KENT**

### **Desktop Study**

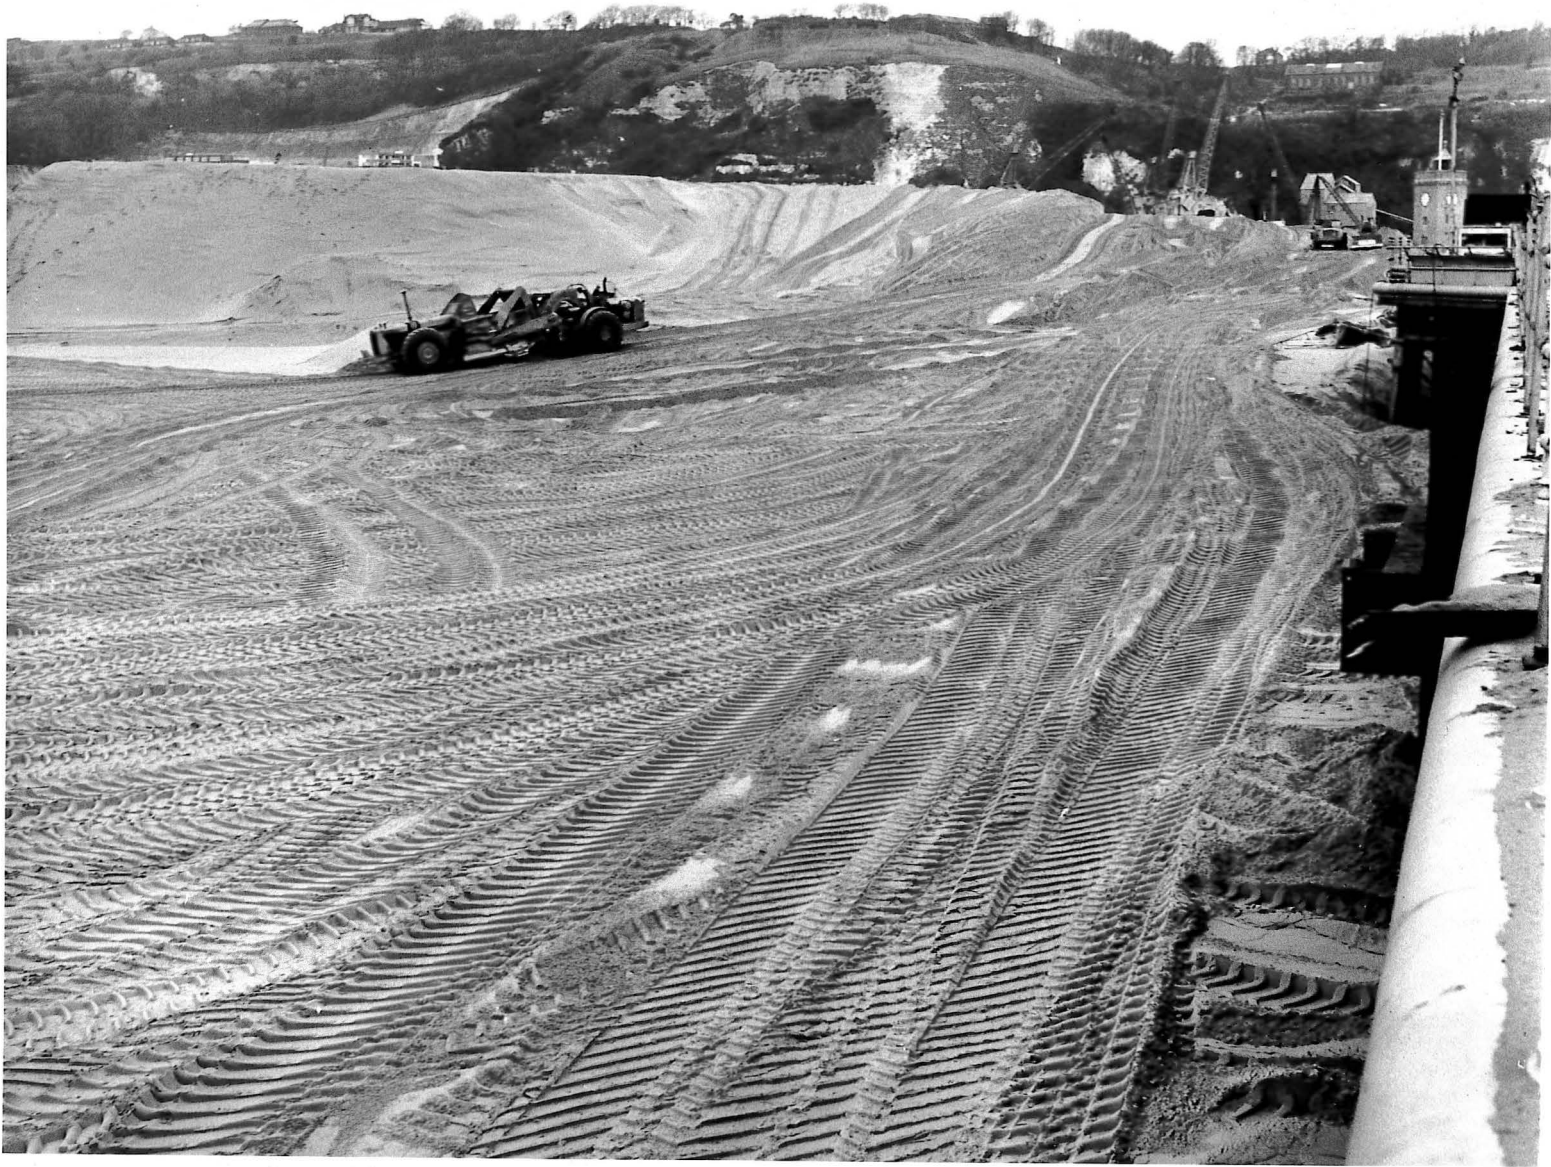
**Figure 2:** The land which has been reclaimed in order to create a foundation for the rest of the works, looking West, 13/01/1976, DHB.

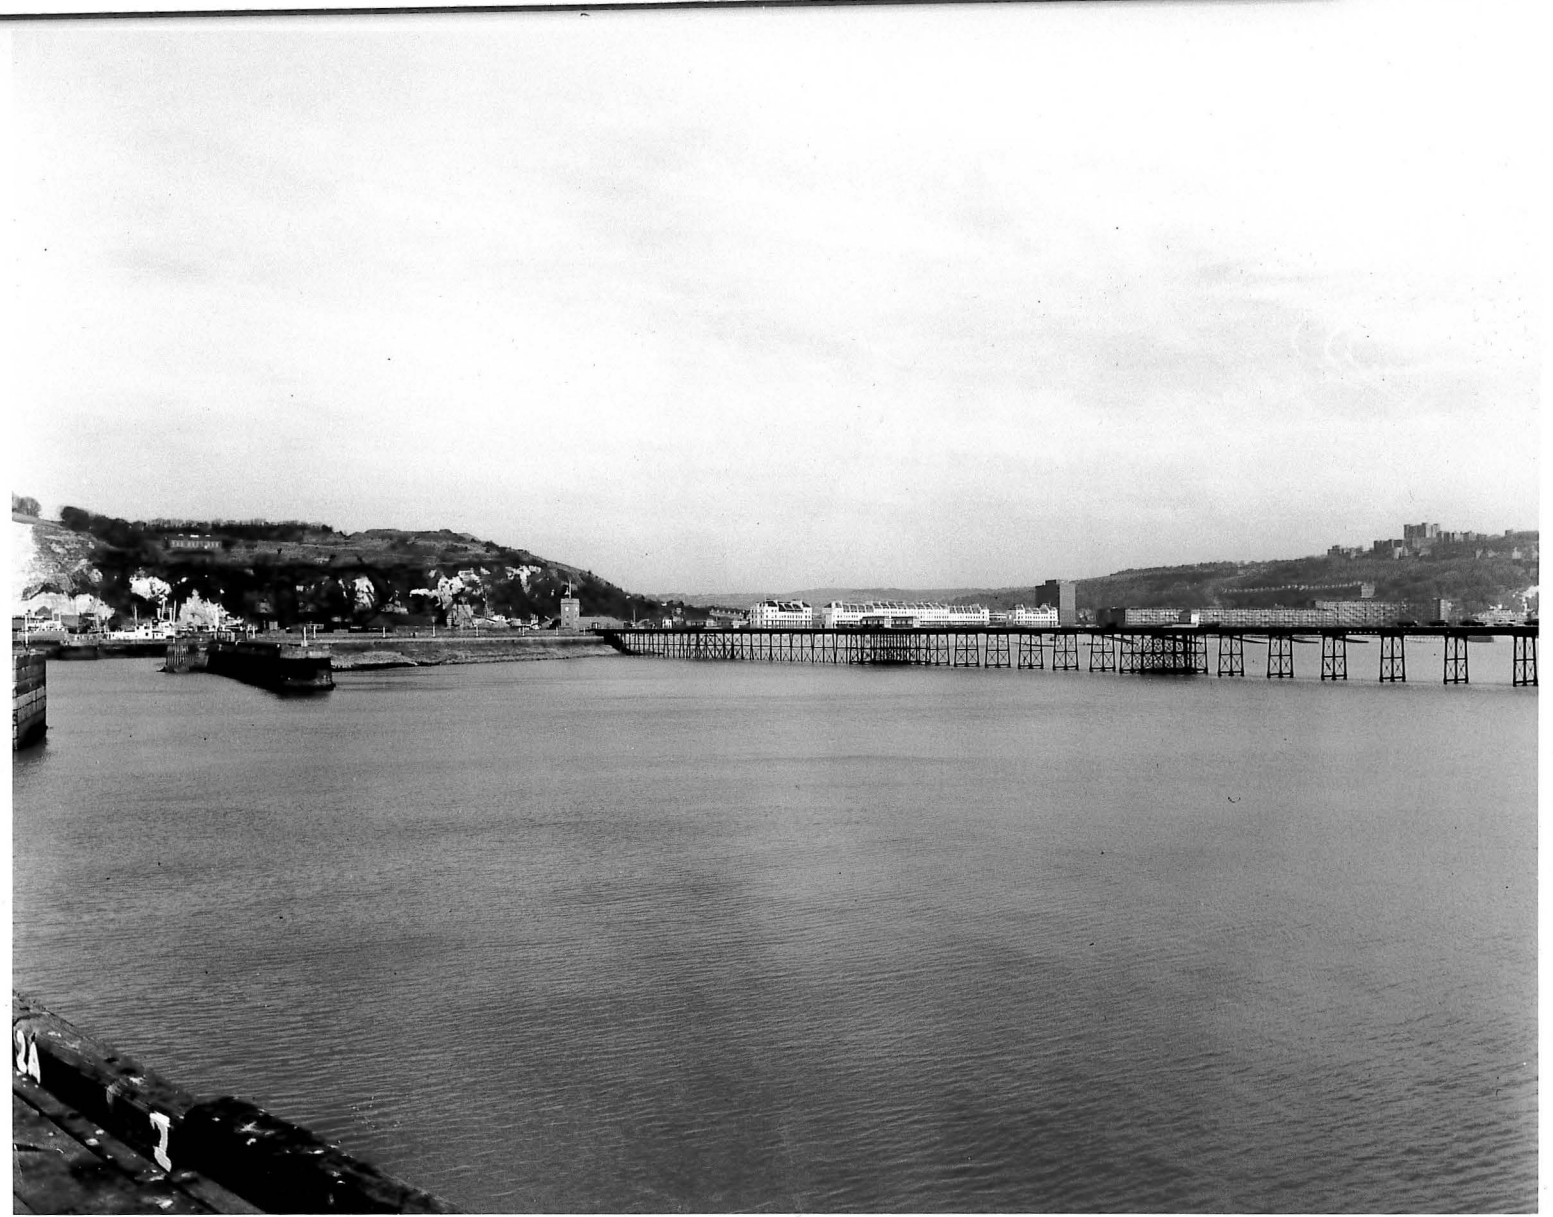
**Figure 3:** View from the Admiralty pier, of the Prince of Wales Pier before the reclamation works had started, the original Victorian lattice structure can be seen clearly, looking north-west, 05/04/1976, DHB.

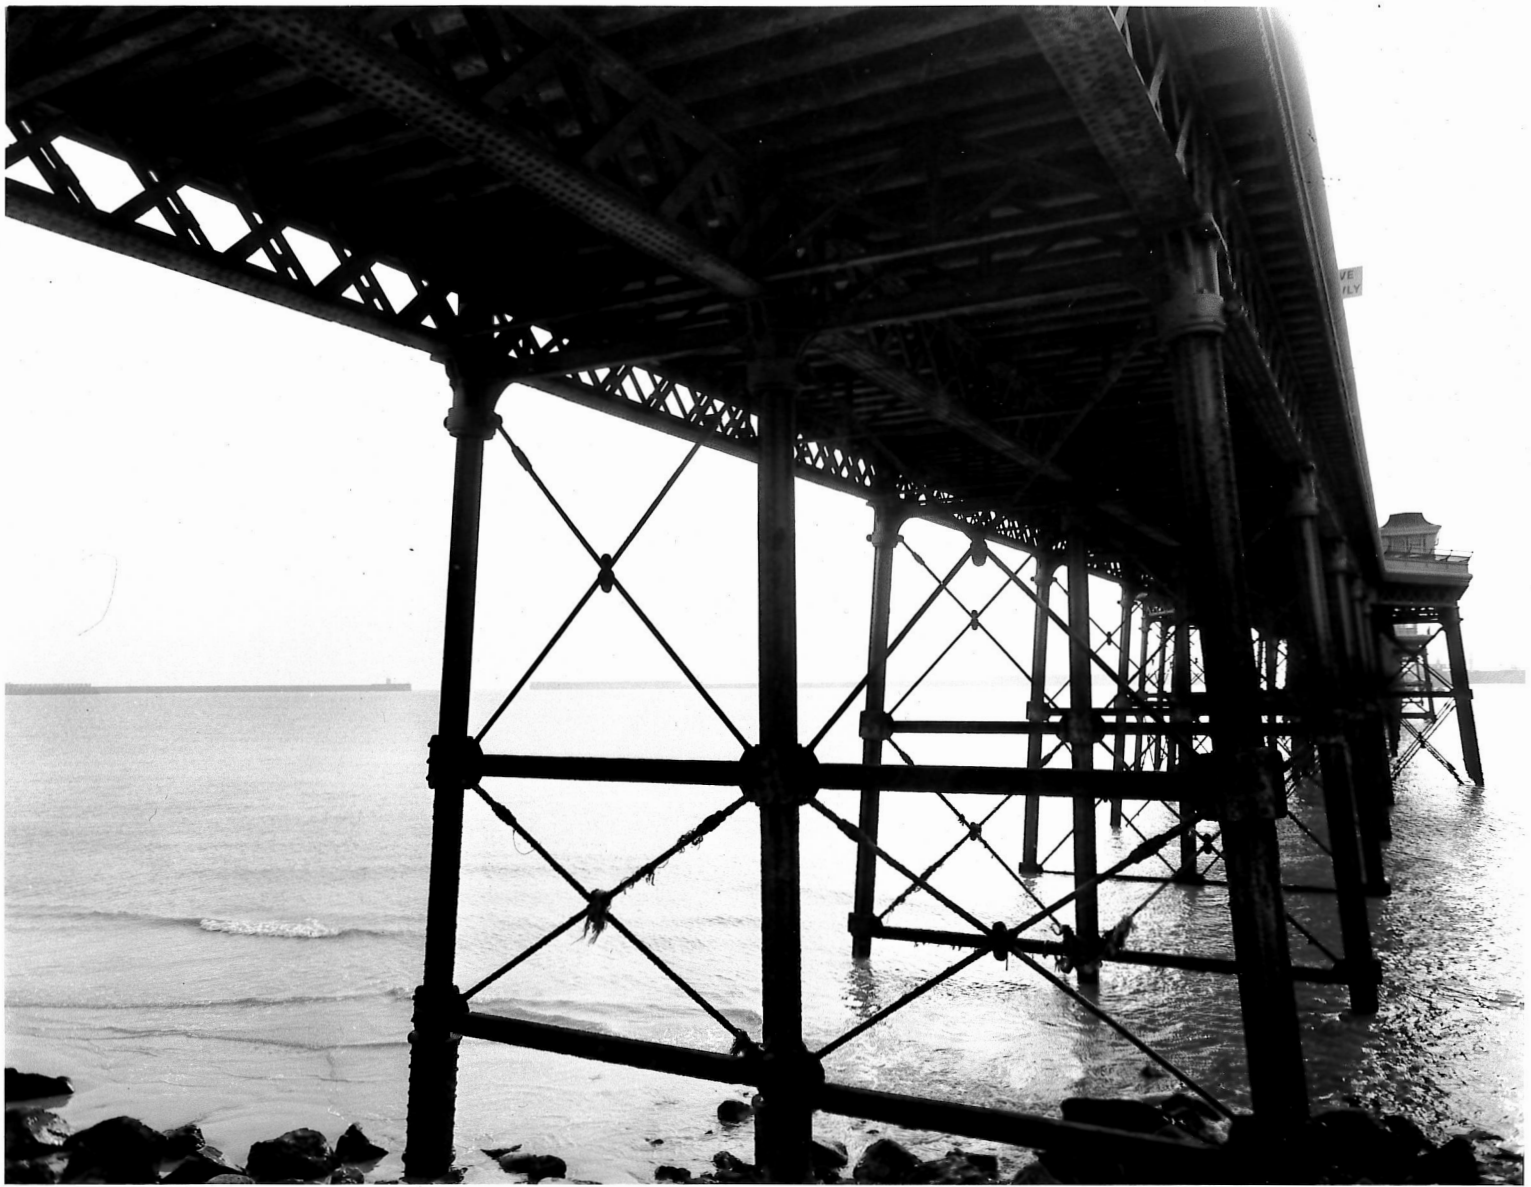
**Figure 6:** The original lattice steel structure that would have formed a large section of the Prince of Wales Pier, looking south-east, 05/04/1976, DHB.

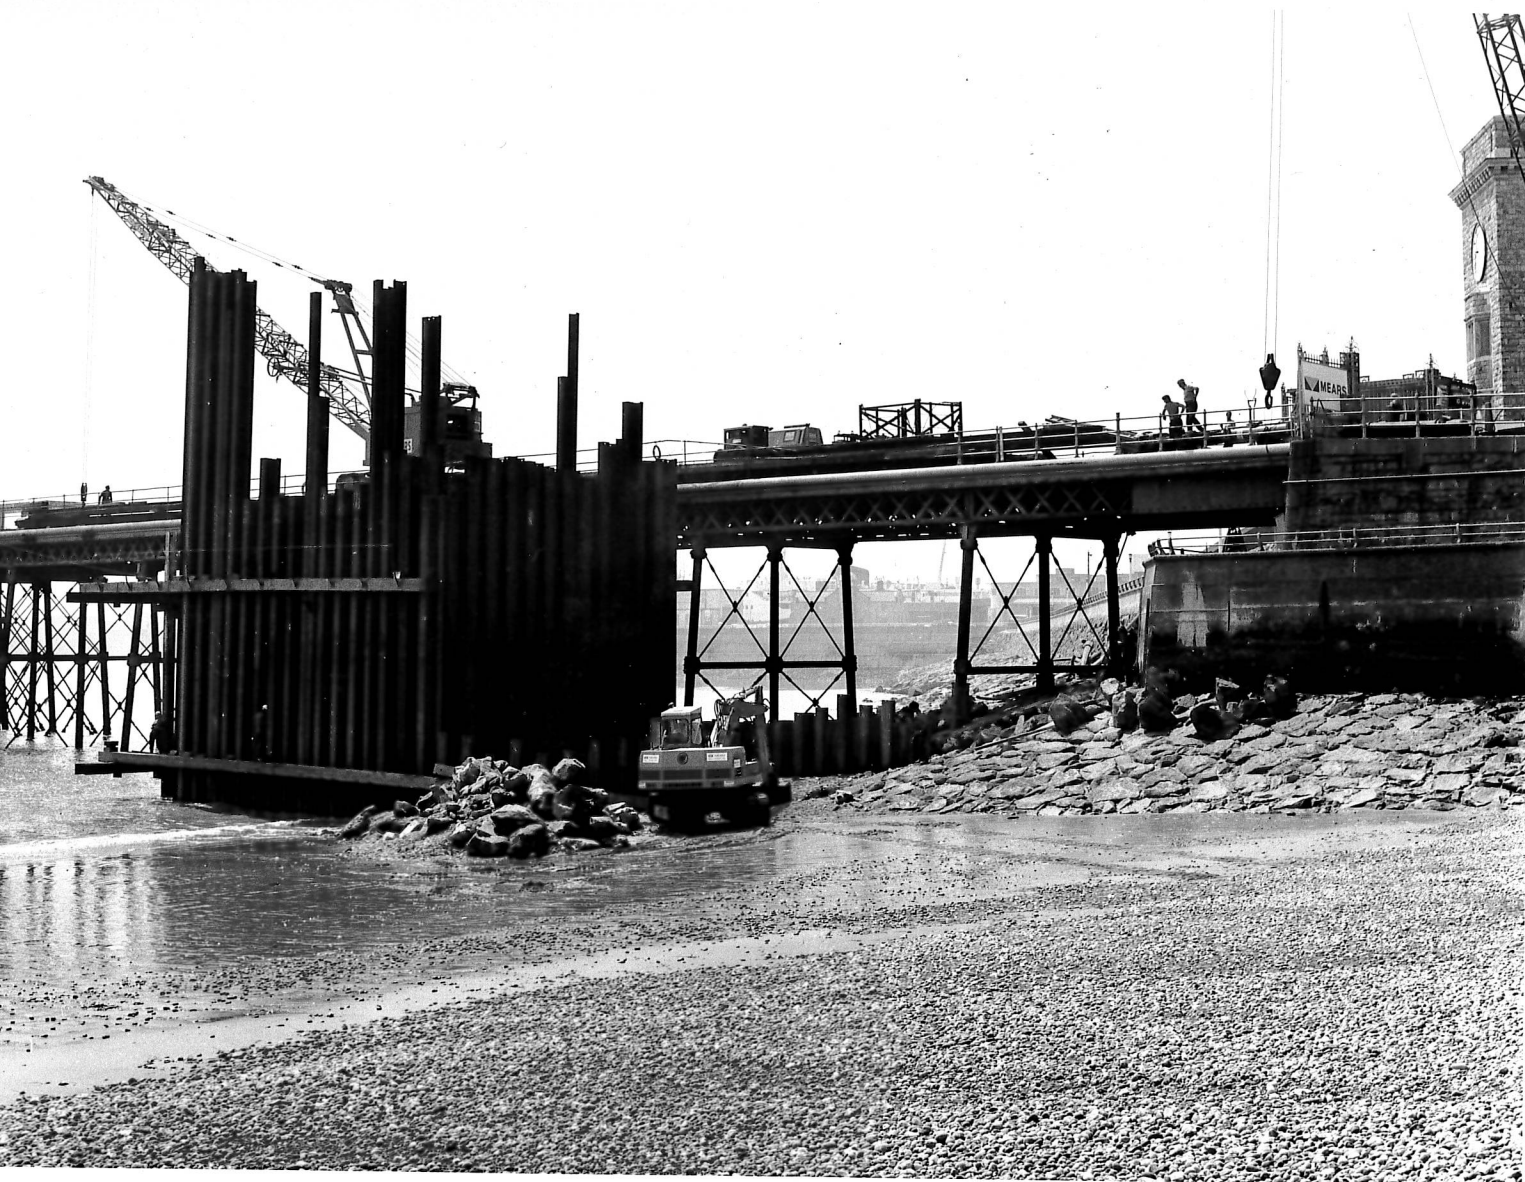
**Figure 9:** The beginnings of the sheet piling being installed to cover the original structure, looking South, 18/06/1976, DHB.

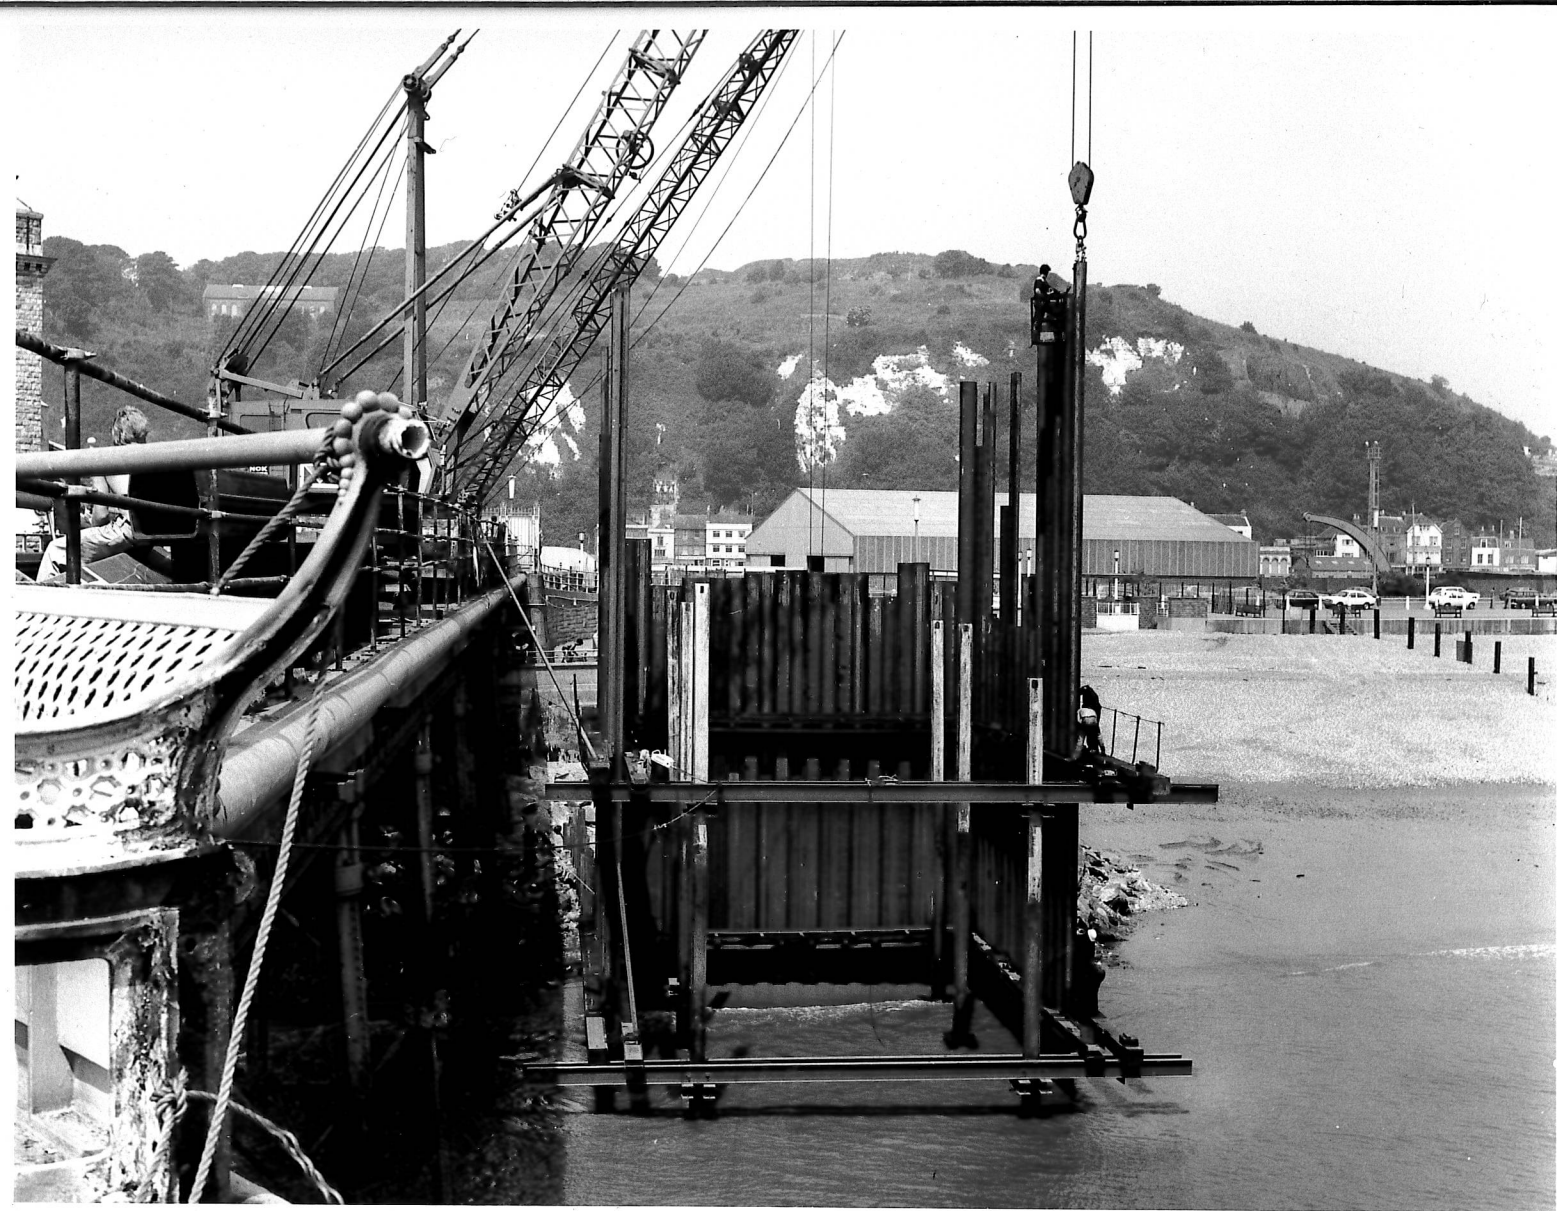
**Figure 10:** Sheet piling being put into place, seating is again visible here, looking West, 18/06/1976, DHB.

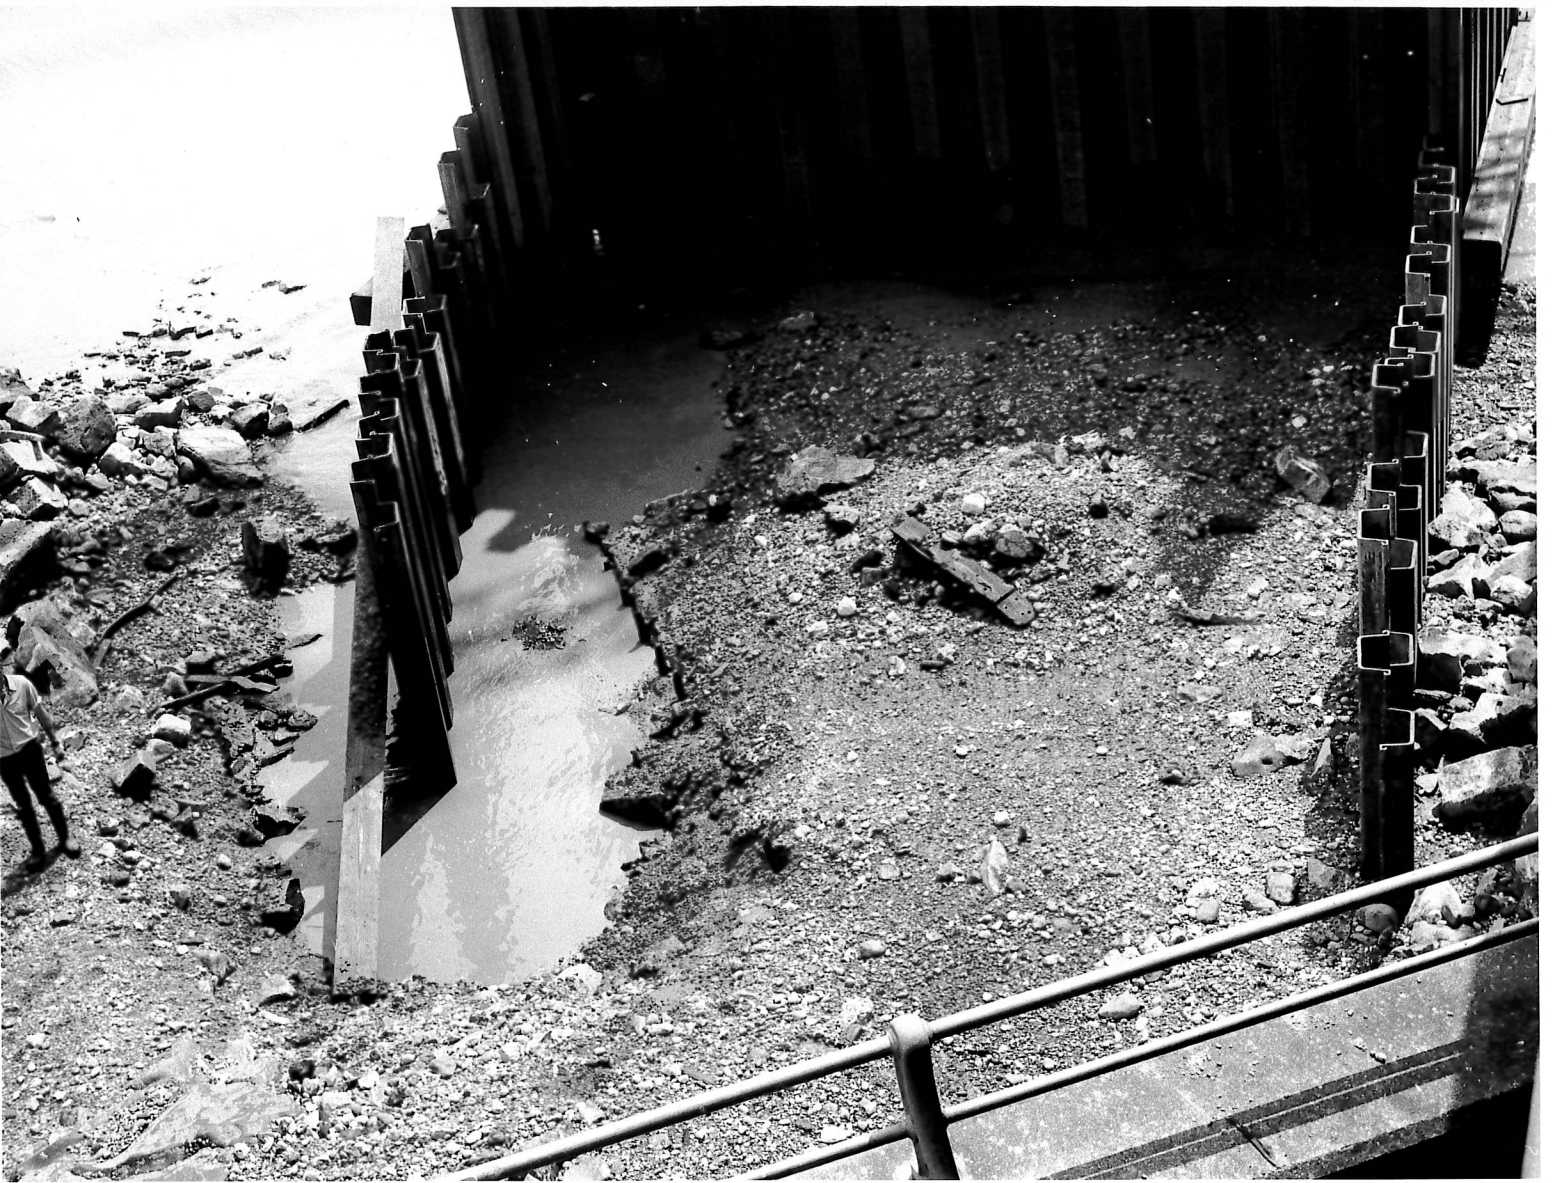
**Figure 11:** Pile foundations being installed, 18/06/1976, DHB.

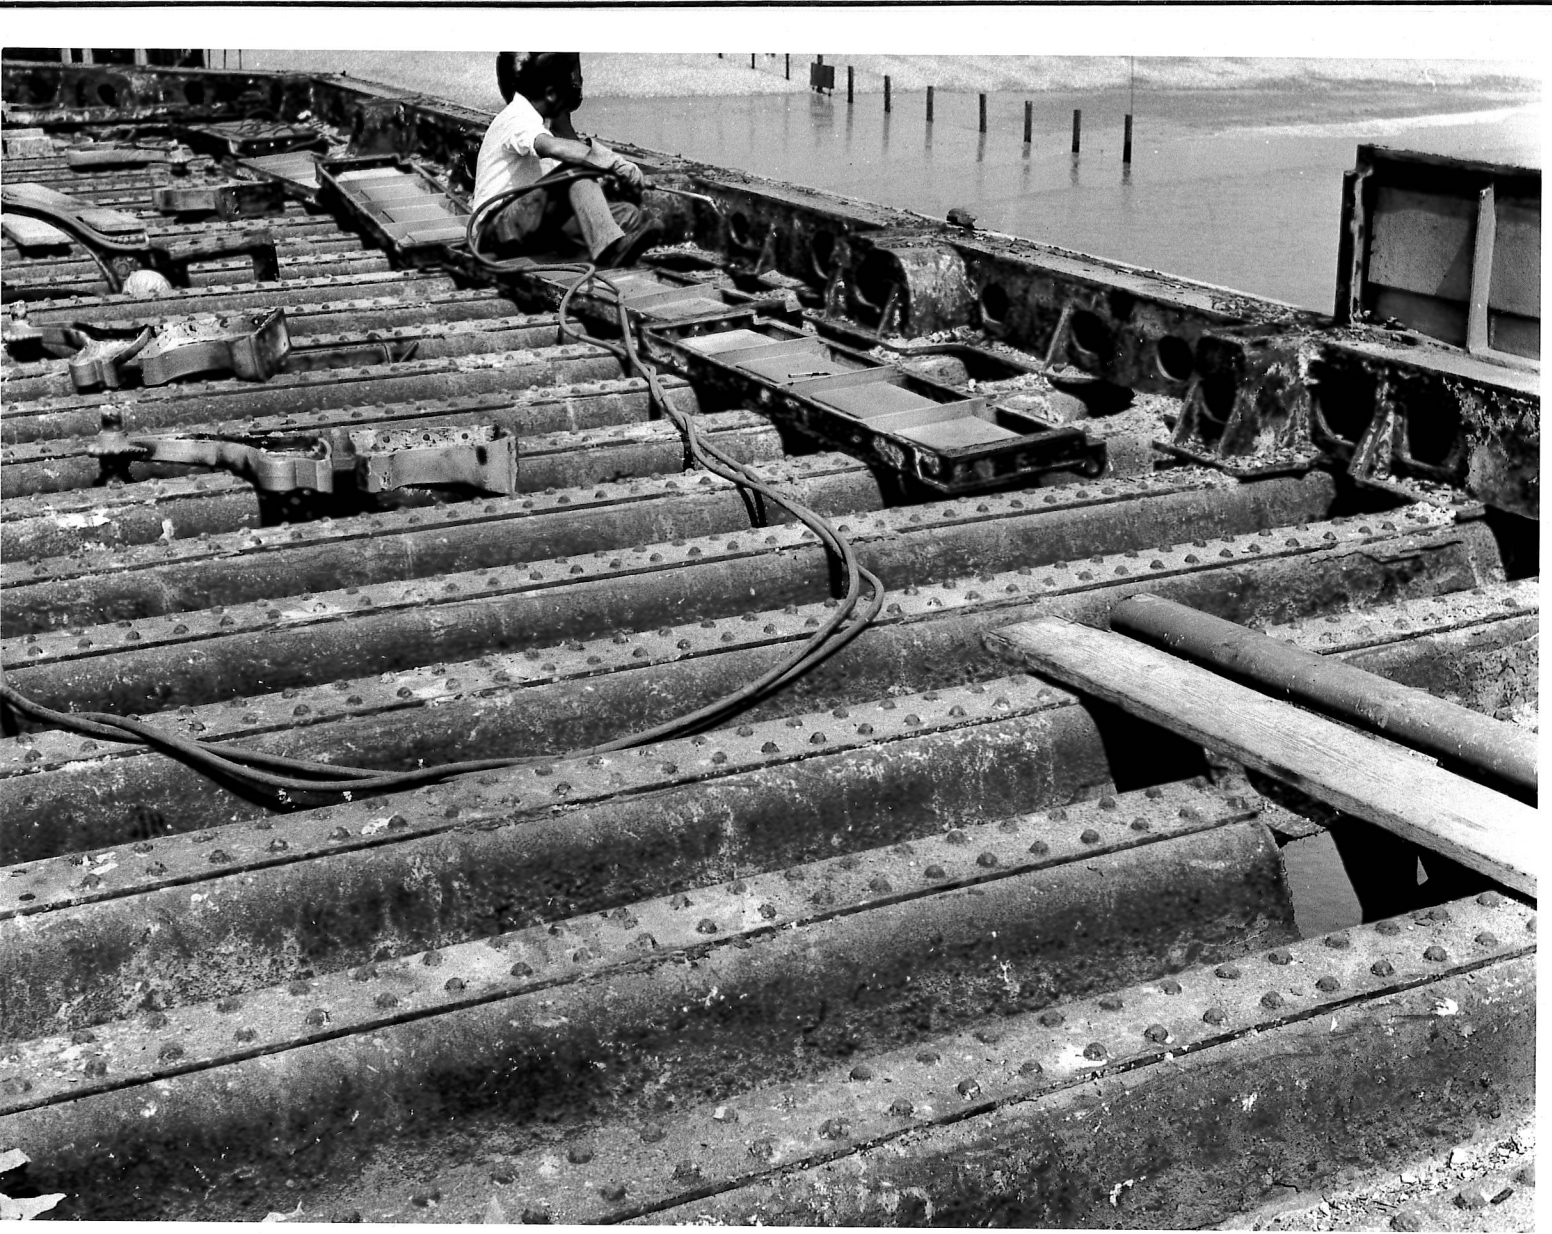
**Figure 13:** Pile foundations, looking North, 18/06/1976, DHB.

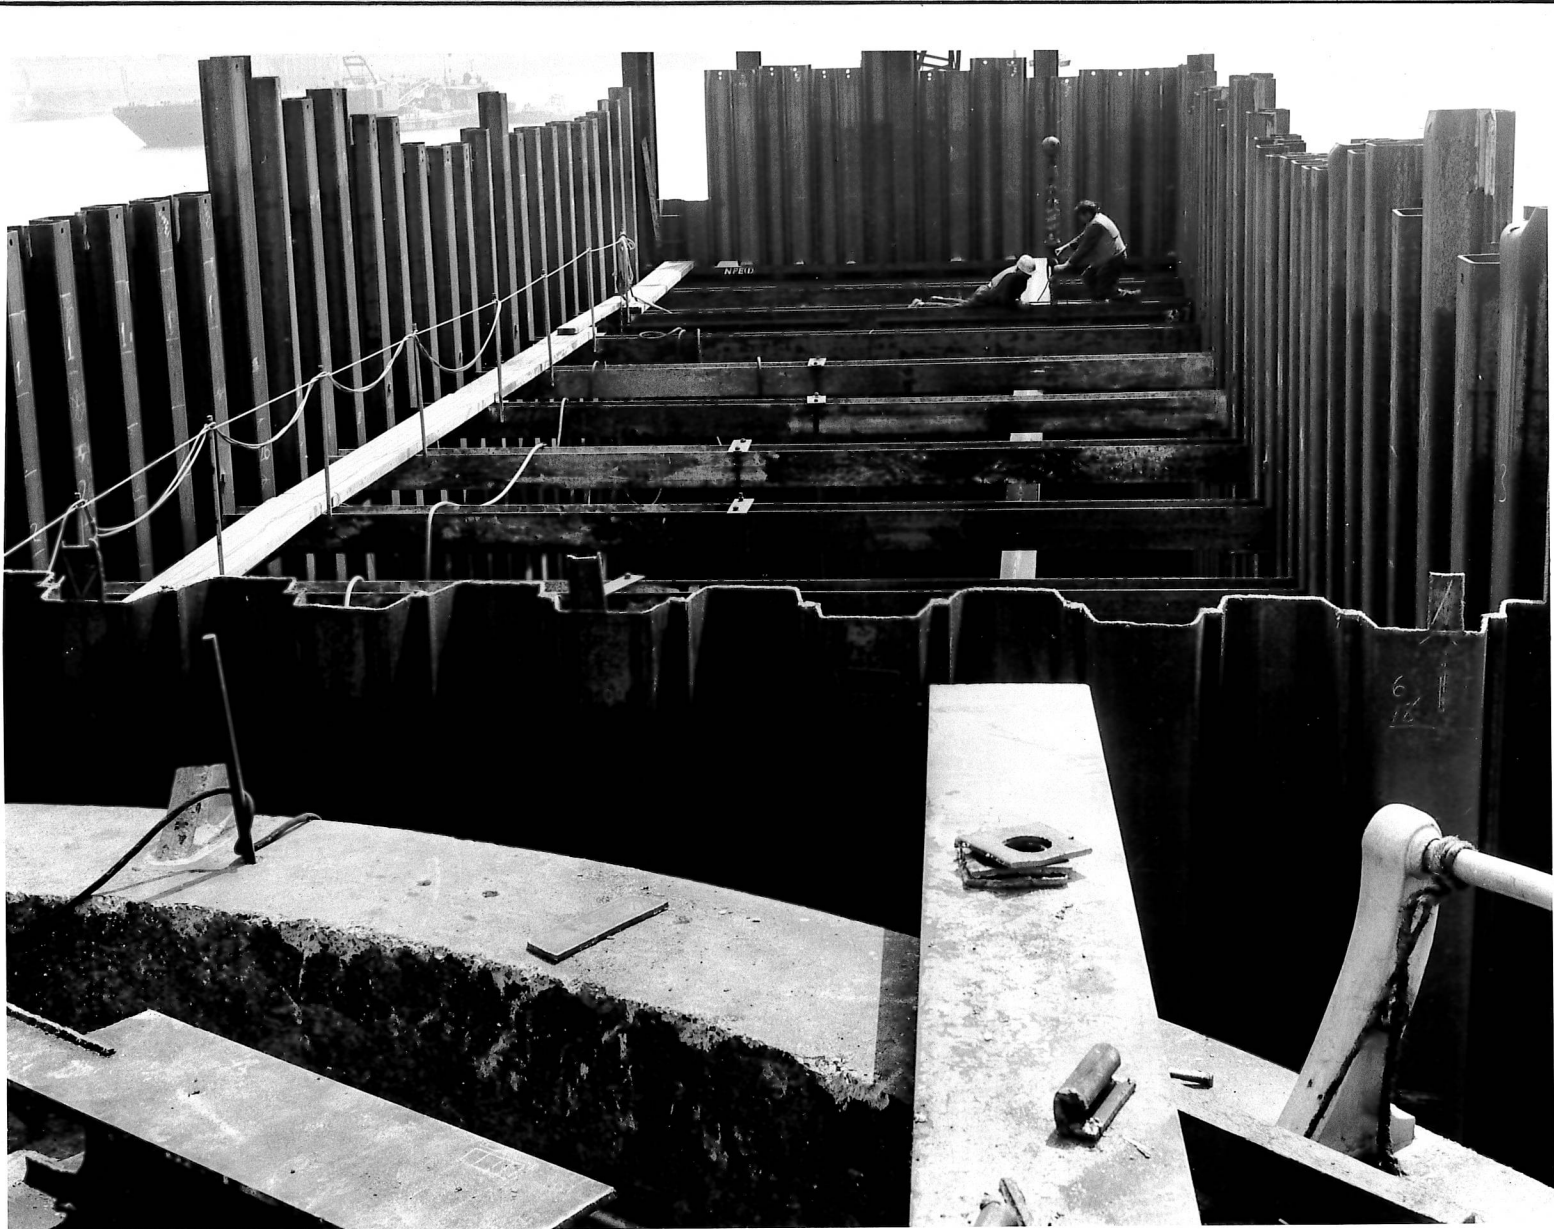
**Figure 14** Piling preparation works, 18/06/1976, DHB.

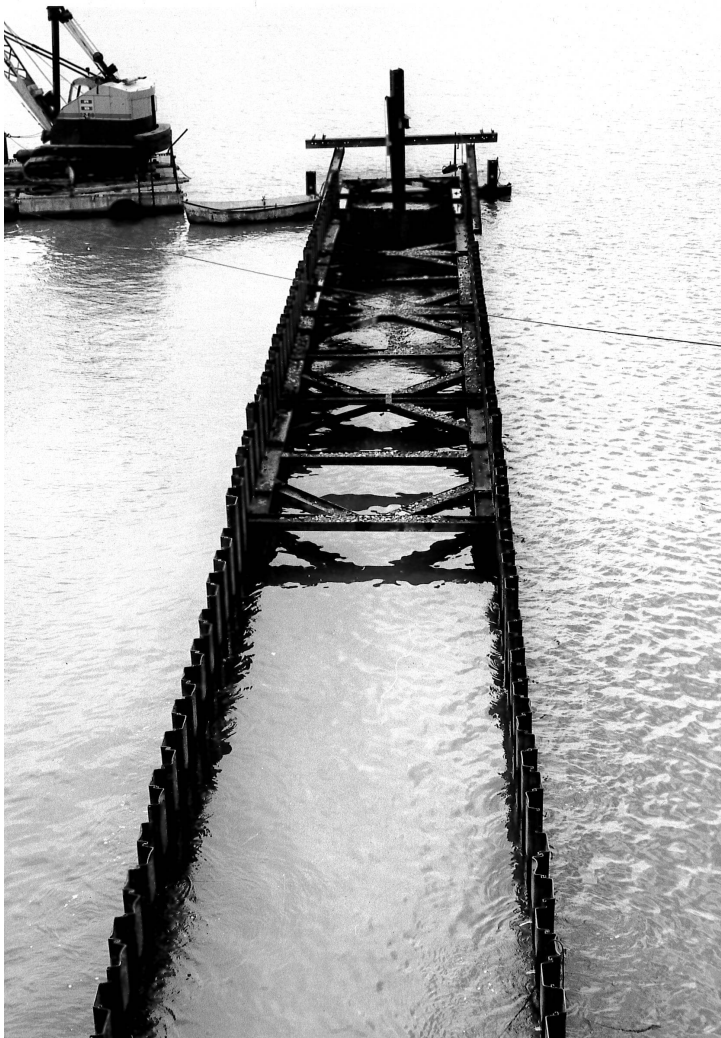
**Figure 15:** Staging for the construction works, 02/08/1976, DHB.

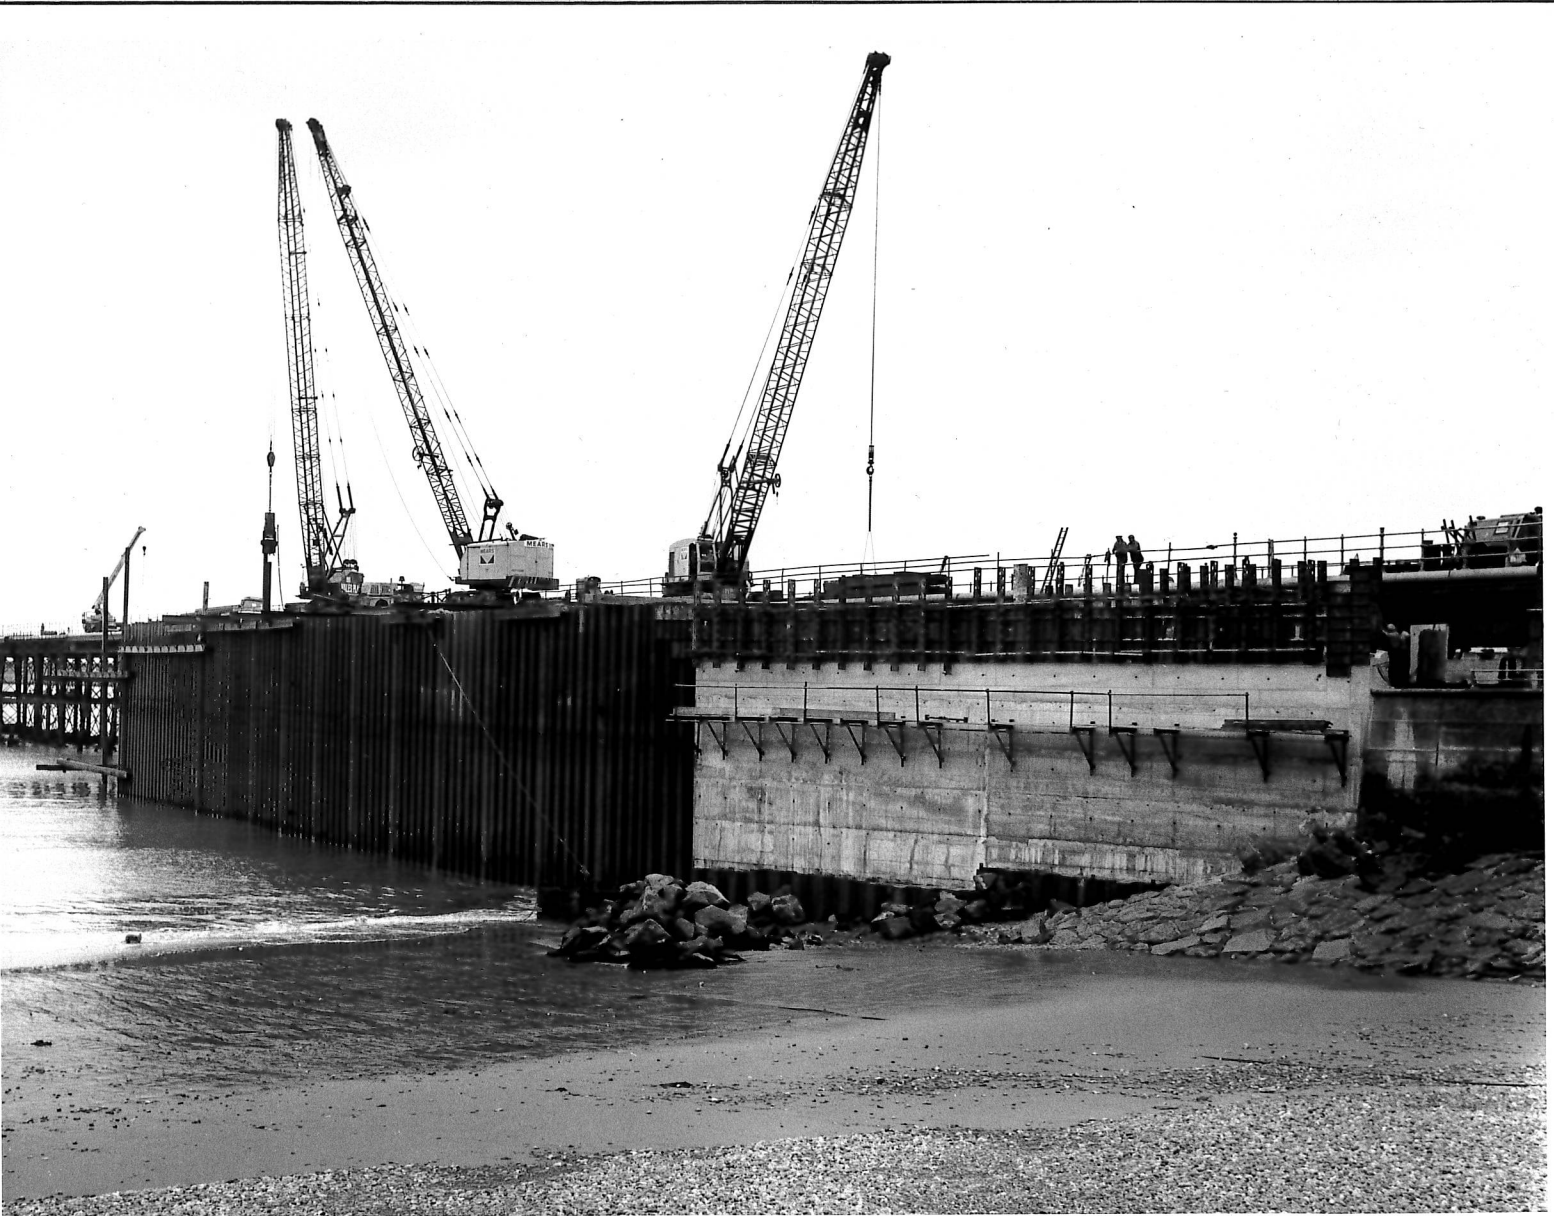
**Figure 16:** Work has progressed here with the majority of the landward end of the pier being covered, 02/08/1976, DHB.

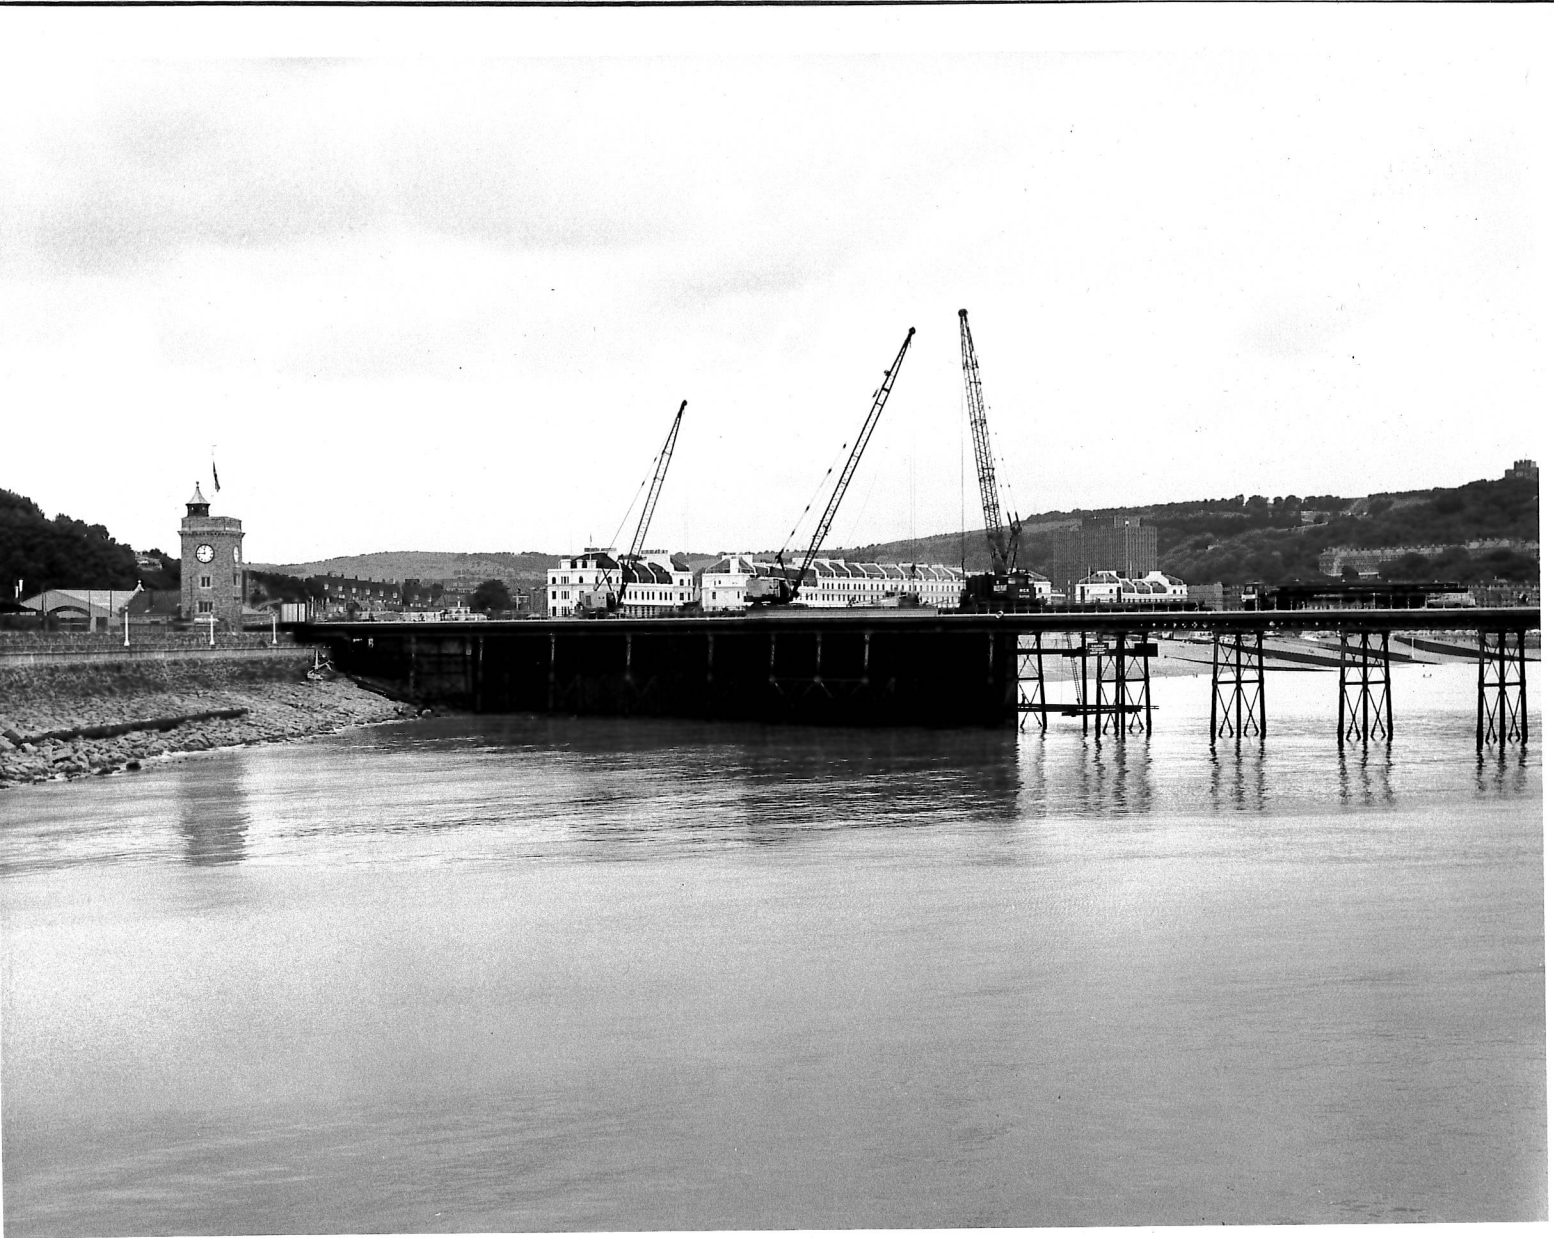
**Figure 17:** Sheet piling has been installed, the clock tower and waterloo crescent are also visible here, looking north-west, 02/08/1976, DHB.

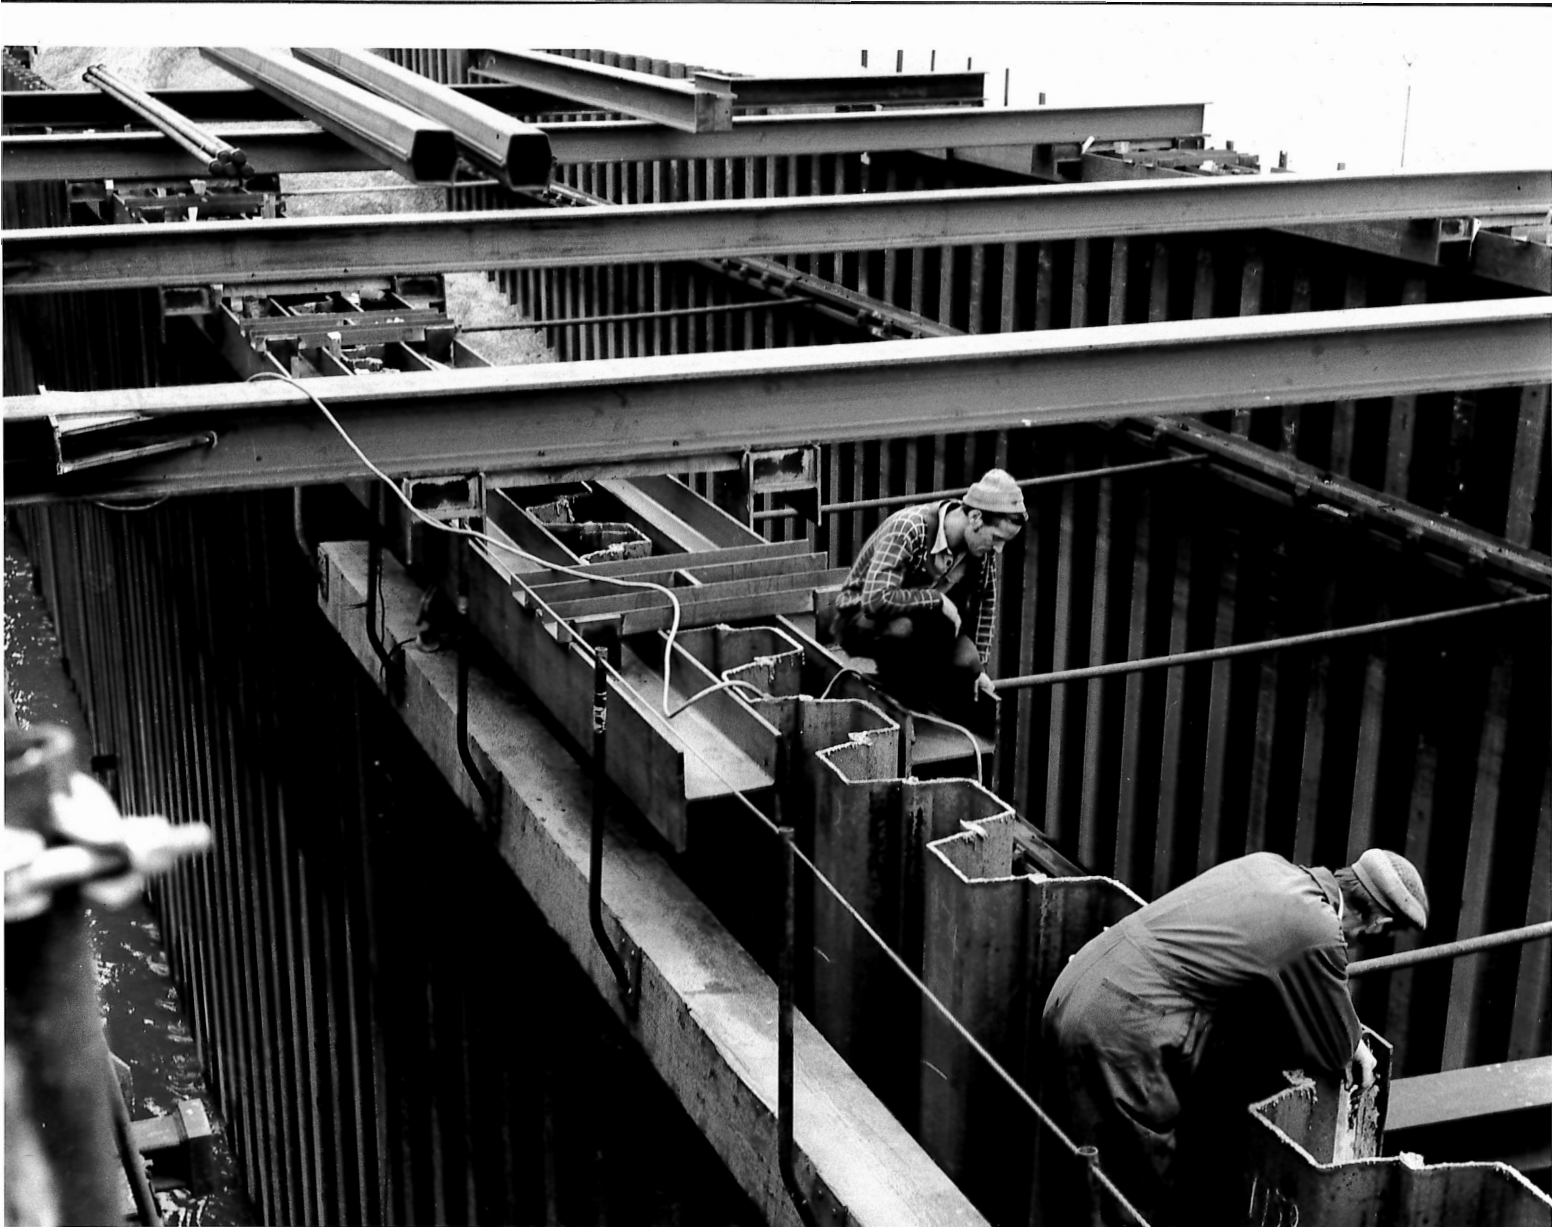
**Figure 18:** Construction workers attaching the sheet piling, 02/08/1976,, DHB.
