## **DOVER HARBOUR BOARD**

### **HERITAGE RECORDING PRINCE OF WALES PIER**

### **TO THE DOVER WESTERN DOCKS, DOVER, KENT**

### **Desktop Study**

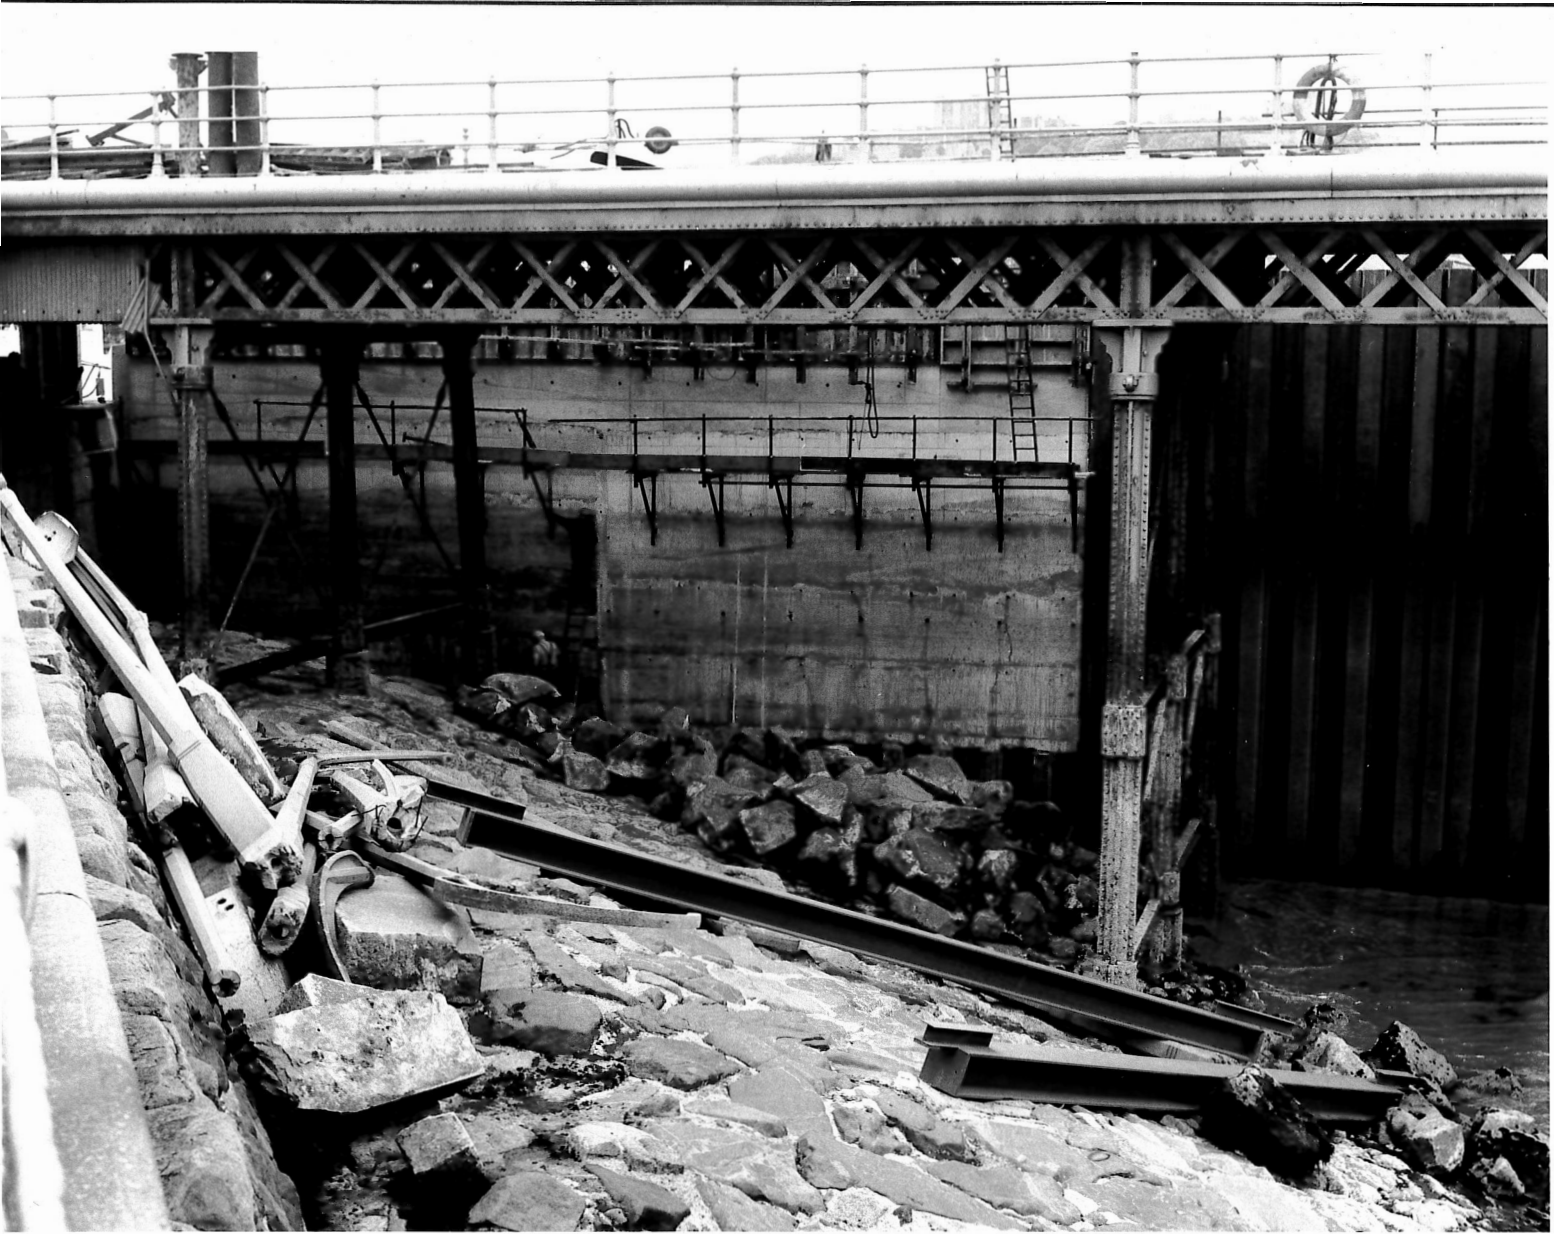
**Figure 19:** Both original and added material to the pier, concrete and steel structures can be seen, looking North, 02/08/1976, DHB.

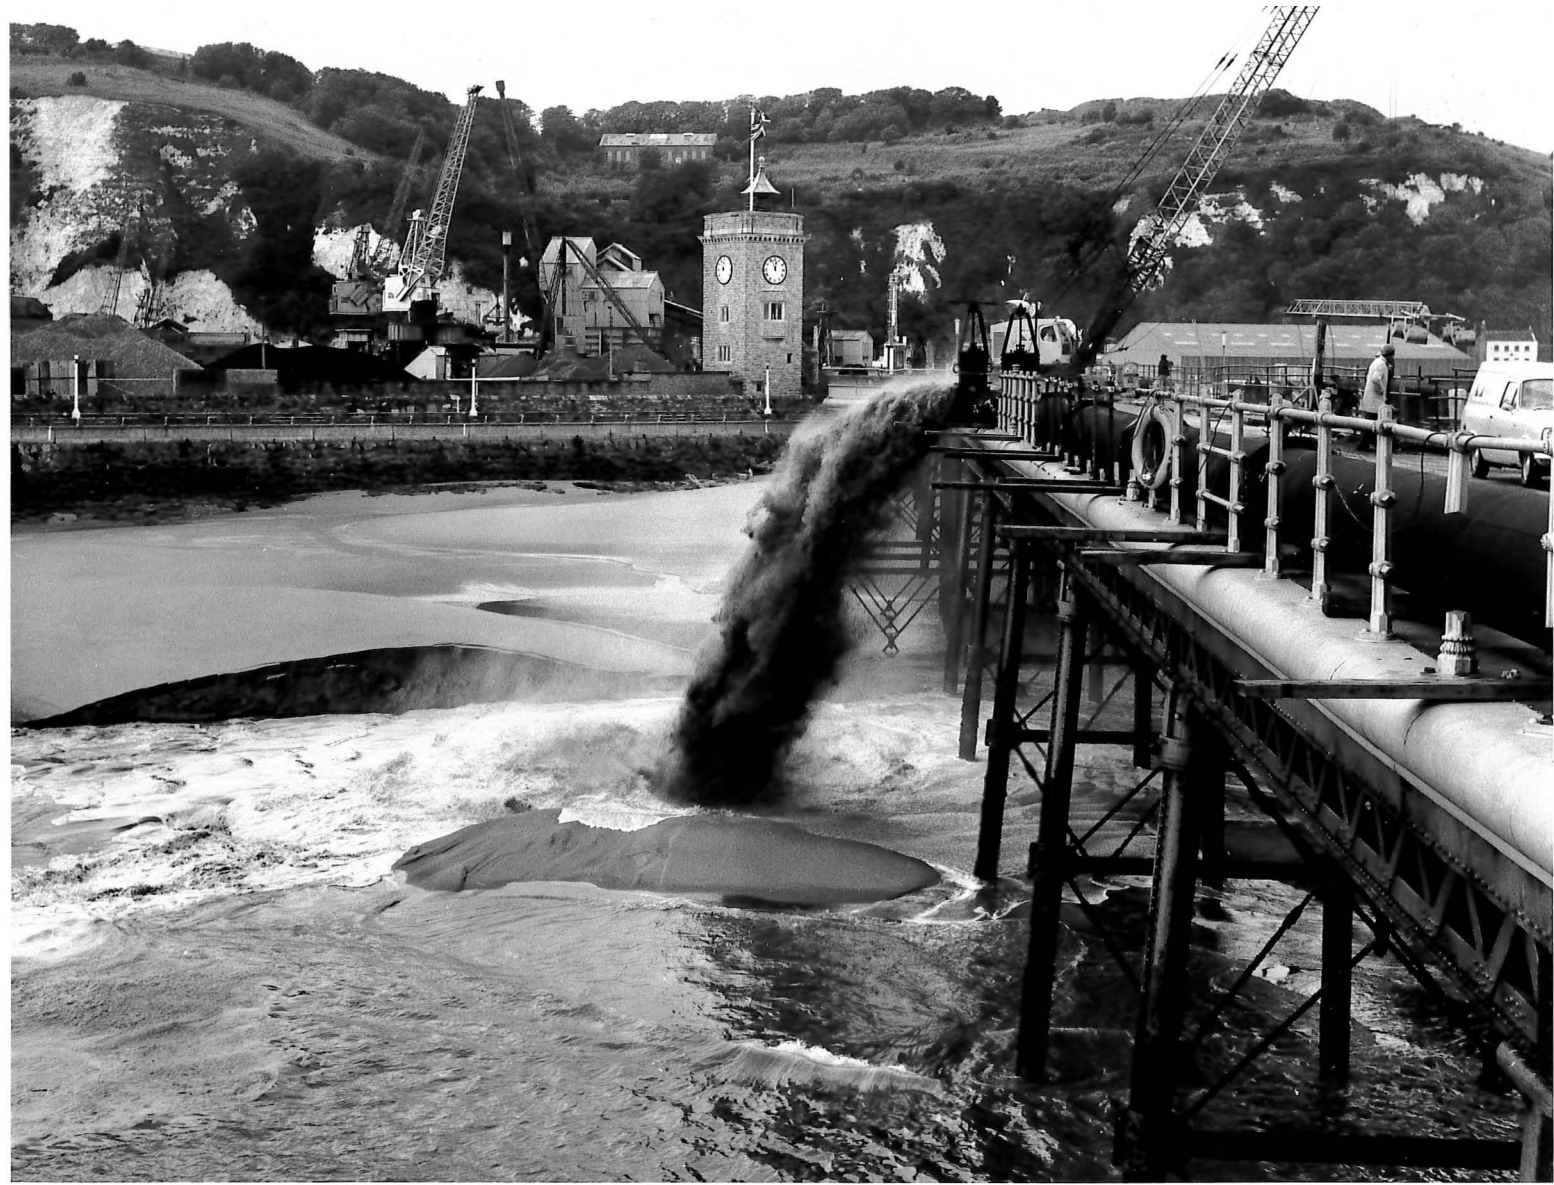
**Figure 20:** Sand being unloaded into the space to be reclaimed behind the Prince of Wales Pier, looking West, 14/09/1976, DHB.
