## **DOVER HARBOUR BOARD**

# **HERITAGE RECORDING THE TELFORD SLUICES AND ASSOCIATED SLUICE MECHANISMS TO THE DOVER WESTERN DOCKS, DOVER, KENT**

### **Desktop Study**

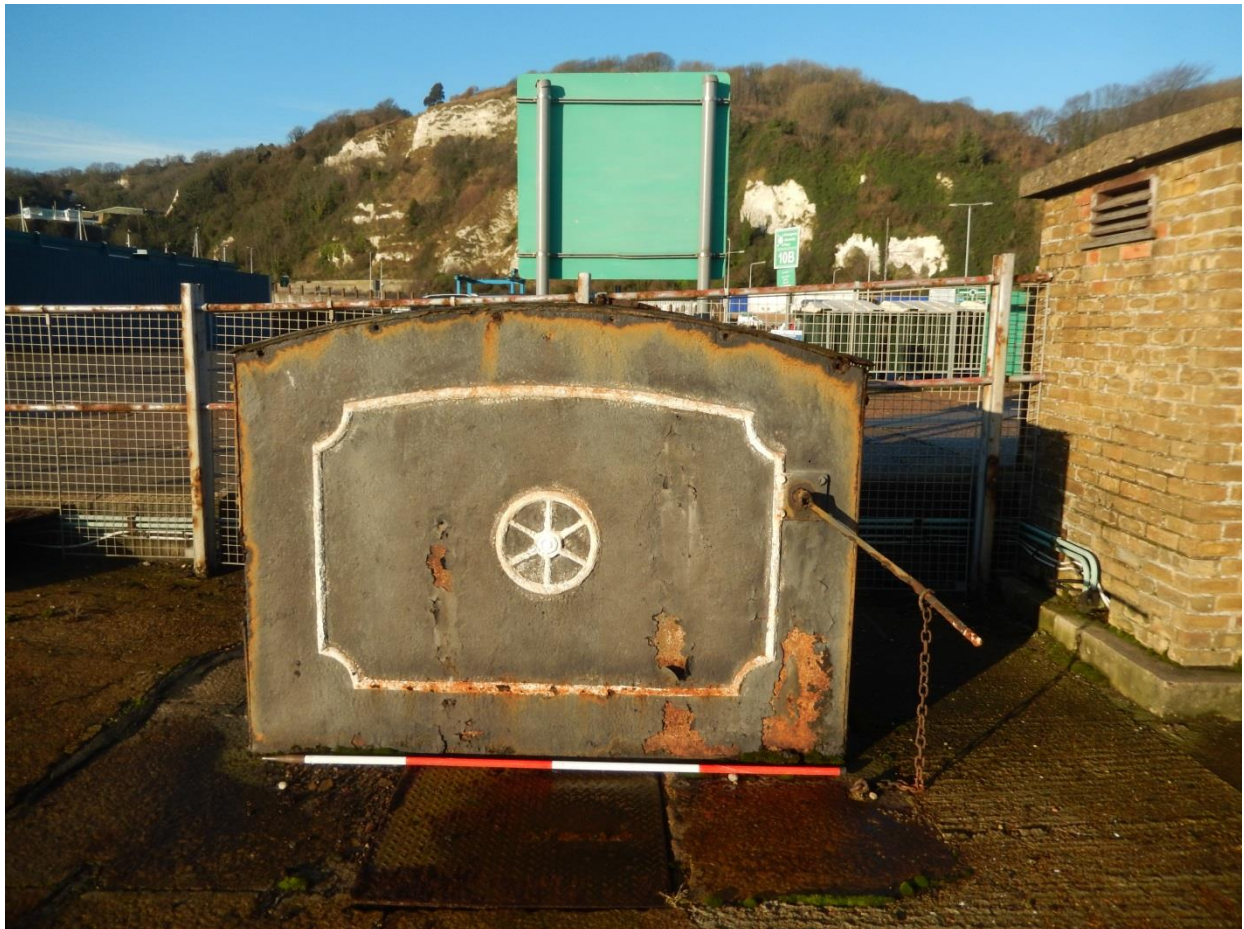
**Plate 11:** Side view of sluice A with crank mechanisms to the right, looking West, 2m Scale, DHB.

In 2022, the tunnel containing this sluice was permanently filled with concrete. Images of the sluice mechanism can be seen in **Plates 11-14** below, with the date of installation clearly marked on the side (1845). These images were taken as part of the Level 1 Heritage Recording, Area 002, Swingbridge, Zone 1, Photo Set 010 (Dover Harbour Board 2016). Images of the culverts which operated alongside the sluice mechanisms can be found in **Plates 15-16**.

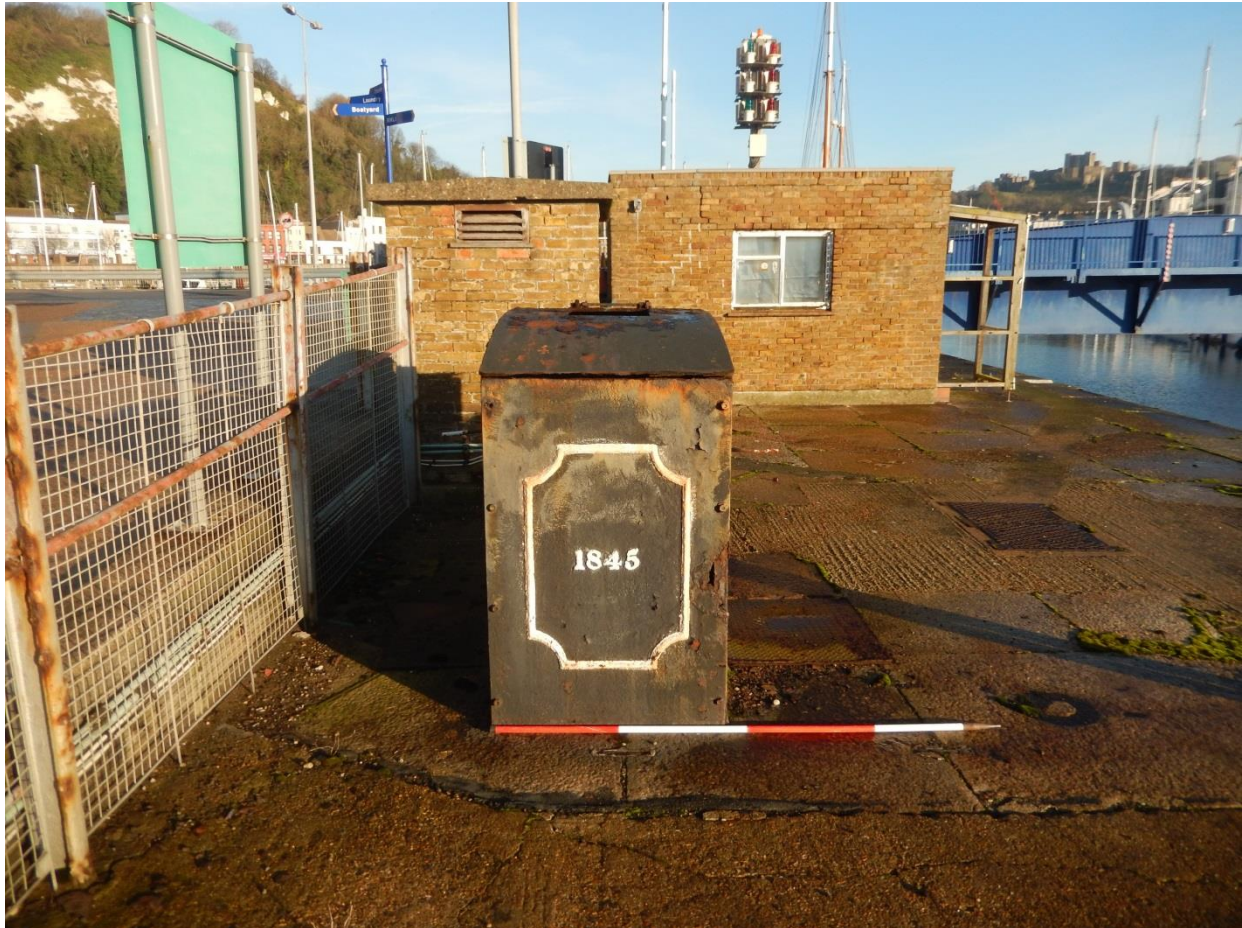
**Plate 12:** Front view of sluice A showing date of 1845, looking North, 2m Scale, DHB.

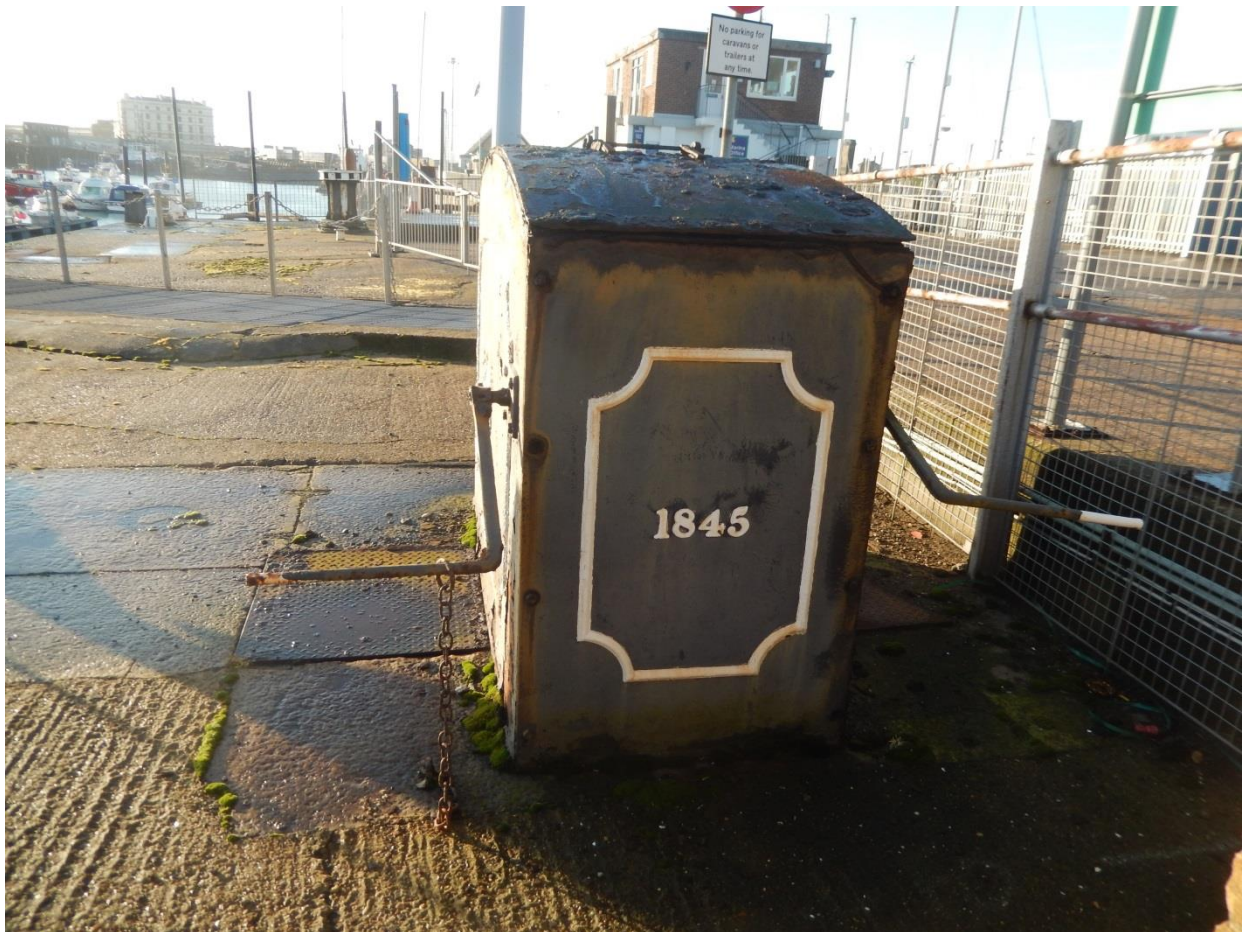
**Plate 13:** Back view of sluice A with visible crank mechanisms, looking North, DHB.

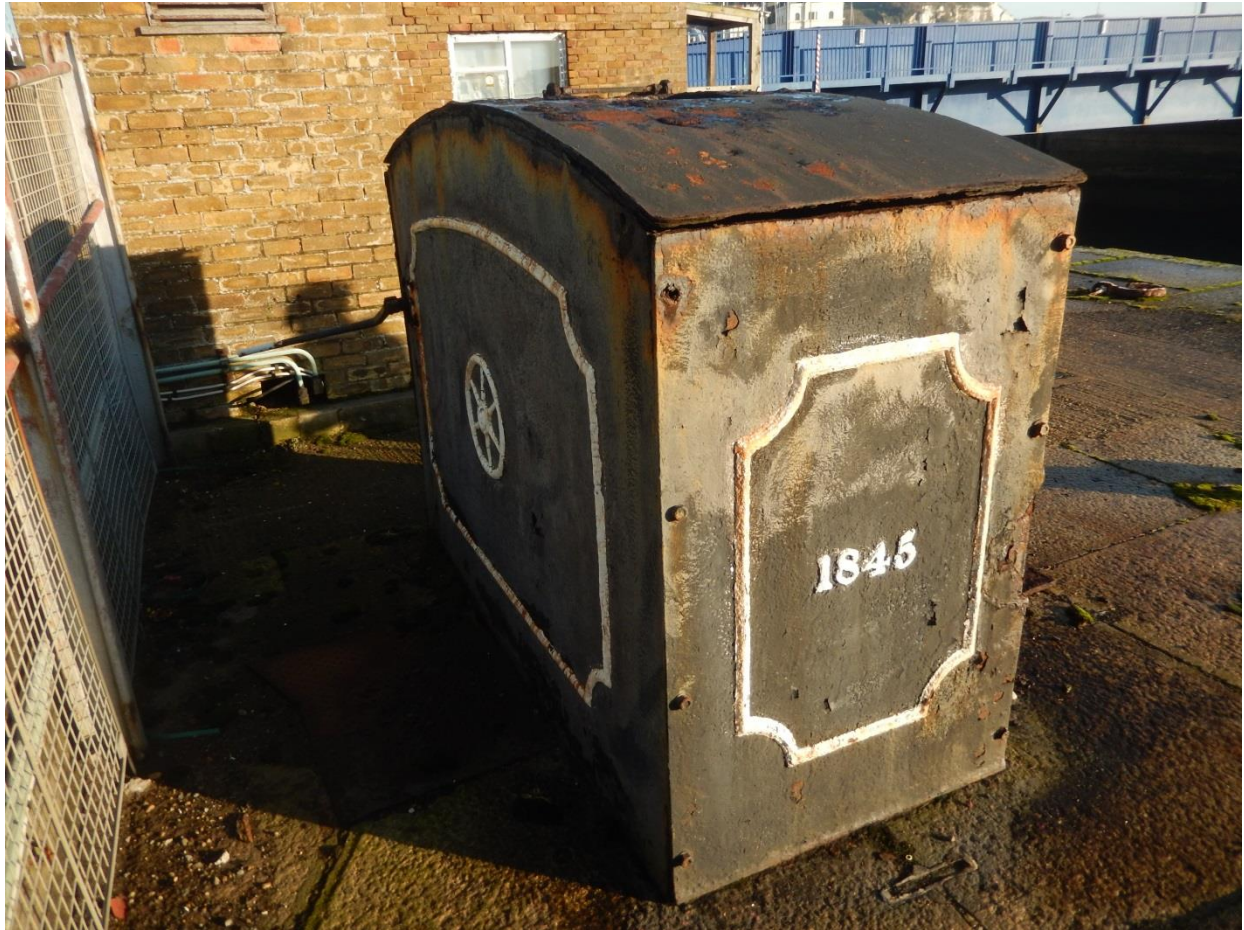
**Plate 14:** Side view of Sluice A showing date from 1845, looking north-east, DHB.

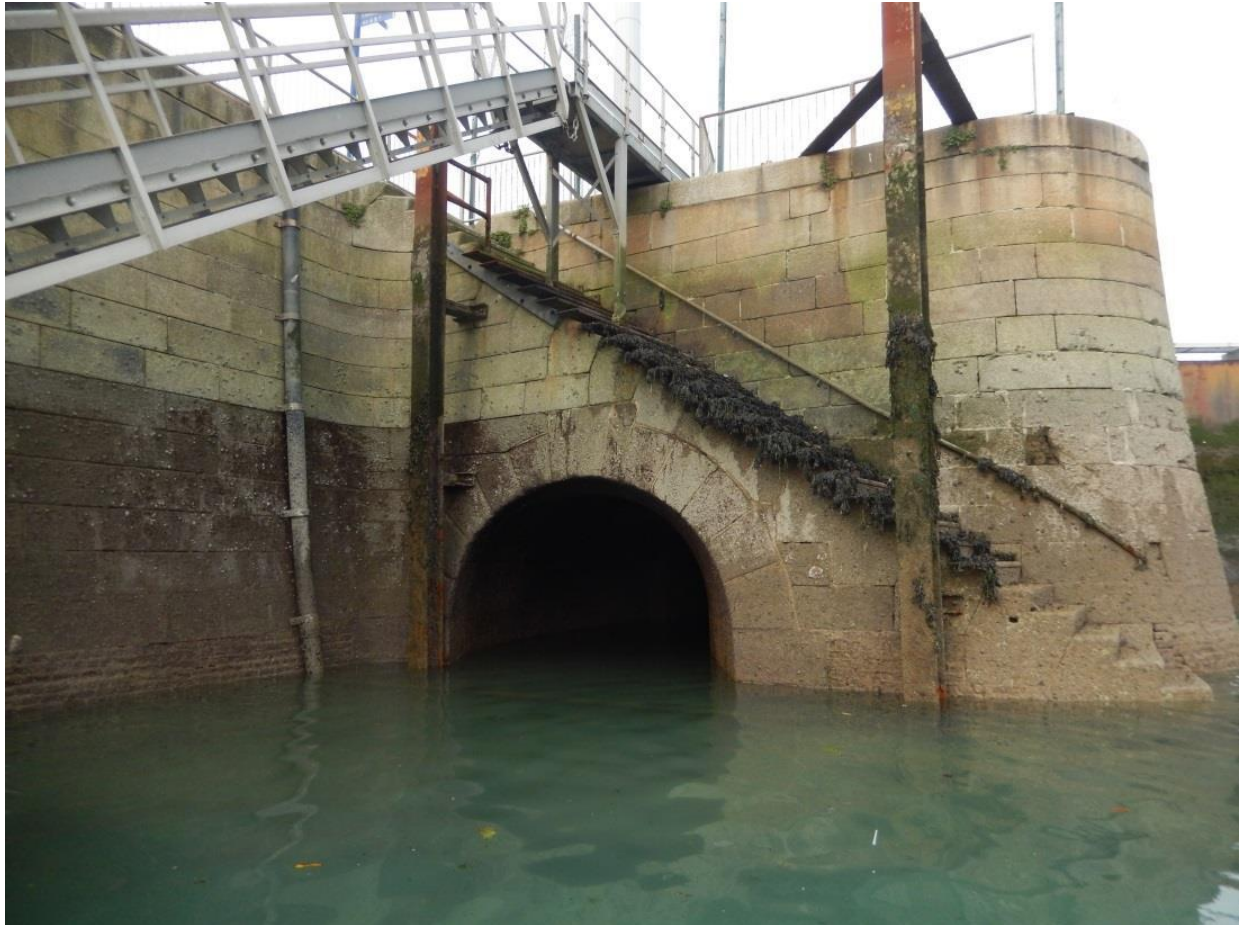
**Plate 15:** *The culvert that operated with the mechanisms of Sluice A, controlling the water within the Wellington Dock, dating to 1845, looking North, DHB.*

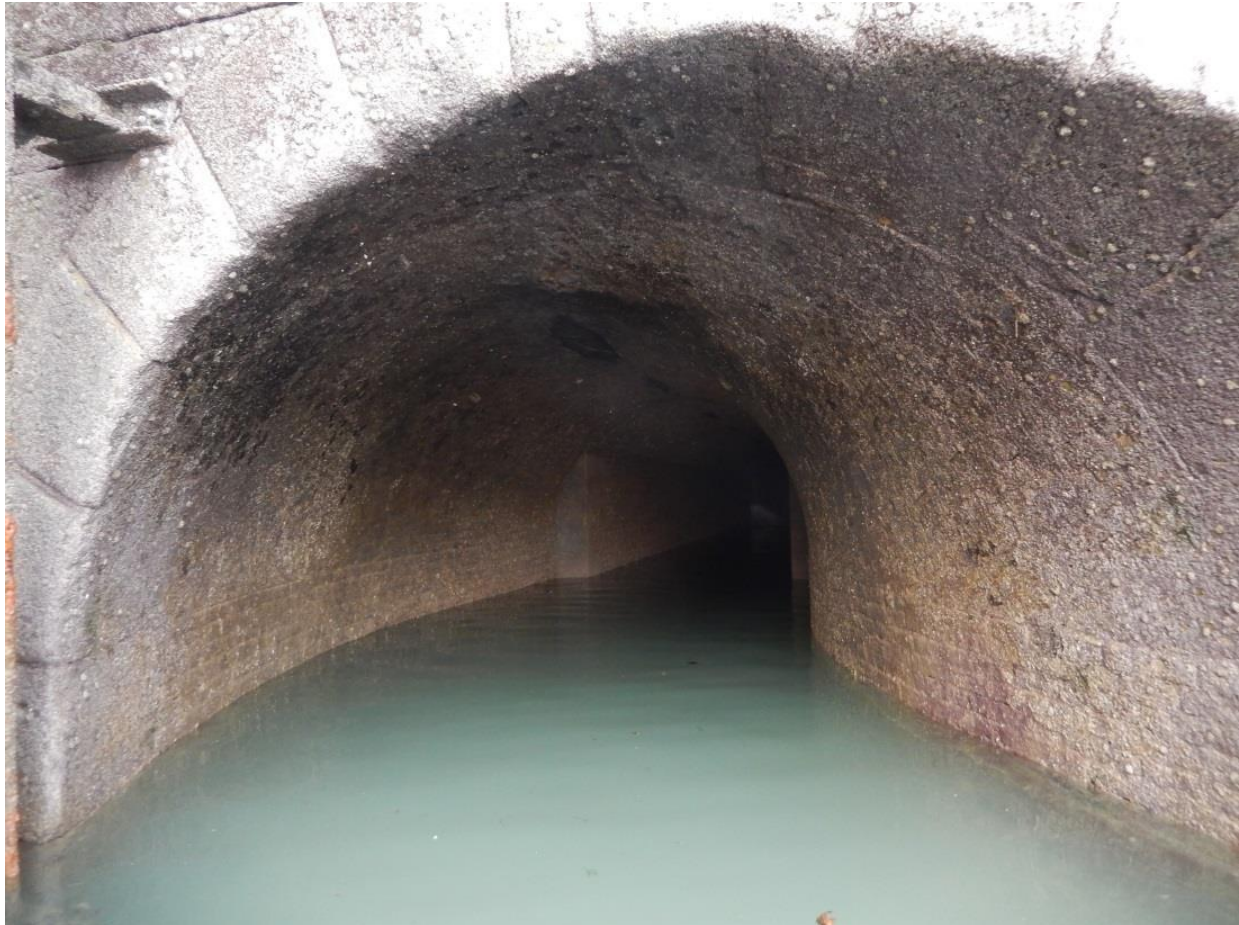
**Plate 16:** *A look inside the culvert that is associated with Sluice A, which would have controlled the water within The Wellington Dock, looking North, DHB.*

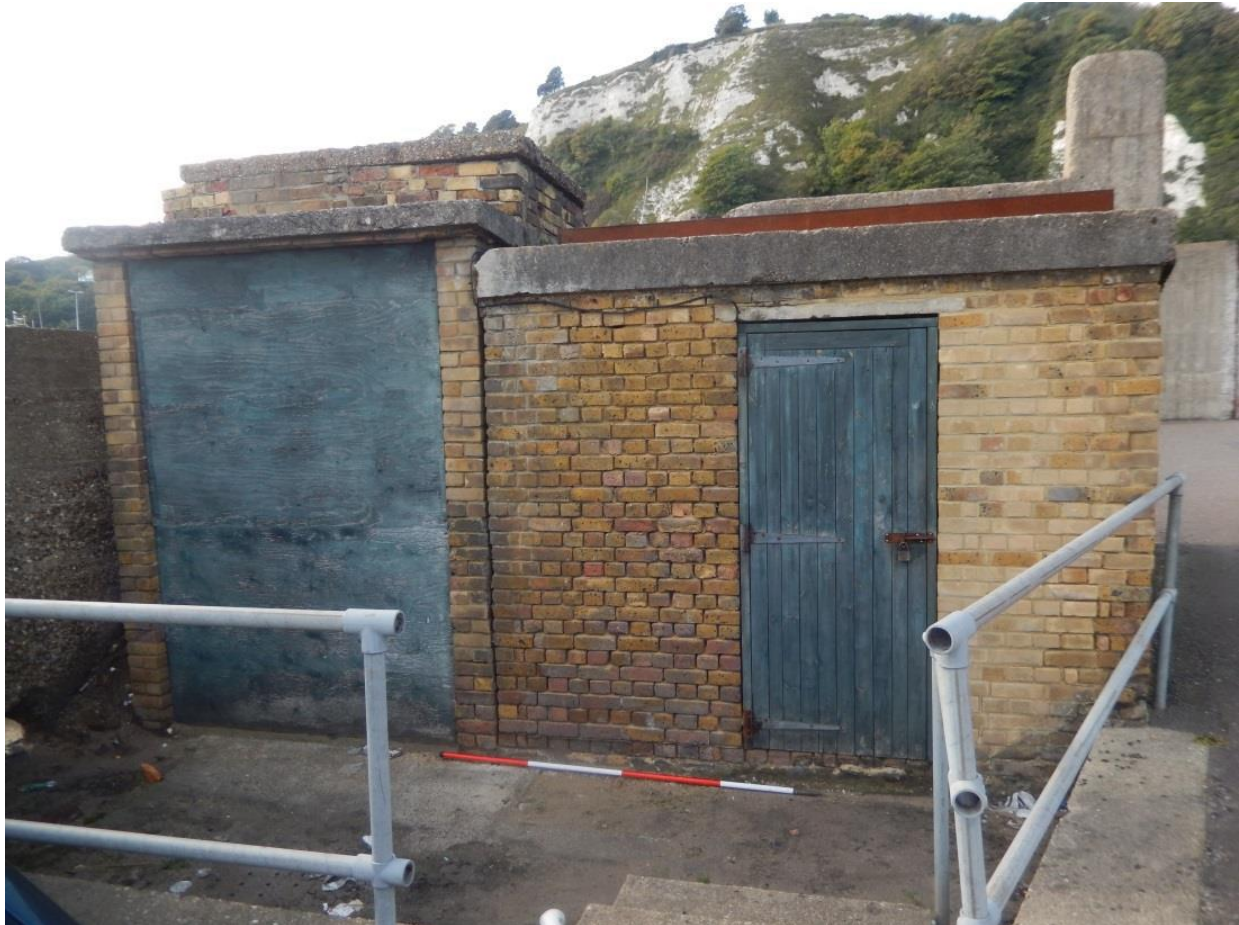
**Plate 17:** *The small brick building which holds sluice B, looking West, 2m Scale, DHB.*

Images of the sluice can be seen in **Plates 17-20** below, with the dated of installation clearly marked on the side. These images were taken as part of the Level 1 Heritage Recording, Area 002, Swingbridge Carpark, Zone 004, Photo Set 06 (Dover Harbour Board 2016).

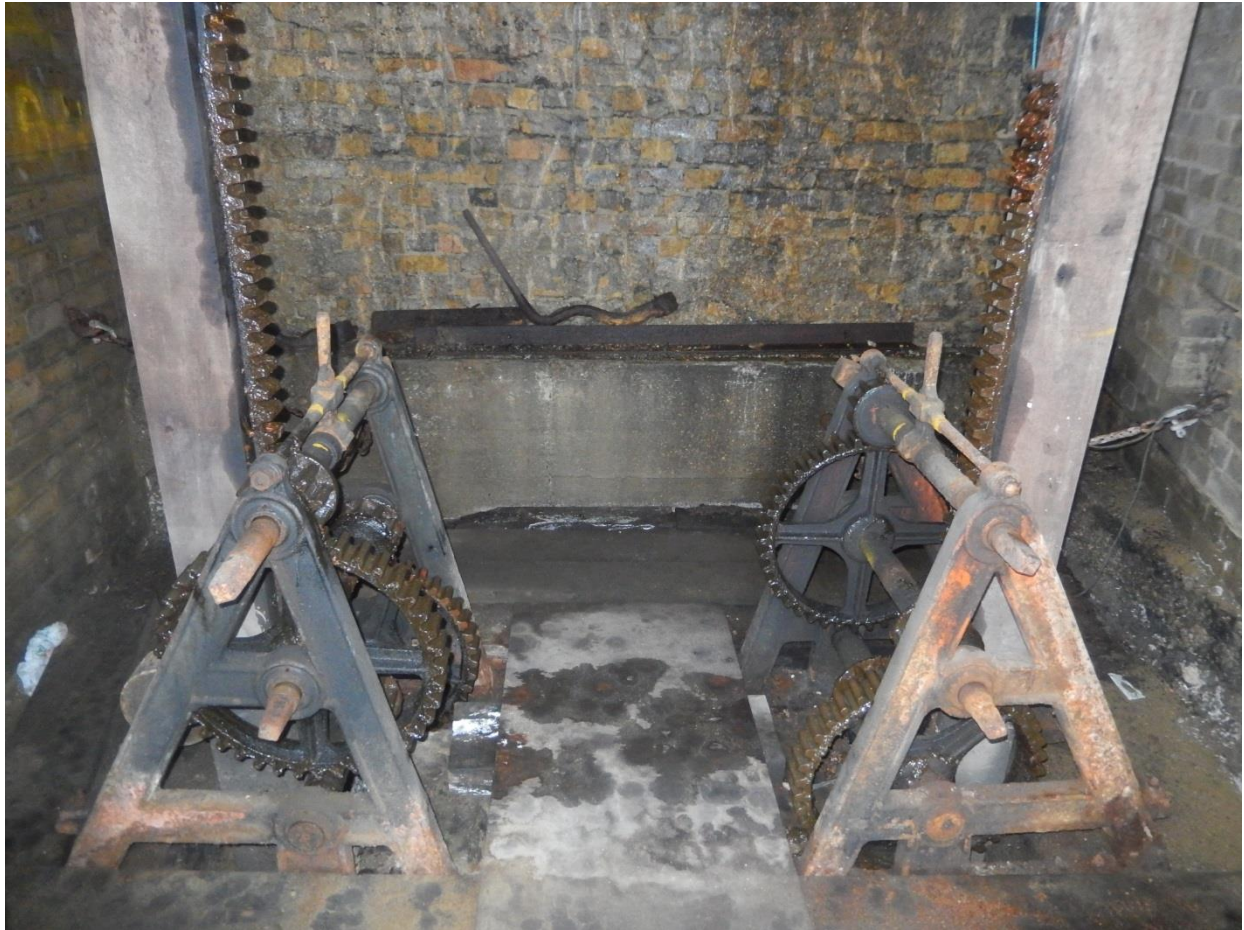
**Plate 18:** *The two mechanisms which form sluice B, DHB.*

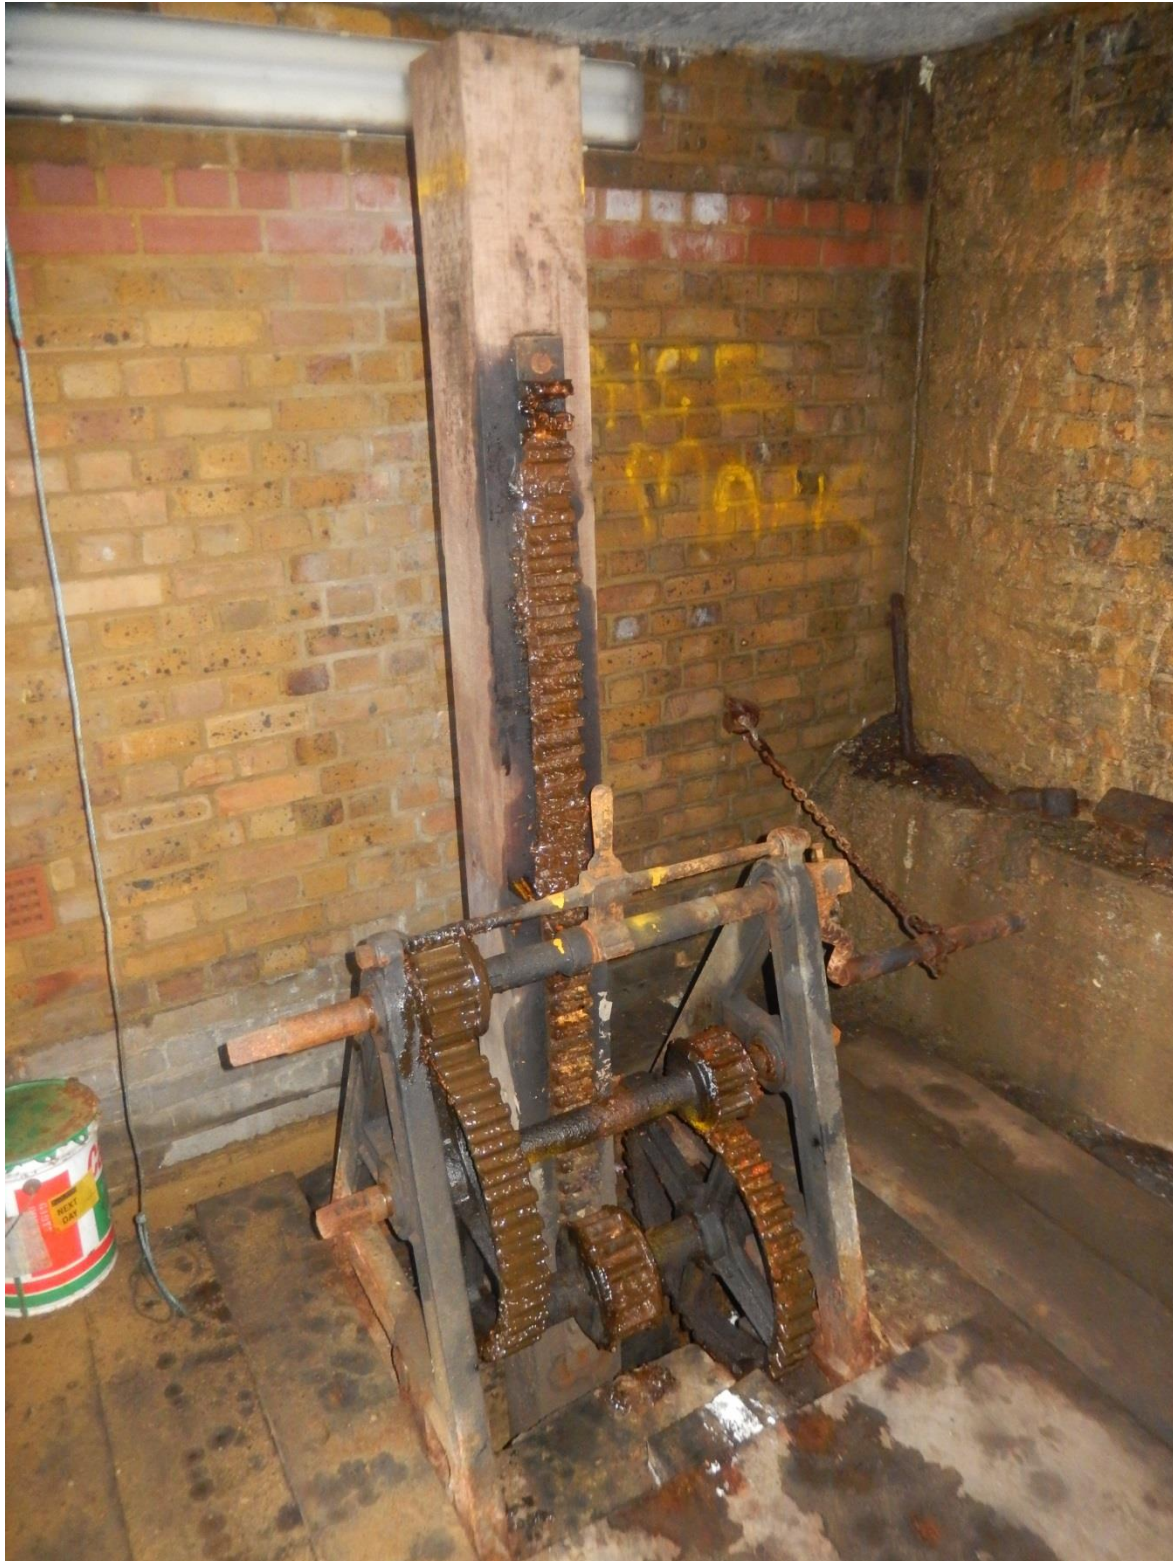
**Plate 19:** *One half of the two mechanisms that form sluice B, DHB.*

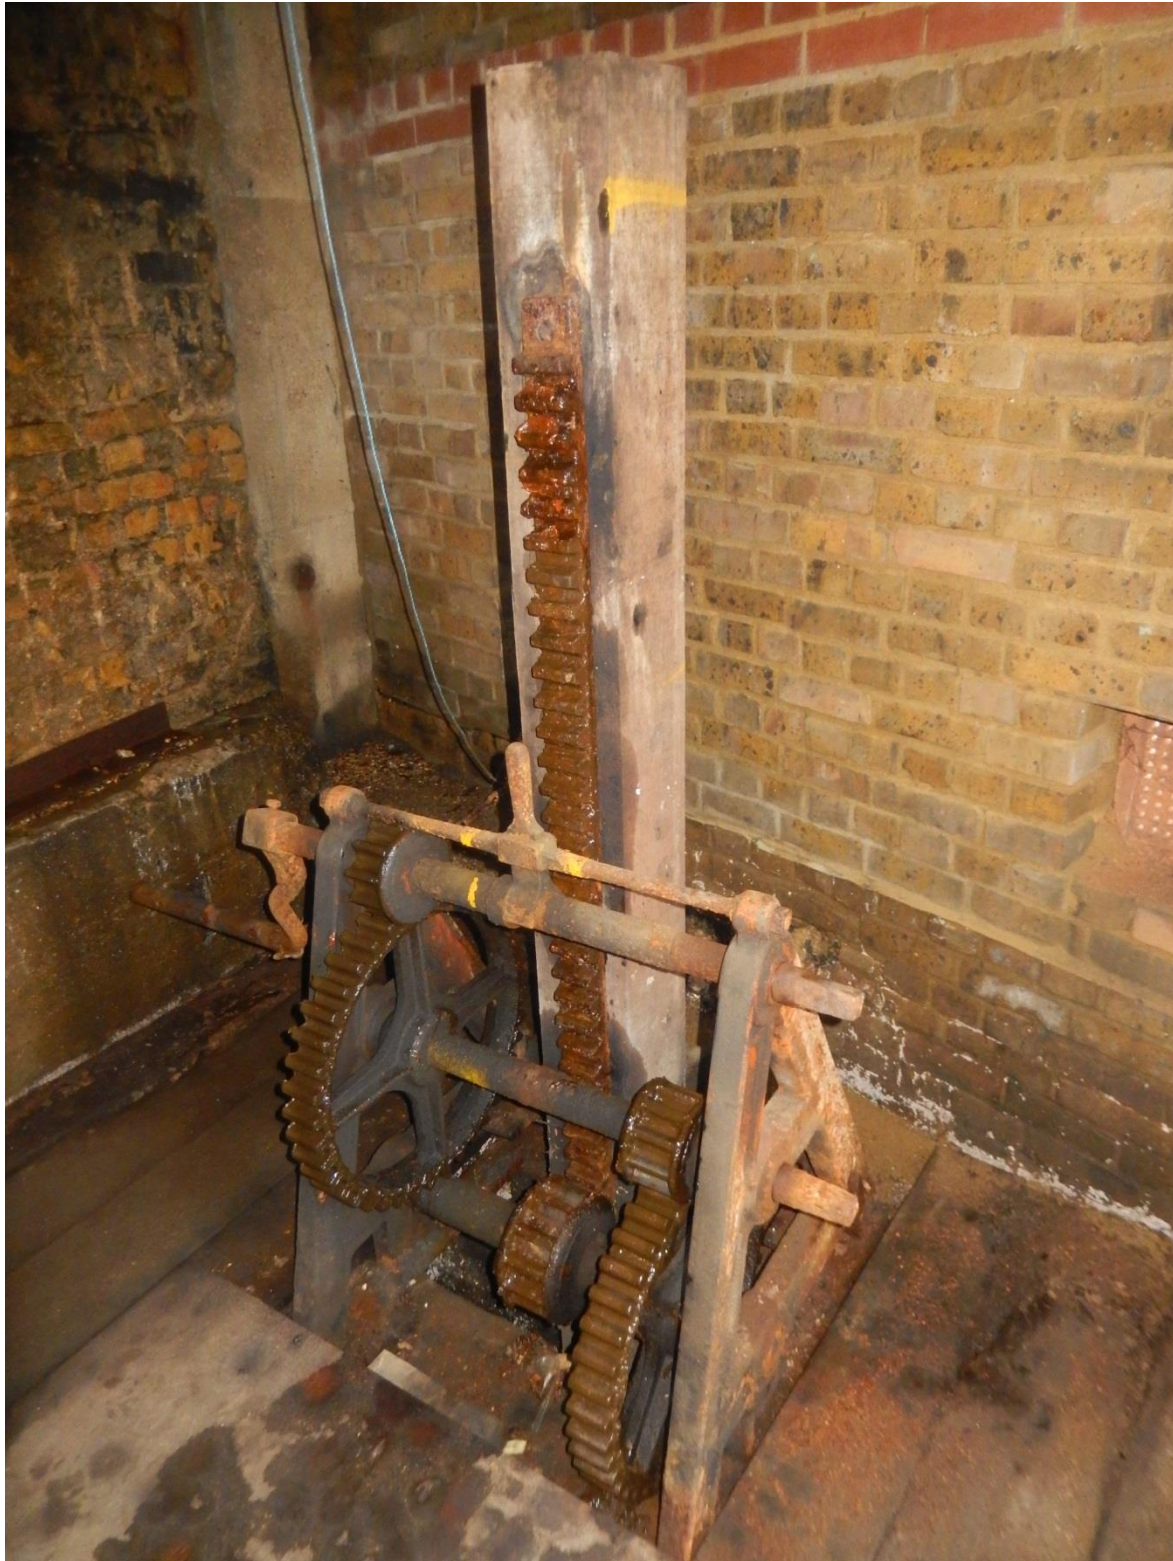
**Plate 20:** *One half of the two mechanisms that form sluice B, DHB.*

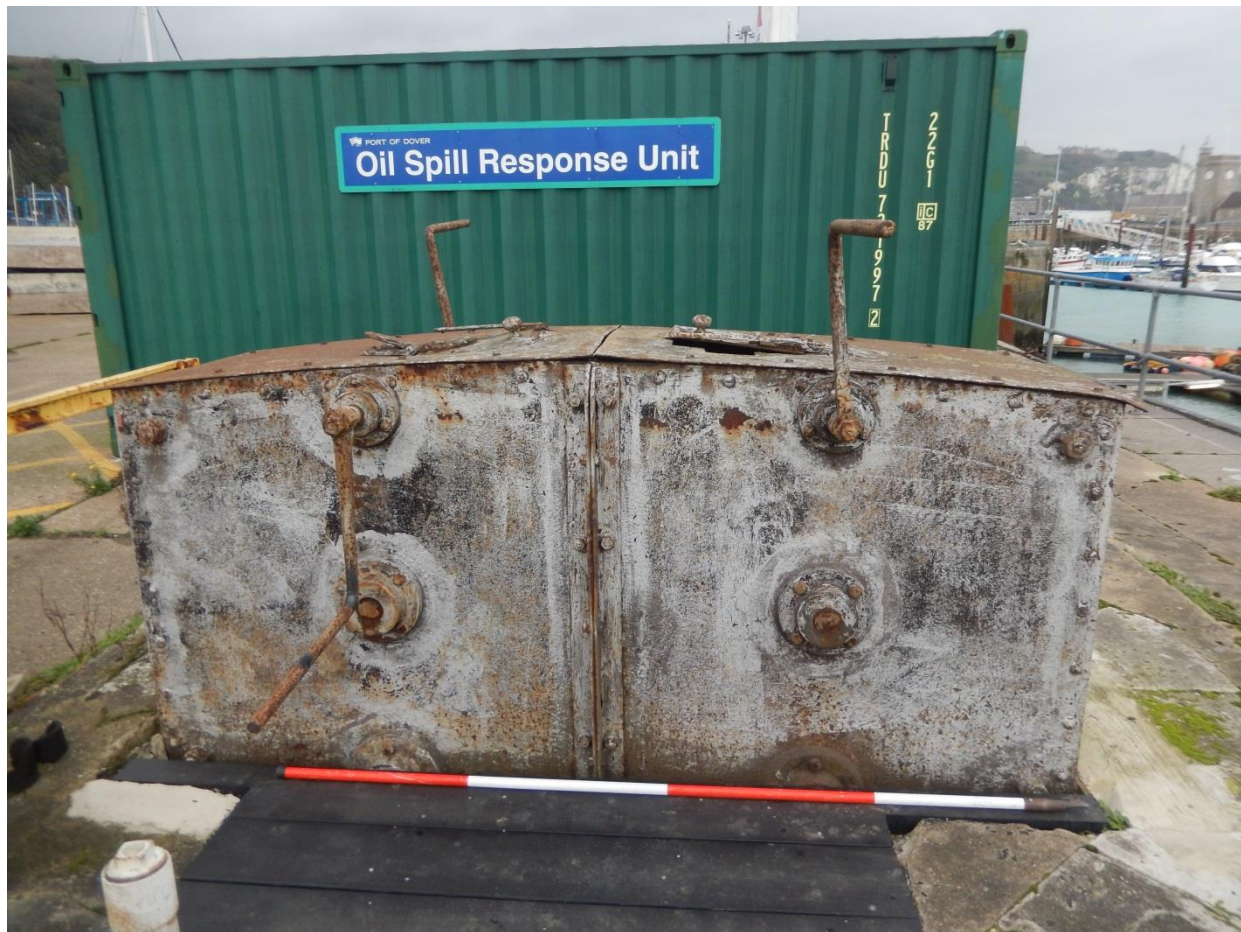
**Plate 26:** *Sluice C positioned on the Crosswall, 2016, Scale 2m, looking North, DHB.*

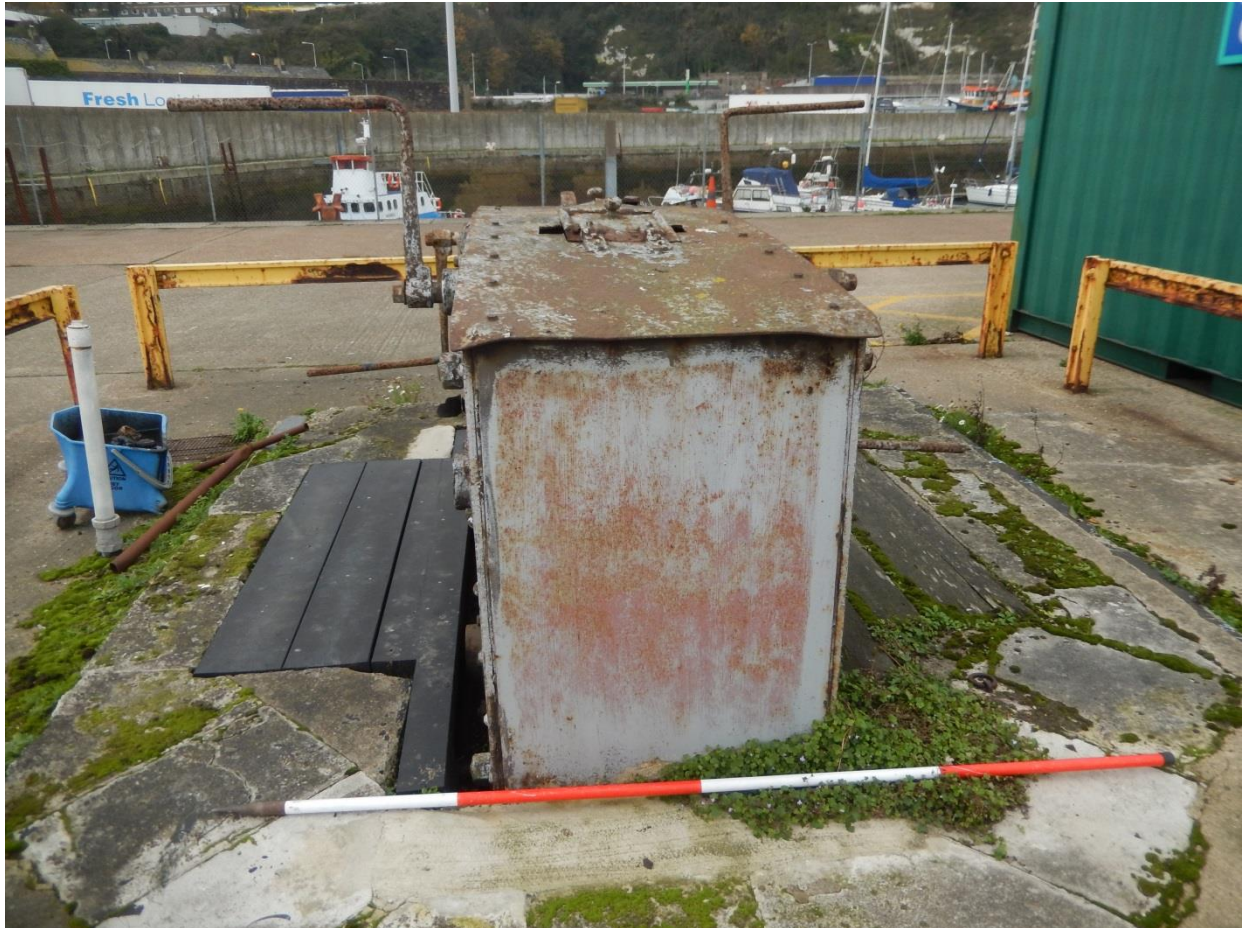
**Plate 27:** *Sluice C positioned on the Crosswall, 2016, Scale 2m, looking West, DHB.*

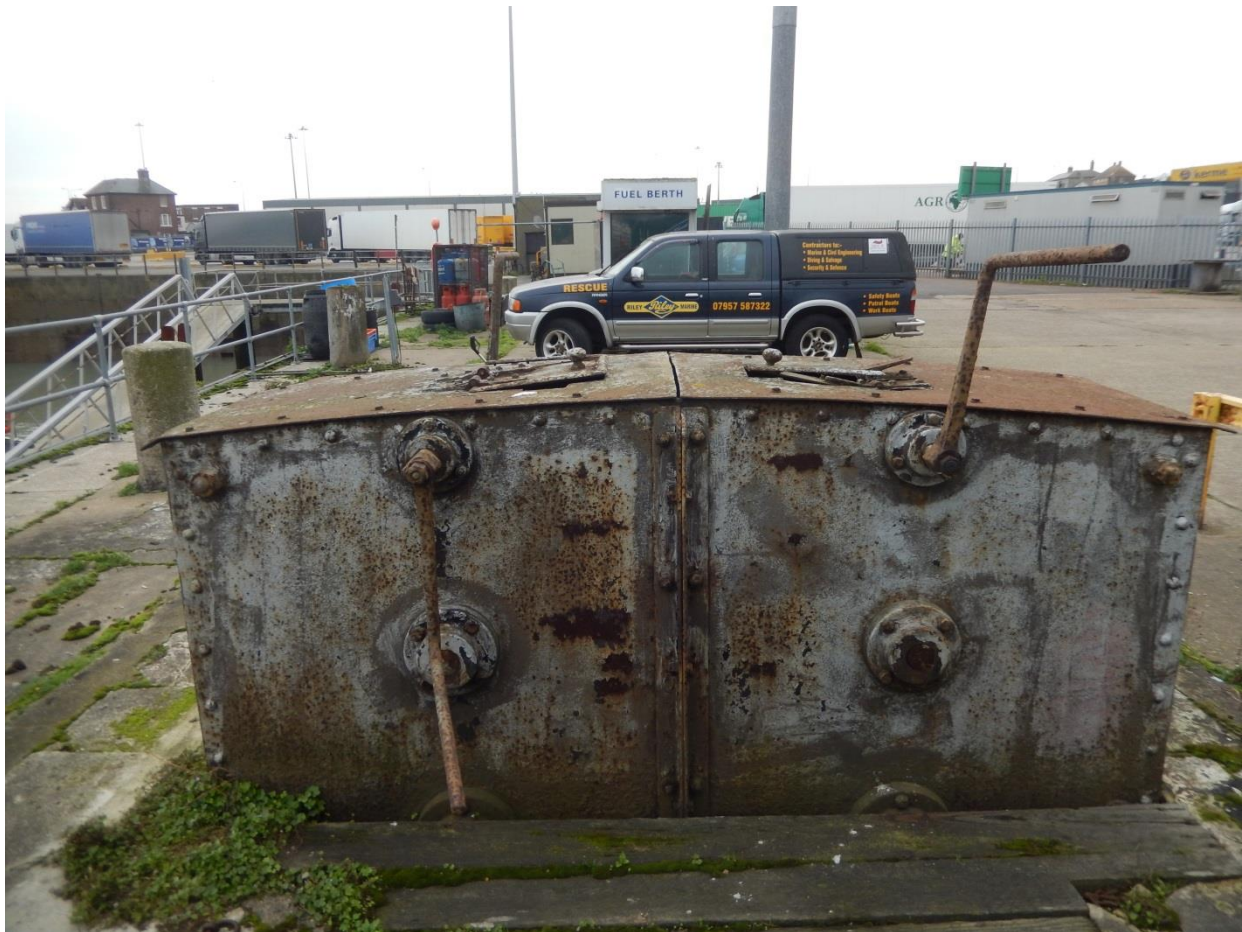
**Plate 28:** *Sluice C positioned on the Crosswall, 2016, Scale 2m, looking South, DHB.*

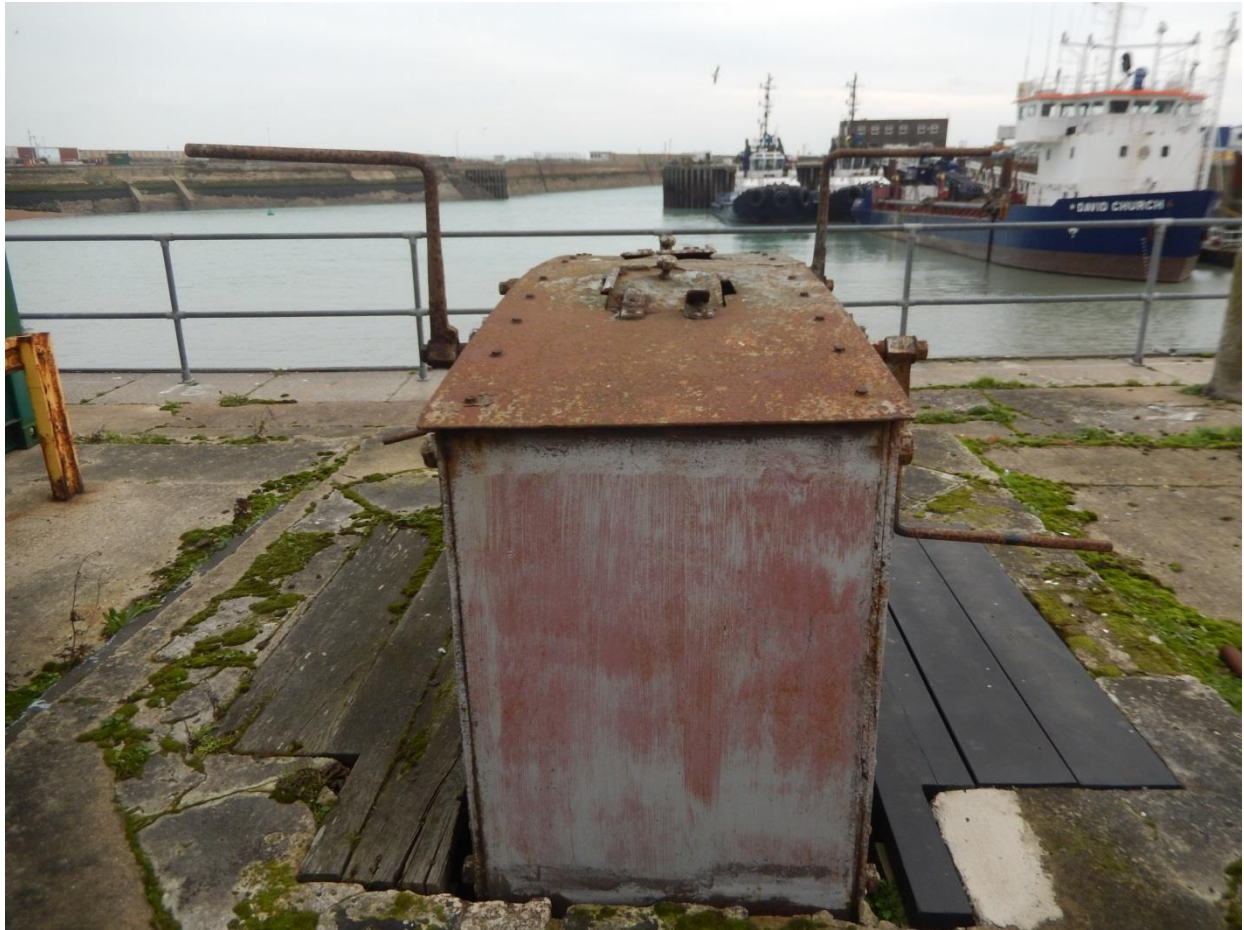
**Plate 29:** *Sluice C positioned on the Crosswall, 2016, looking East, DHB.*

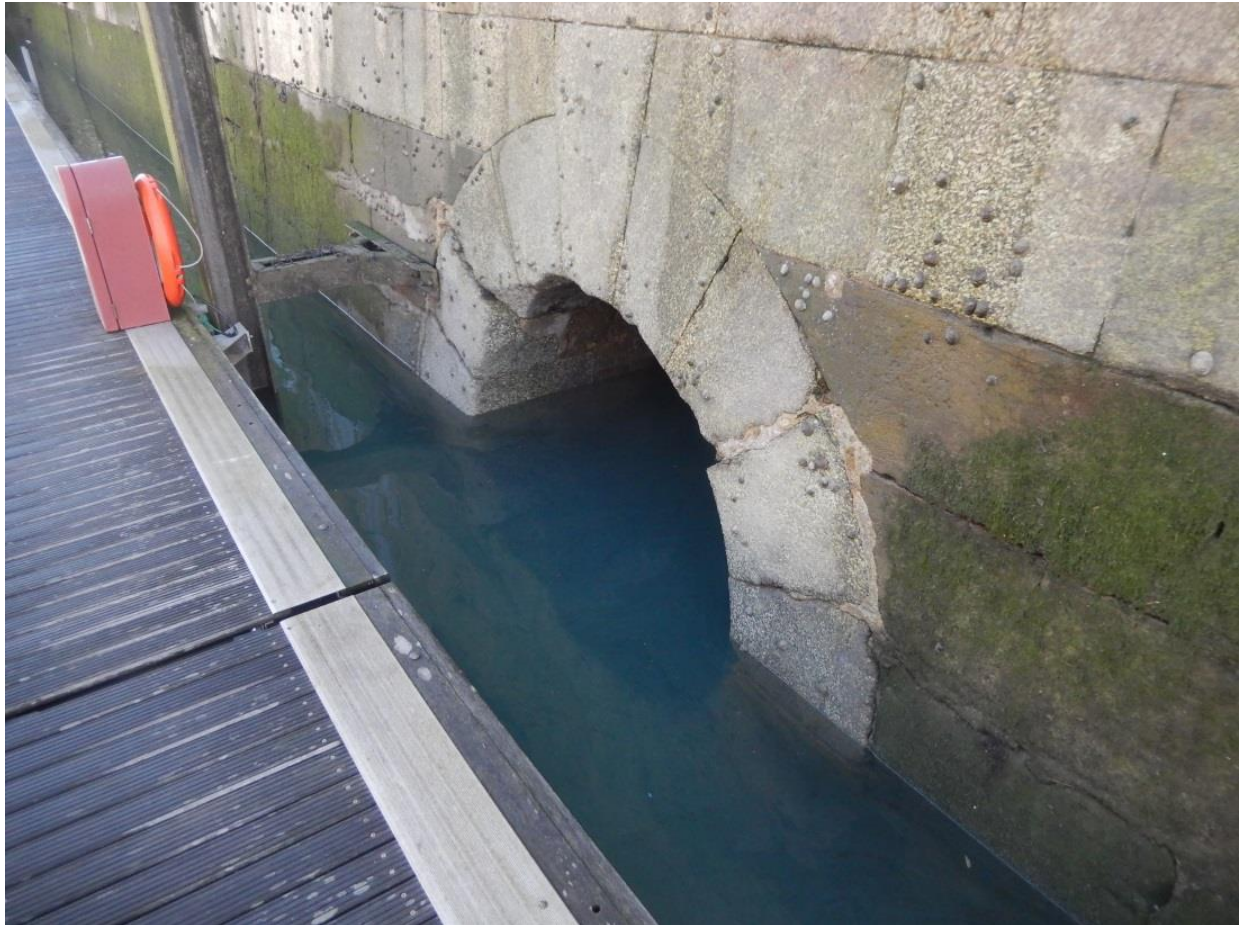
**Plate 30:** *The culvert connected to Sluice C, present on The Crosswall, 2016, looking north-east, DHB.*

**Plate 30** shows the culvert that would have once been connected to Sluice C, but is now no longer attached or working. **Plate 31** shows the position of the other culvert which would have been present on The Crosswall, this is no longer connected to a sluice mechanisms, nor is there one remaining as it has been totally removed. These would have been the culverts connected to the sluice mechanisms clock and compass houses present in the 1870 (see **Plate 23**).

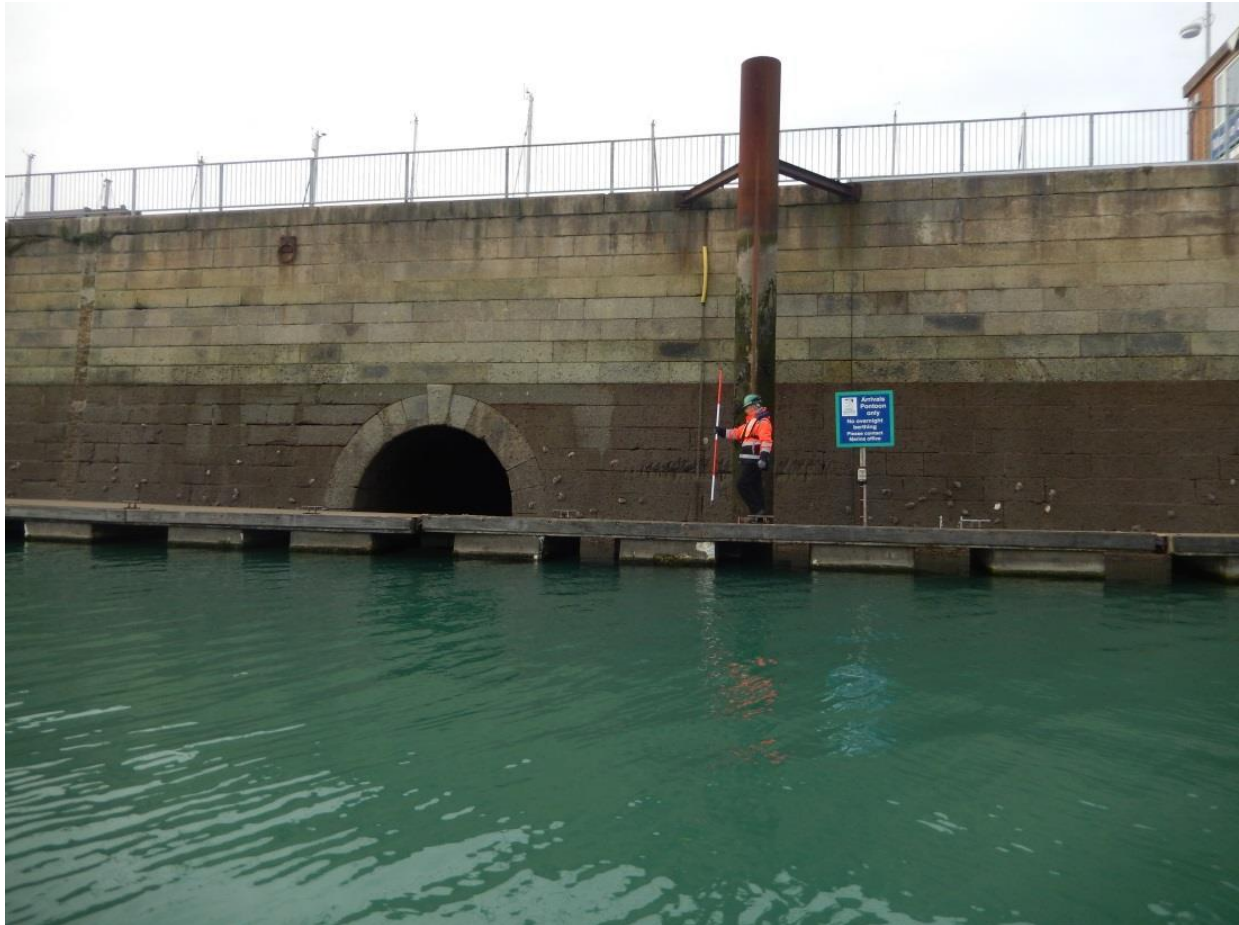
**Plate 31:** *The culvert present on The Crosswall, no longer in use or attached to sluice mechanism, 2016, looking north-east, DHB.*
