## **DOVER HARBOUR BOARD**

### **HERITAGE RECORDING UNION STREET SWING BRIDGE AND WELLINGTON DOCK GATES**

#### **TO THE DOVER WESTERN DOCKS, DOVER, KENT**

#### **Desktop Study**

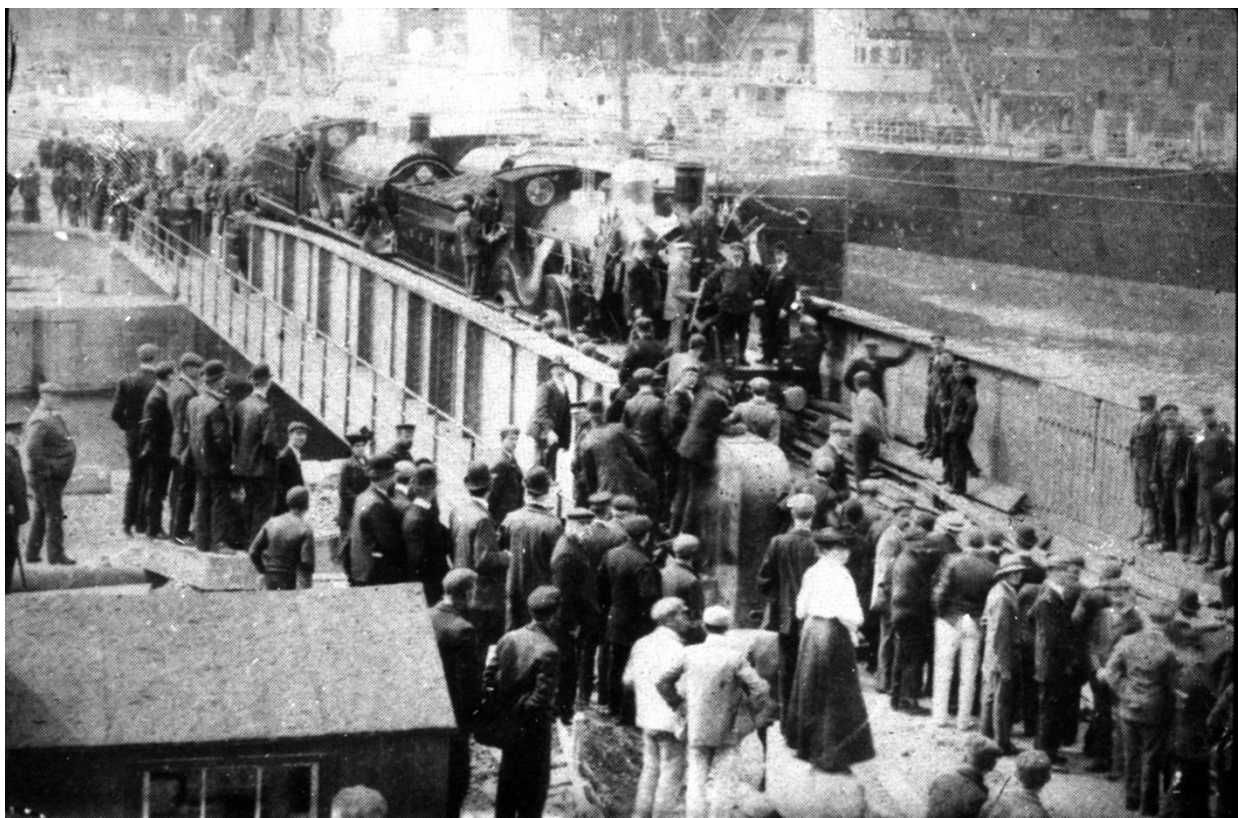
**Plate 5:** *Locomotive testing on the new swing bridge recently installed, c.1904, Budge Adams Collection, Dover Museum d26561.*

This new bridge had to be specially balanced with weights in order for it to swing efficiently, this was installed by Pearson and Son and was designed to be run off the same electricity line as the train tracks on the Prince of Wales Pier. Pearson and Son were a well established company from Bradford who had also worked on the construction of the Admiralty Pier, as well as having an involvement in the land reclamation of the Eastern Docks. The bridge also had a back up power source in the form of a two man cranking system, this was in case the electriclty componant of the gate failed and this way it could still be operated if needed (Dover Express, 1904).

The train tracks that ran along the pier continued over onto the swing bridge, running through the gap of what used to be the Esplanade Hotel; this was demolished in order to create a pathway for the rail way tracks. There is evidence of the train lines being fitted in a newspaper article from 1904 as funding for the introduction of electricity lines was being investigated due to money arrears (Dover Express, 1904). Locomotive testing for the newly installed bridge can be seen taking place in **Plate 5**. The new design of the bridge can also be seen clearly here as it is much more engineered compared to the previous bridge which was arched and quite svelte.

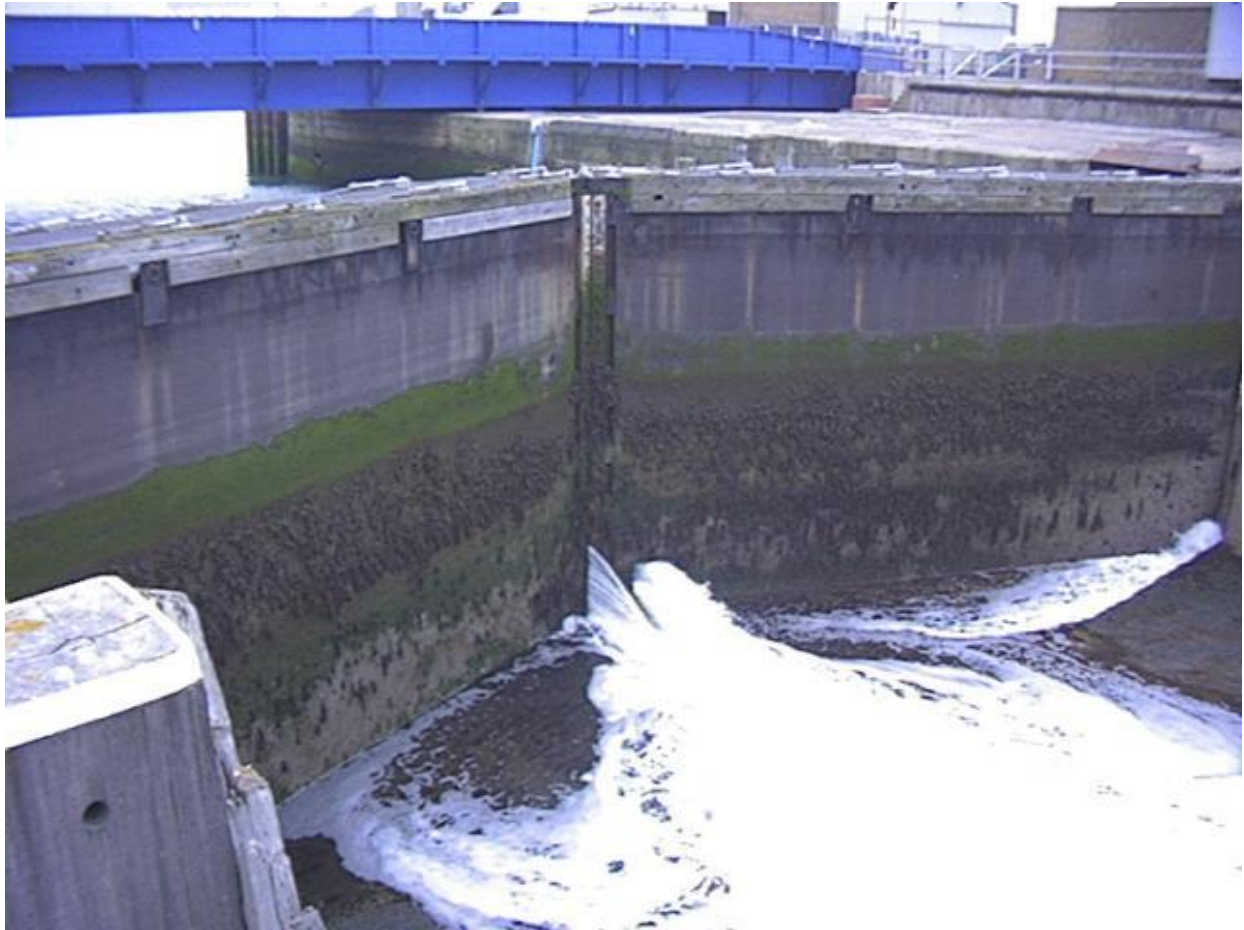
**Plate 17:** *The dock gates at a low tide, exposing the leaking seal, looking north-east, 10/12/11, DHB.*

In 2012 repairs had to be made to the seal of the Wellington Dock Gates as they were leaking water when shut (Kent Online, 2011). Rather than fully draining Wellington Dock in order to inspect the gates it was instead slowly allowed to drain naturally, then returning to a tidal based dock system which allowed the water to flow through the Western Docks. This left the water at a very low level without being totally empty which lifted and dropped with the normal tide. Any boats moored in the dockyard were alerted in advance and lifted out of the dock so that this work could go ahead. Images of the Wellington Dock being drained in 2011 can be found in **Plates 17-20**.

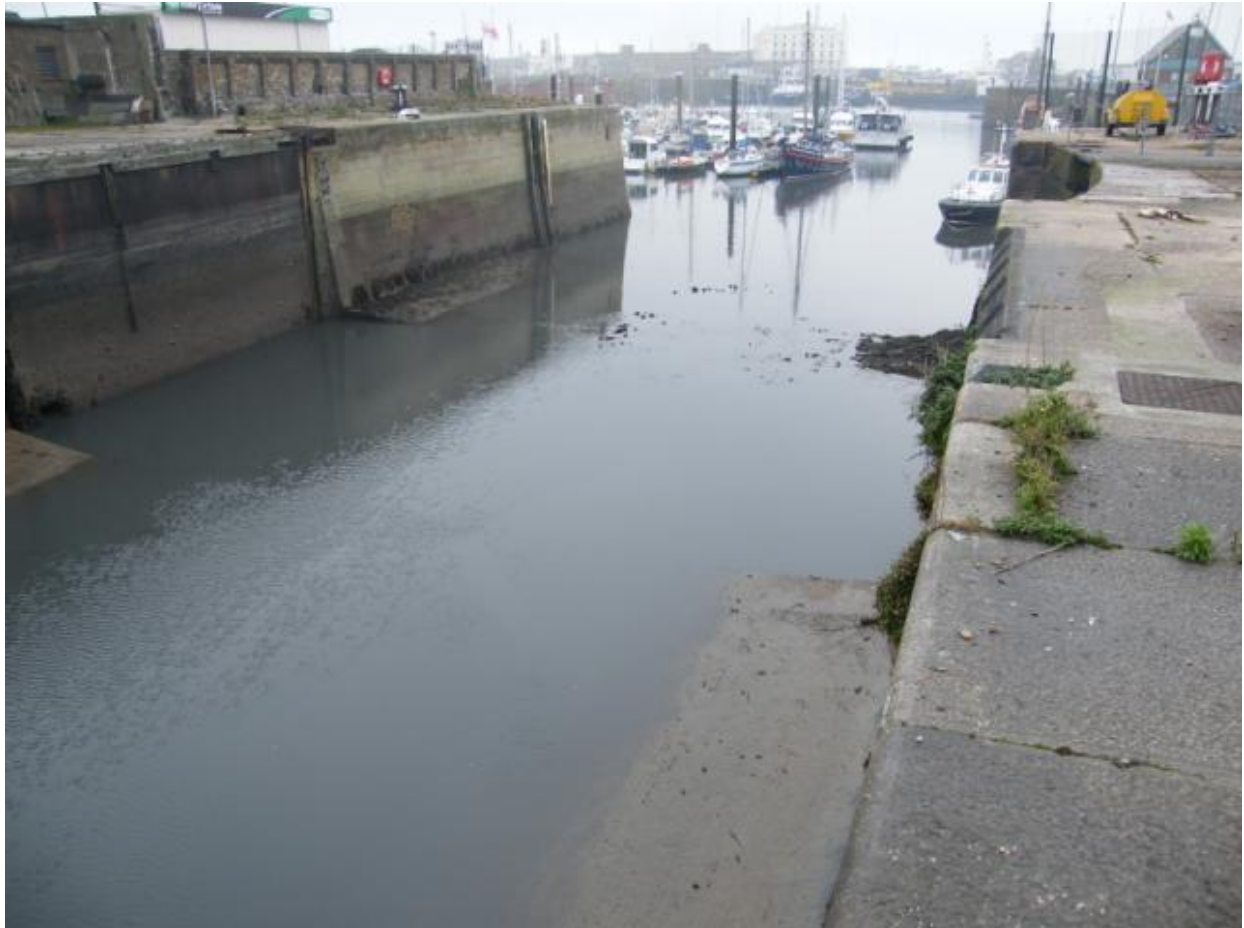
**Plate 18:** *The location of the Wellington Dock Gates, with them removed for repair and the dock drained, looking South, 21/12/11, DHB.*

The dock gates had to be removed, repaired and reinstalled which happened from November 2011 to December 2011, with the gates being out of position for less than three weeks (Programme of Works, 2011). Whilst the level of water in the dock was much lower than normal the opportunity was present to have a general inspection of the listed dock walls, as well as deal with any rubbish which may be in the base of the dock. Before these works on the Wellington Dock Gates took place in 2011, the last time the dock had been drained previously was 1996 for now unknown reasons.

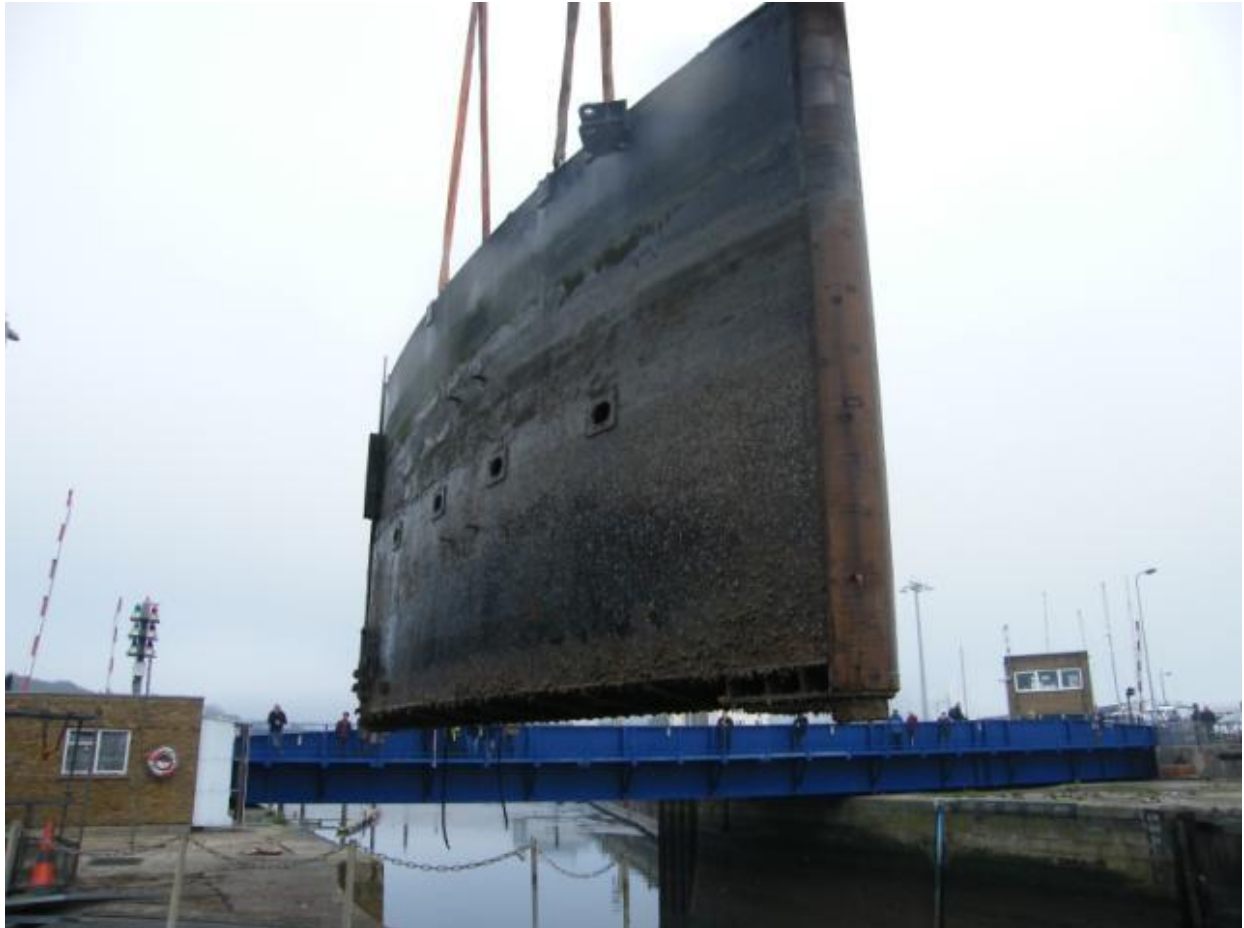
**Plate 19:** *The dock gate being lifted from its position, looking North, 21/12/11, DHB.*

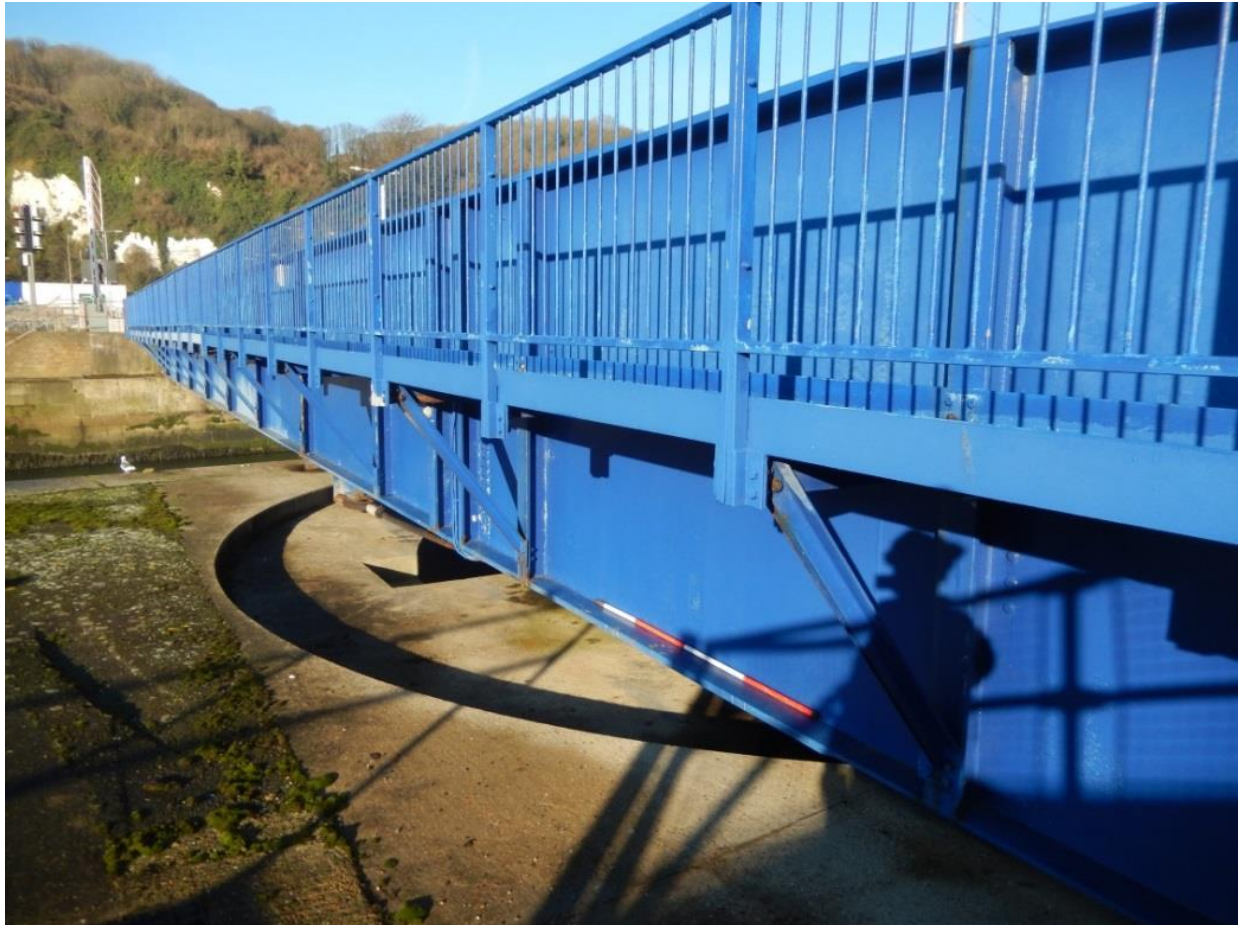
**Plate 24:** Image of the south side of the bridge, showing the walkway, 25/01/2016, DHB.

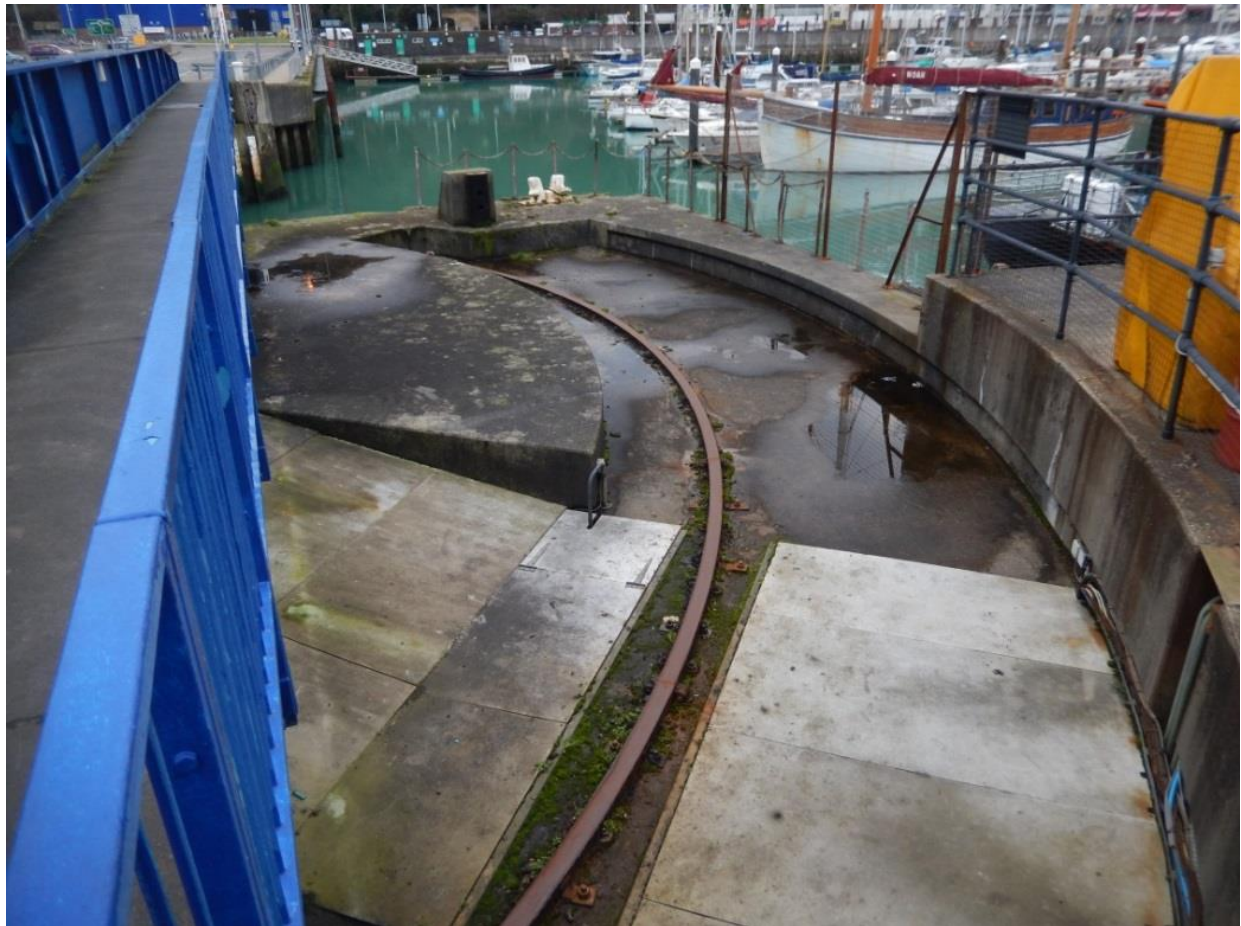
**Plate 25:** The swinging track of the swing bridge, looking west, 25/01/2016, DHB.

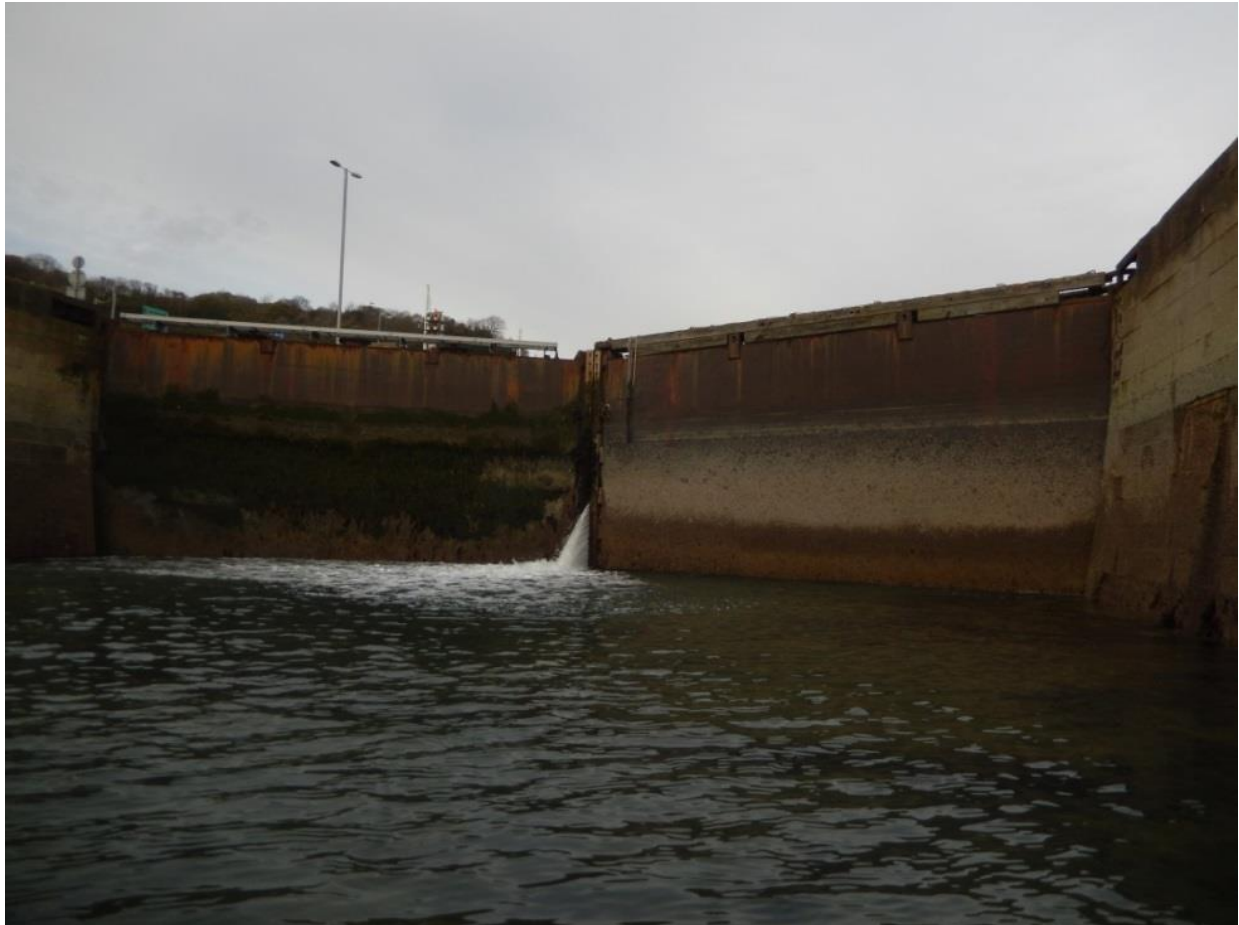
**Plate 32:** *Water coming through the back of the Wellington Dock Gates, looking north, 25/01/2016, DHB.*
