## **DOVER HARBOUR BOARD**

### **HERITAGE RECORDING FOR THE PROMENADE**

### **TO THE DOVER WESTERN DOCKS, DOVER, KENT**

#### **Desktop Study**

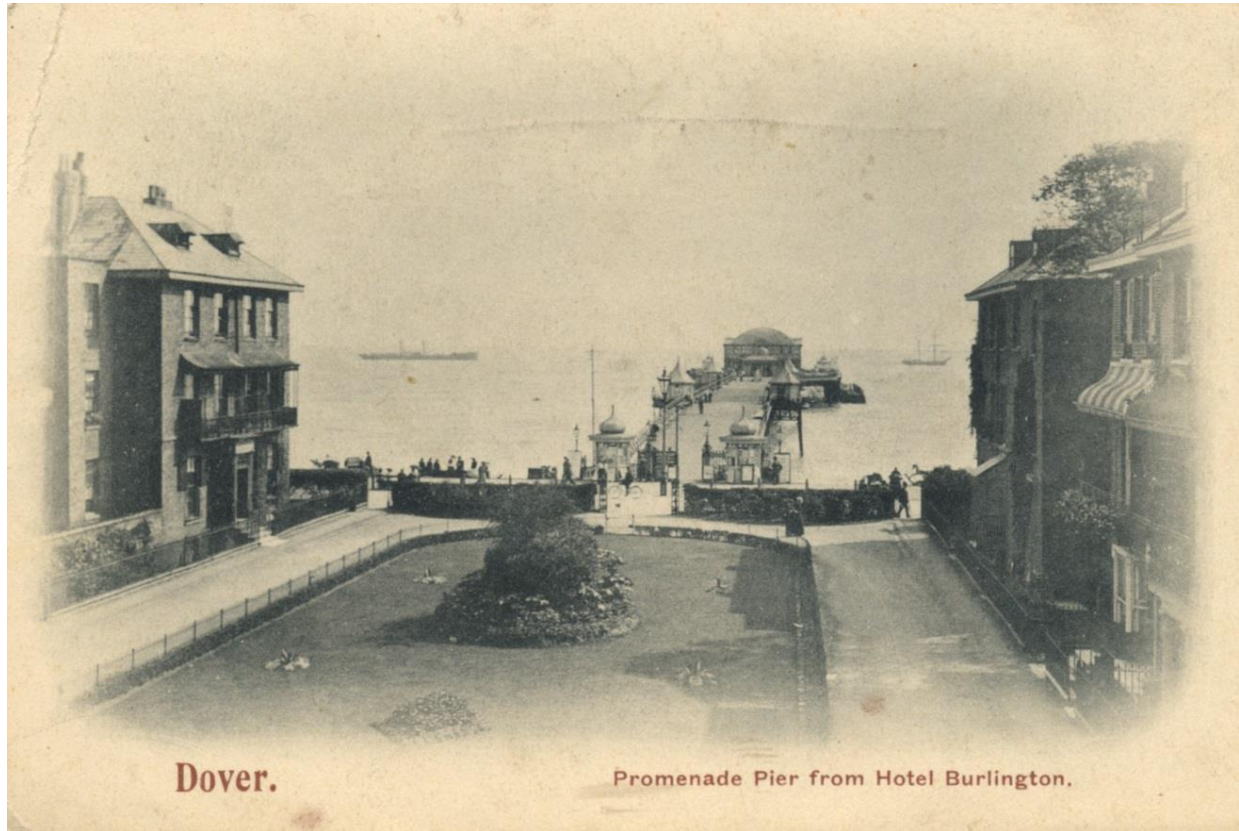
**Plate 4:** *The Pleasure Pier from the Burlington hotel, 1908, Looking south-east, Dover Museum d27773.*

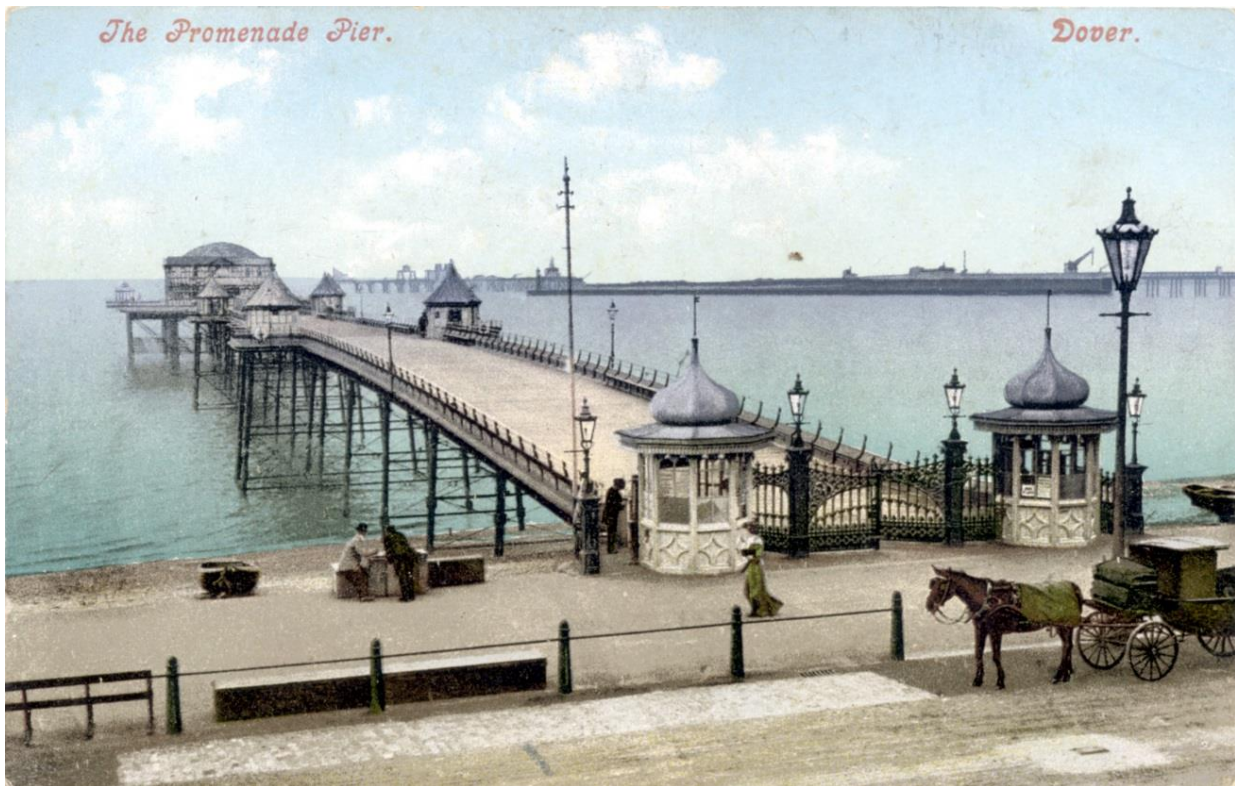
**Plate 5:** *The Pleasure Pier with added colour, 1908, Looking south-east, Dover Museum d27775.*
